APOLLO 15

30-DAY FAILURE AND ANOMALY LISTING REPORT

SEPTEMBER 1971

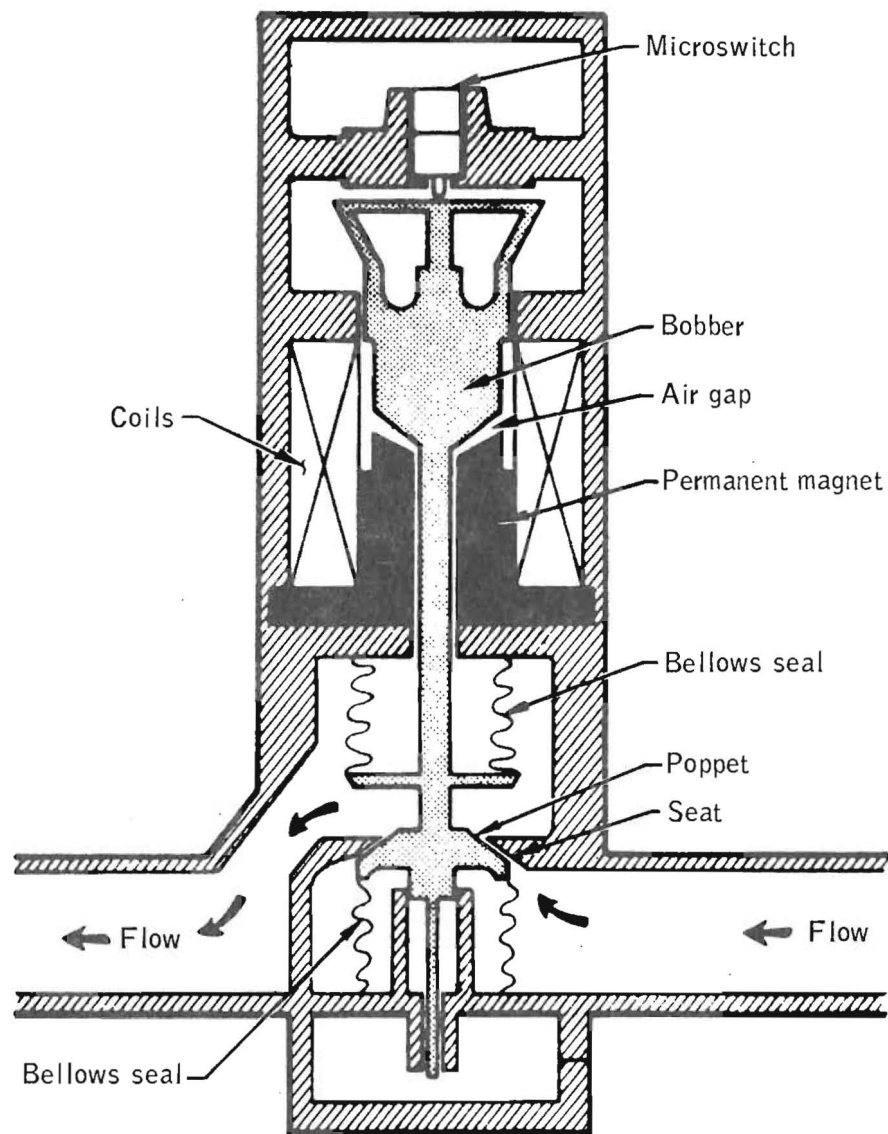
Figure 2-1.- Cross section of reaction control system isolation valve.

This type of valve (a magnetic latching valve, shown in fig. 2-1) has, in previous missions, closed as a result of pyrotechnic shocks. Ground tests have shown that the valve will close at a shock level of approximately 80g sustained for 8 to 10 milliseconds. There were no indications of shock levels of the magnitude required to close the valve during boost.

During acceptance testing of one valve for command and service module 117, the latching voltage changed from approximately 13 volts to 3 volts (the lower specification limit is 3.1 volts). Additional testing of the spacecraft 117 valve verified the low voltage condition. Additionally, the valve stroke was proper, thereby eliminating contamination as a possible cause of the problem.

Previous testing has shown that if the polarity to a valve is reversed with 28 volts supplied to the valve, the latching voltage will drop to a point where the valve will no longer remain latched (magnet completely degaussed). In addition, at lower voltages with reversed polarity, the magnet would become partially degaussed. During the test on spacecraft 117, the valve was disconnected from spacecraft power (28 volts) and was being supplied power through a variable power supply (approximately 20 volts, maximum, applied to the valve). The spacecraft 117 valve was most likely subjected to a reversed polarity at a voltage level which would partially degauss the magnet.

A magnetic latching force test was not performed on the valves after assembly into the system for the Apollo 15 command and service module, as on some previous missions. Tests and analyses are planned to determine if a test can be performed which will verify that the valve latching forces are satisfactory for launch without electrically disconnecting the valves.

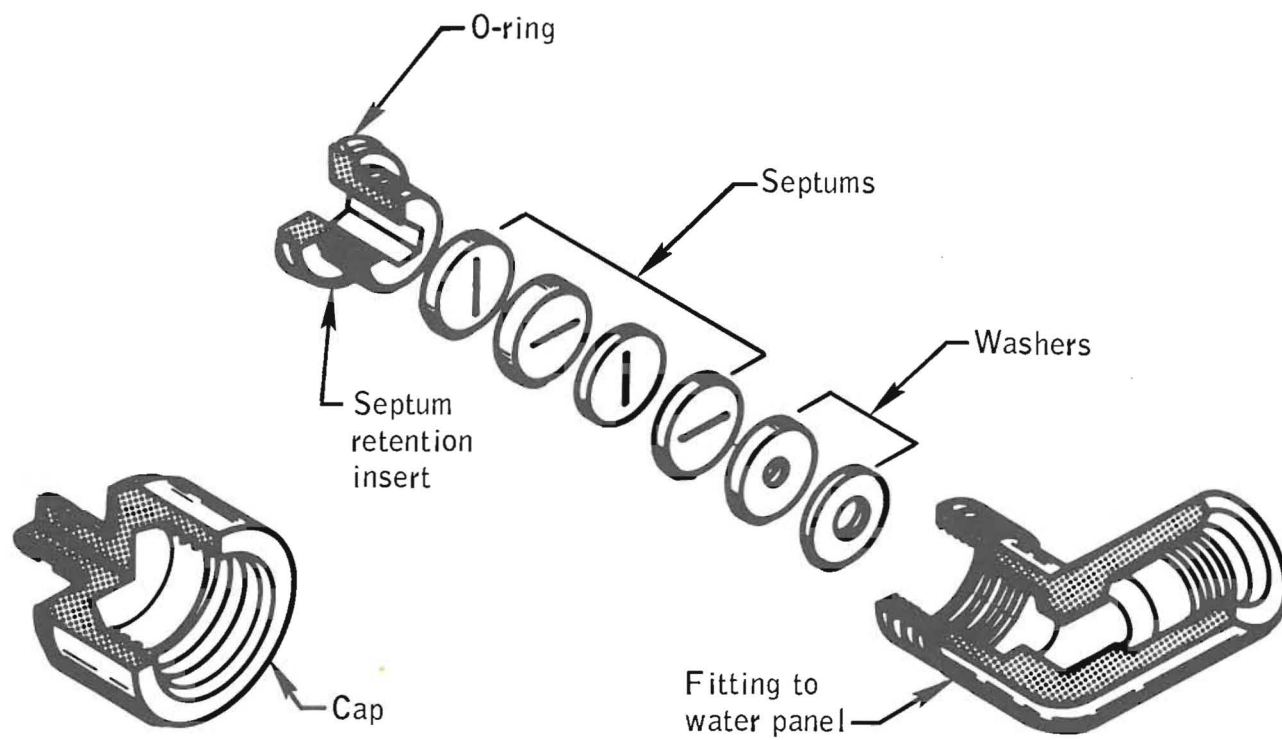
Figure 2-2.- Water panel chlorine injection port.

Minor leakage was noted from the chlorination injection port when the cap was removed to perform the prelaunch water chlorination. The cap was reinstalled and the leak ceased. A leak of approximately 1 quart in 20 minutes also was noted at the chlorine injection port as the crew removed the injection port cap for the third injection at about 61 hours. The crew tightened the port septum retention insert (fig. 2-2) and satisfactorily stopped the leakage. Leakage recurred at about 204 1/2 hours and was corrected.

As the cap is removed, the septum retention insert can back out of the water panel fitting because of the low torque values (5 in-lb maximum) used to squeeze the septums and washers into the fitting. Postflight inspection and dimensional checks of the injection port assembly will be made to determine the reason for loosening of the insert. The use of a spacer and a higher torque value is being evaluated for use on future systems.

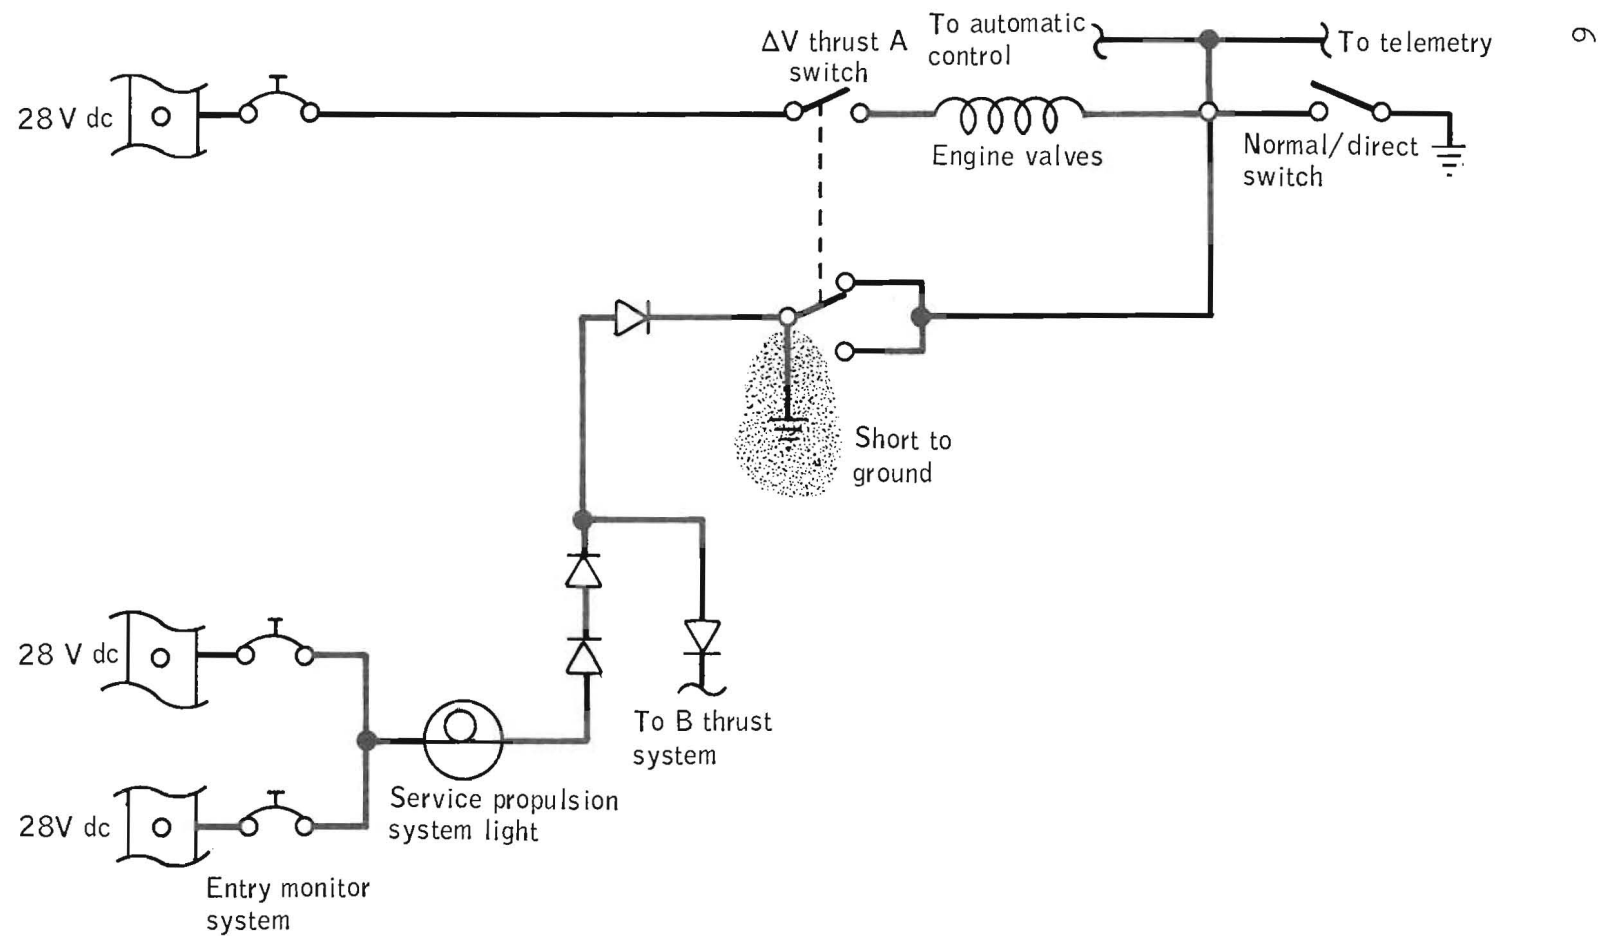
Figure 2-3.- Service propulsion system thrust light circuitry.

A test firing performed at 28:40:30 indicated a short on the ground side of the service propulsion system pilot valve solenoids. The short was further isolated to the system A delta-V thrust switch which was found to be intermittently shorted to ground (fig. 2-3).

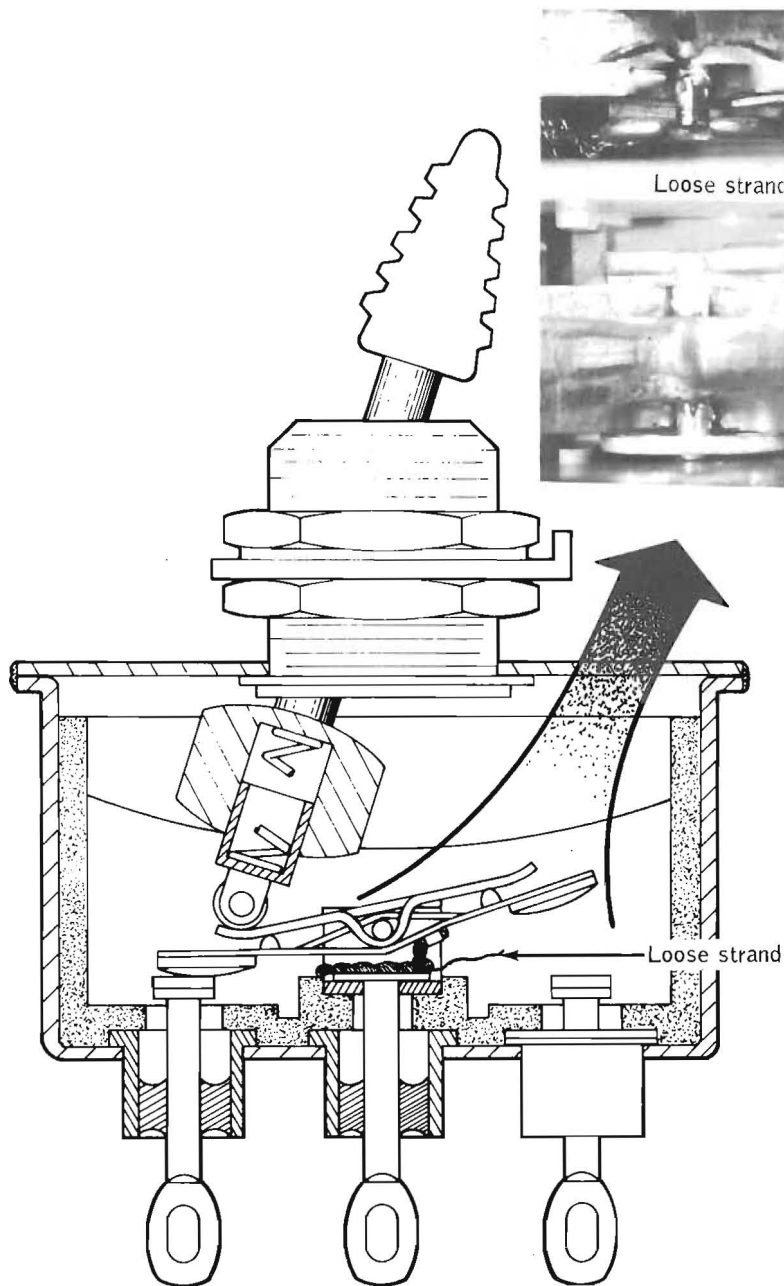
Figure 2-4.- Service propulsion system delta-V thrust switch.

The delta-V thrust switch (fig. 2-4) was shorted to ground both before and after removal of panel 1 from the command module during post-flight testing. The short-to-ground ceased, however, after a change in panel position. The switch was then removed from the panel and X-rayed. The X-rays showed a wire strand extending from the braid strap which was thought to have caused the grounding problem. After switch dissection, an internal inspection verified that a strand extended from the braid strap; however, it did not appear to be long enough to cause a ground at any point within the switch (fig. 2-4). The bracket assemblies (pivot brackets, pigtail braids, and movable contacts) and the plastic liner were removed from the switch. Microscopic examination revealed that a wire strand (approximately 0.060 inch long) was present on the flange on terminal 2 (fig. 2-5). The strand appeared to be attached, but was later moved quite easily.

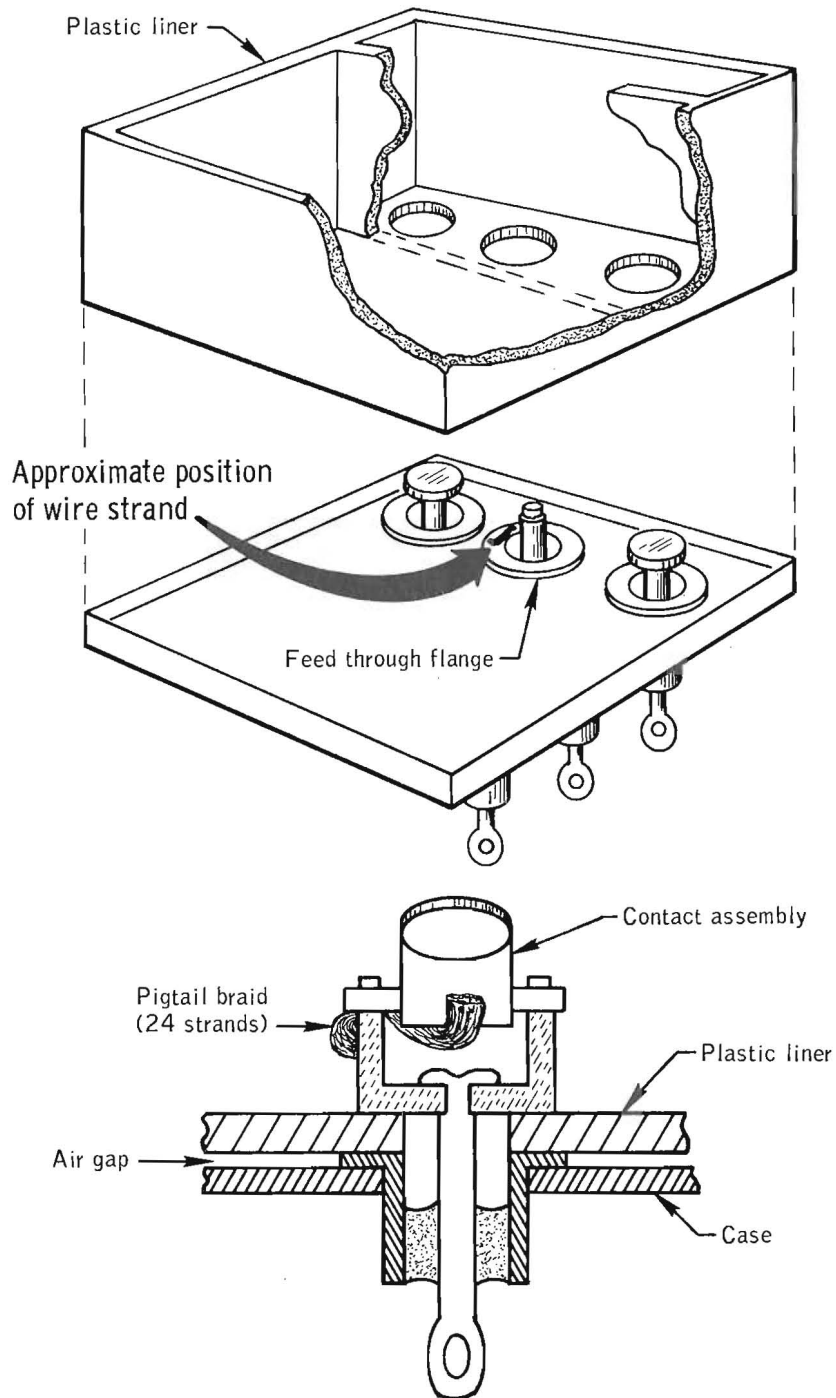
Figure 2-5.- Disassembled service propulsion system thrust switch.

The bottom of the plastic case liner was examined, and showed no evidence of a scratch or deformation conforming to the shape of the wire strand. A sample wire strand was placed on a feed-through flange of a scrap switch unit, and the plastic case liner was pressed on as would occur during normal switch assembly. When the scrap switch was disassembled, an indentation in the plastic case liner was readily apparent. This test indicated that the strand could not have been trapped between the case liner and the flange surface; therefore, it is postulated that it might have been enclosed in the cavity of feed-through terminal 2 (fig. 2-5). The maximum clearance between the interior of the feed-through terminal wall and the terminal itself is 0.032 inch. The wire strand could easily have bridged this distance, and yet is short enough to move quite freely within the feed-through terminal cavity. In fact, the strand subsequently fell into the cavity. The X-rays will be re-examined to determine if this strand can be detected.

The following switches for Apollo 16 were of an earlier series and have been replaced with 4000 series switches:

Switches for crew safety and mission success for Apollo 17 which are not screened switches will also be replaced.

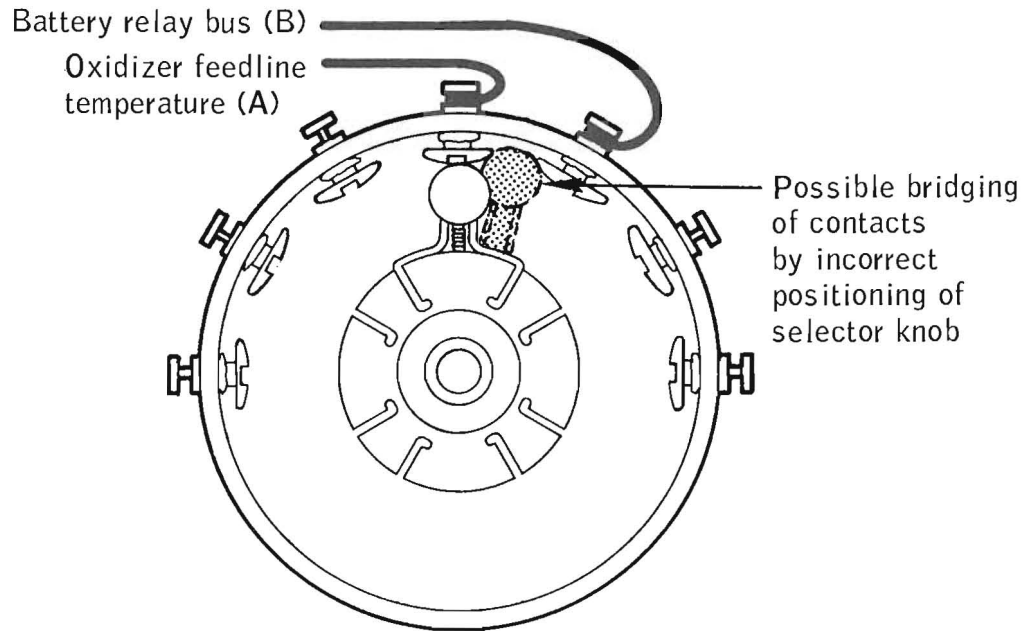
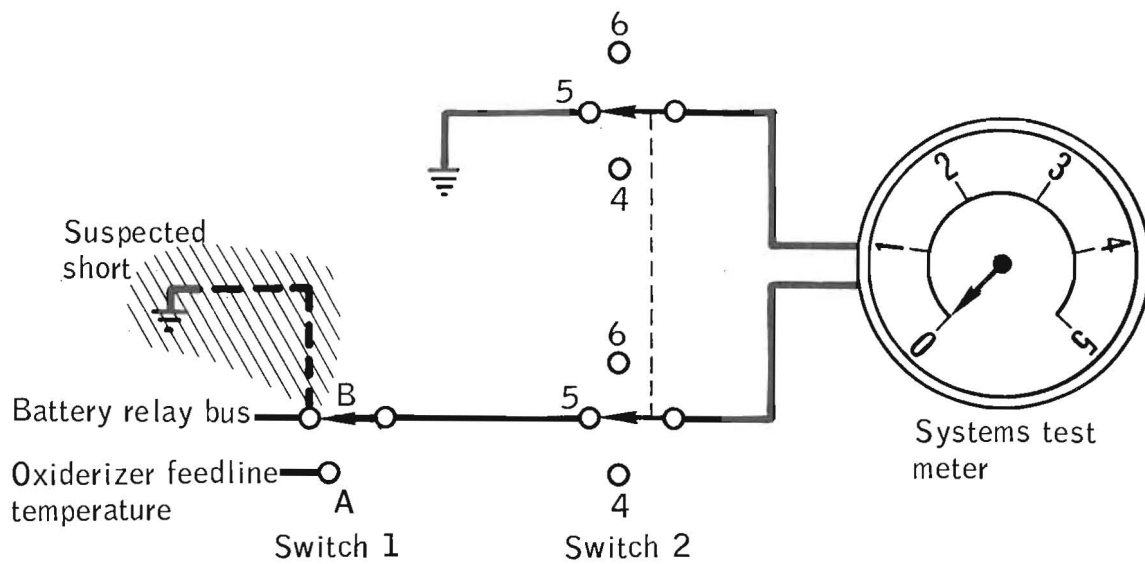
Figure 2-6.- Systems test meter switch.

It was believed that bridging of the adjacent contacts (fig. 2-6) would be the most likely cause of the anomaly. Postflight testing has revealed, however, that bridging of contacts could not reproduce the problem. Analysis indicates that a short of approximately 2.8 kilohms from the battery relay bus contact (fig. 2-6) of the switch to ground will reproduce the reading observed in flight.

The panel containing the systems test meter was removed from the spacecraft and all positions were checked for impedance to ground and to adjacent pins. No abnormal conditions were found. The panel will be installed in the spacecraft and the system tested with the signal conditioning equipment in the circuit. Subsequently, the switch will be removed for teardown inspection if no abnormalities are found.

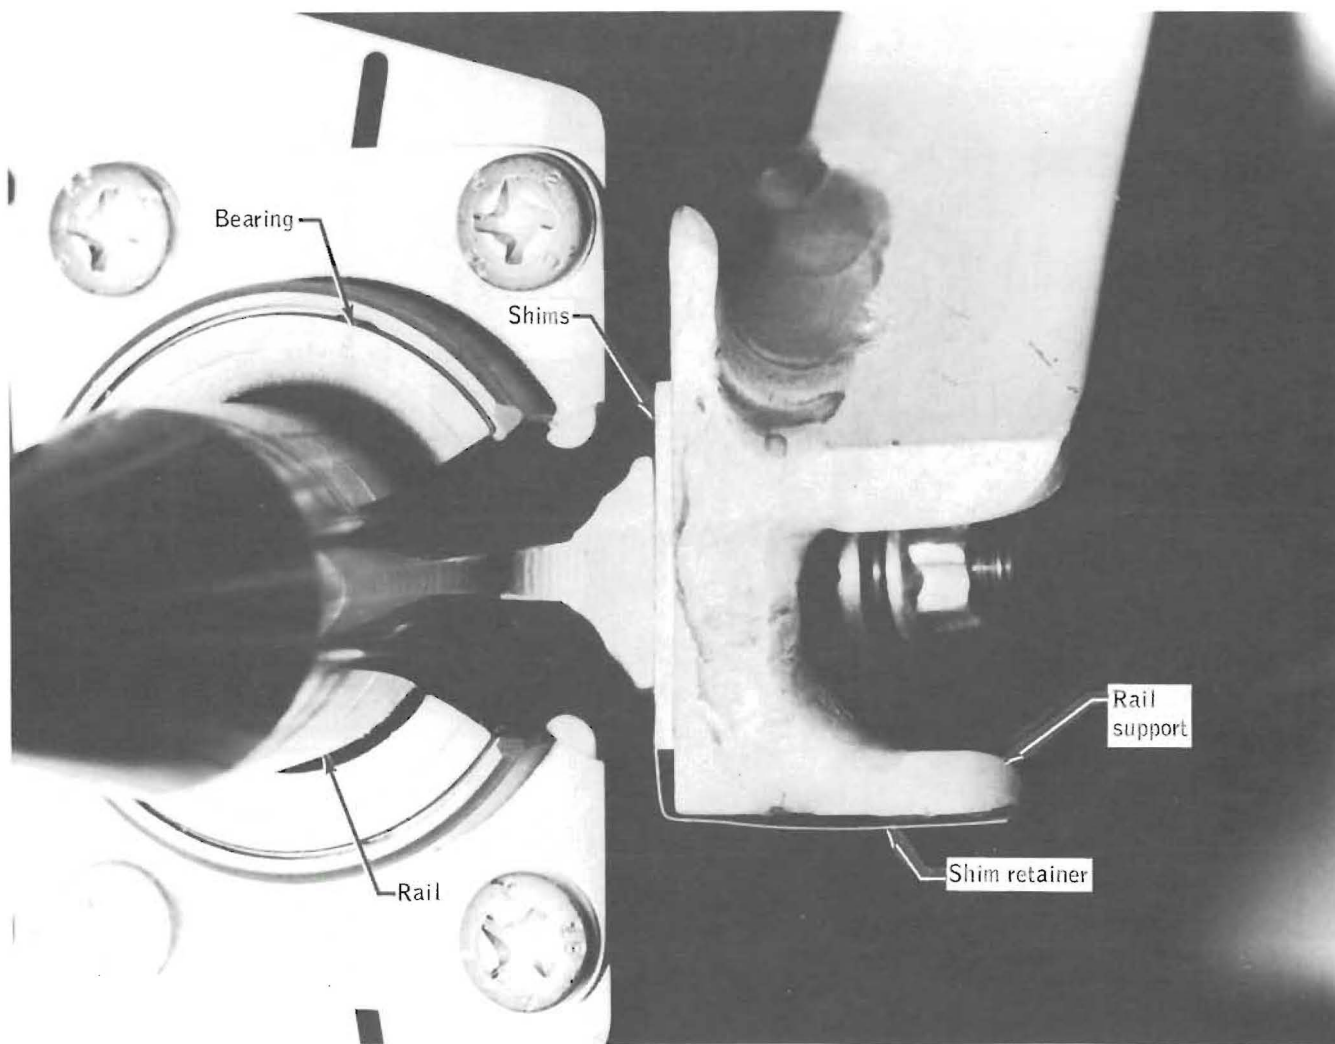
Figure 2-7.- Mass spectrometer right-hand bearing, rail, and rail support.

- a. Interference between the rail support assembly and the spectrometer bearing assembly (fig. 2-7).
- b. Binding in the floating rail.
- c. Spectrometer cable low temperature stiffness or interference problems such as improper stacking, retraction limit switch push rod being blocked, and pinching of cable between bearings and the funnel (fig 2-8).
- d. Interference of tie-down rod end.
- e. Interference of limit switch actuating pin with housing (fig. 2-9).
- f. Cover mechanism interference.
- g. Step lock binding.

Tolerances in these areas are being studied. Also a visual inspection of the Apollo 16 deployment mechanism will be performed and critical clearances will be measured. In addition a thermal vacuum screening test

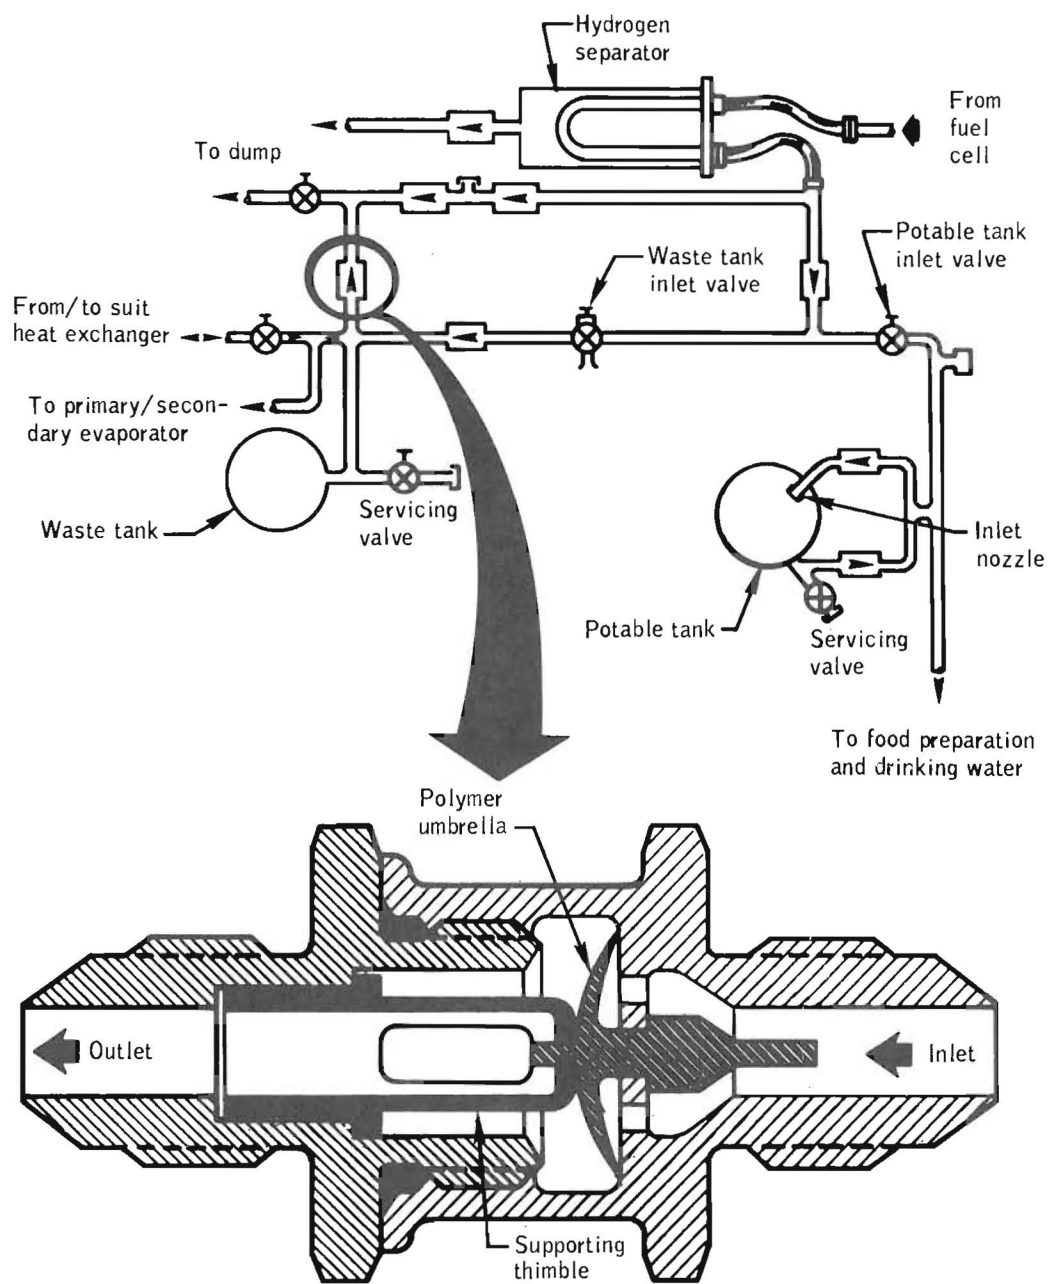
Figure 2-10.- Water management system and failed check valve details.

The potable water tank quantity began to decrease during meal preparation at approximately 277 hours and failed to refill for the remainder of the flight. The waste water tank continued to fill normally and, apparently, accepted fuel cell water for this period. A similar occurrence had been noted earlier, at 13 1/2 hours, when the potable tank quantity decreased, and the tank began to refill only after a waste water dump at 28 1/2 hours. This decrease had been attributed to a closed potable tank inlet valve until the crew verified in their debriefing that the valve had been open during this time. The amount of water drained from the tank verified that the tank instrumentation was reading correctly.

During a postflight fill operation, with water introduced at the hydrogen separator and the waste tank inlet valve closed, the potable and waste water tank filled (fig. 2-10). This shows that the suspect check valve in the waste tank dump leg (fig. 2-10) did not check. The path of least resistance with the check valve leaking would be to the tank with the lower quantity.

The valve will be removed from the spacecraft for further tests and teardown inspection to determine the cause of the malfunction.

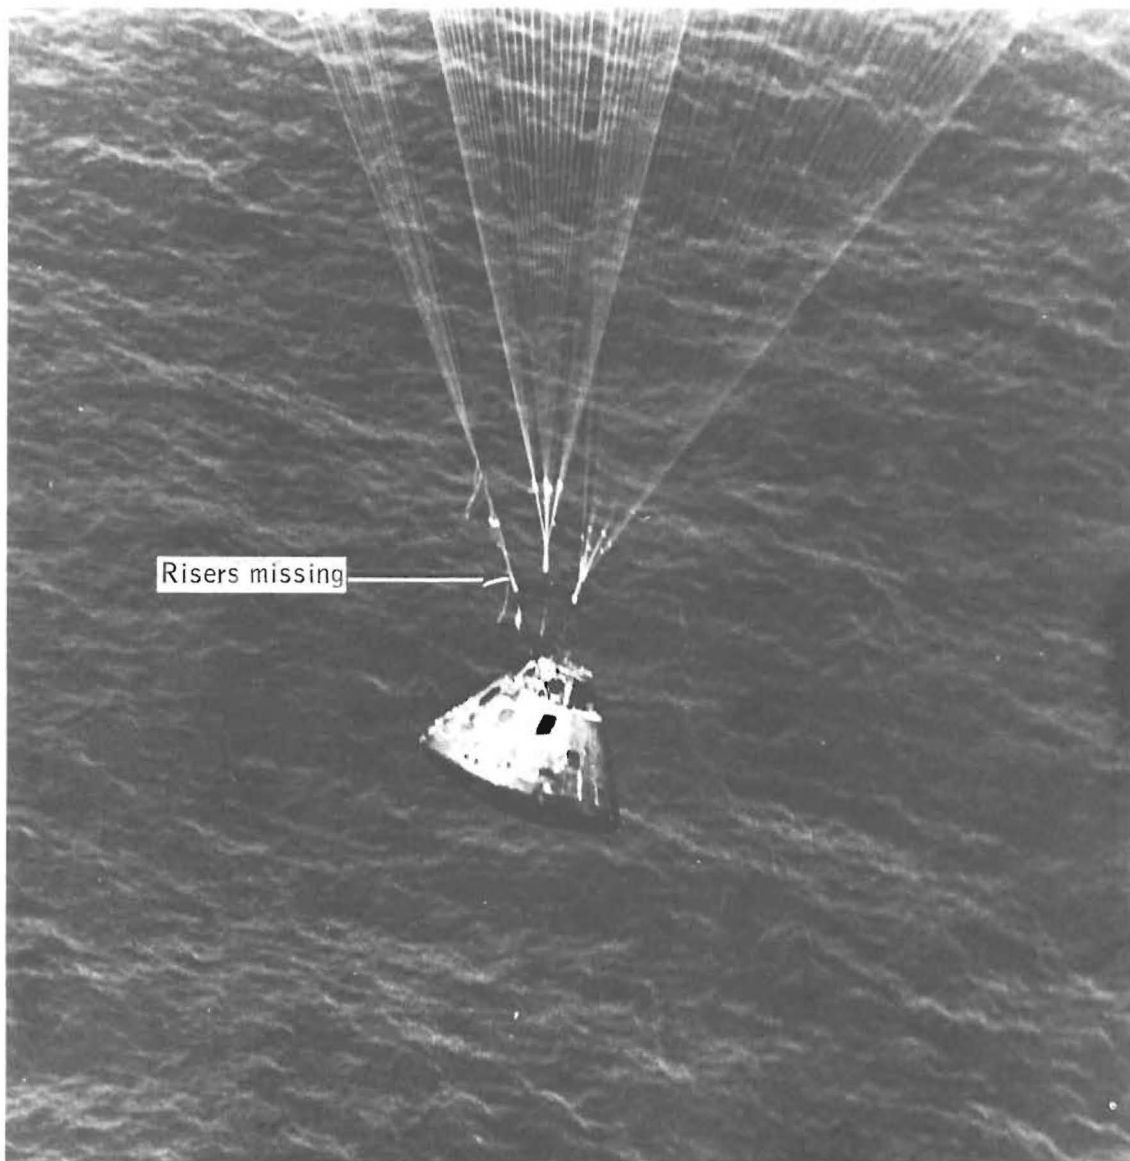
Figure 2-12.- Parachute riser damage noted during final descent.

One of the three main parachutes was deflated to approximately one-fifth of its full diameter at about 6000 feet altitude. The command module descended in this configuration to water impact. All three parachutes were disconnected and one good main parachute was recovered. Accelerometer and rate data show that the load was abruptly relieved about 4 seconds after the reaction control system depletion firing, but before the reaction control system purge had been initiated. The parachute that failed was over the minus pitch and roll reaction control engines to satisfy the force vectors indicated by the accelerometers (fig. 2-11). Photographs of the descent indicate that two or three of the parachute risers were missing (fig. 2-12).

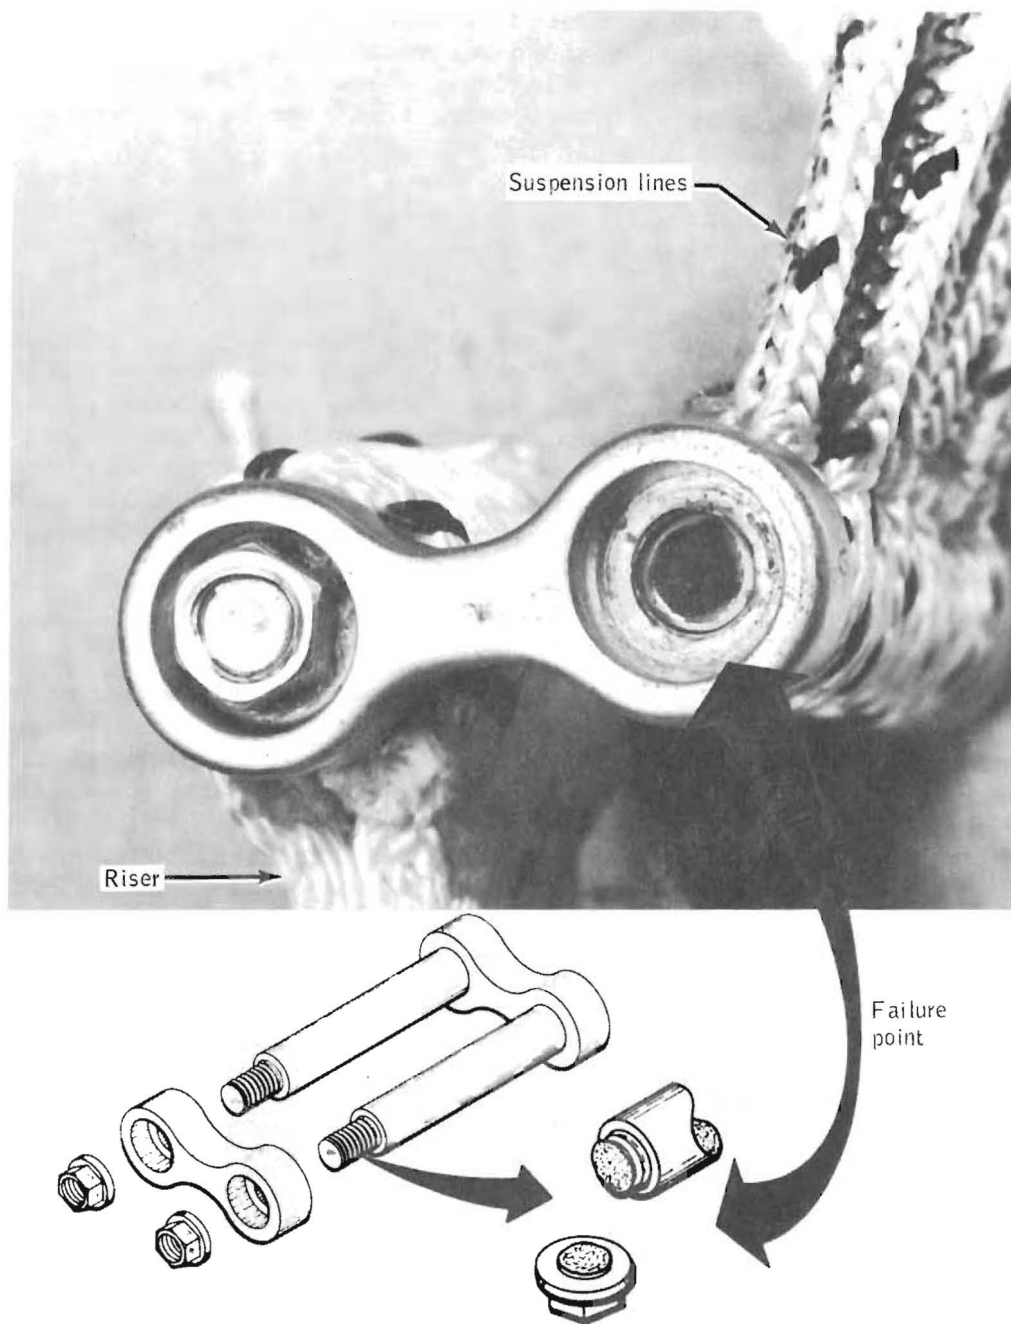
Figure 2-13.- Main parachute connector link failure.

- a. Forward heat shield which was in close proximity to the spacecraft flight path.
- b. Command module reaction control system propellant firing which was just completed.
- c. Broken riser suspension line link which was found on the recovered parachute (fig. 2-13).

The failed link on the recovered parachute implies the possibility of a similar occurrence on the failed parachute. This satisfies the flight data and the visual and photographic data. However, two or three links would have had to separate simultaneously; this item is undergoing further investigation.

Possibilities for the link failure include hydrogen embrittlement, stress corrosion, material defects, manufacturing defects, or assembly problems.

Structural testing and metallurgical examination on the recovered links, and links of different lots, indicate that the hydrogen embrittlement concern was not evident on the flown links. Additionally, all test indications show that saltwater exposure did not induce the cracks, although rusting would be rapid if cracks existed at the time the links were exposed to saltwater. The results indicate the broken link flaw probably occurred prior to saltwater immersion for a reason that is not currently understood.

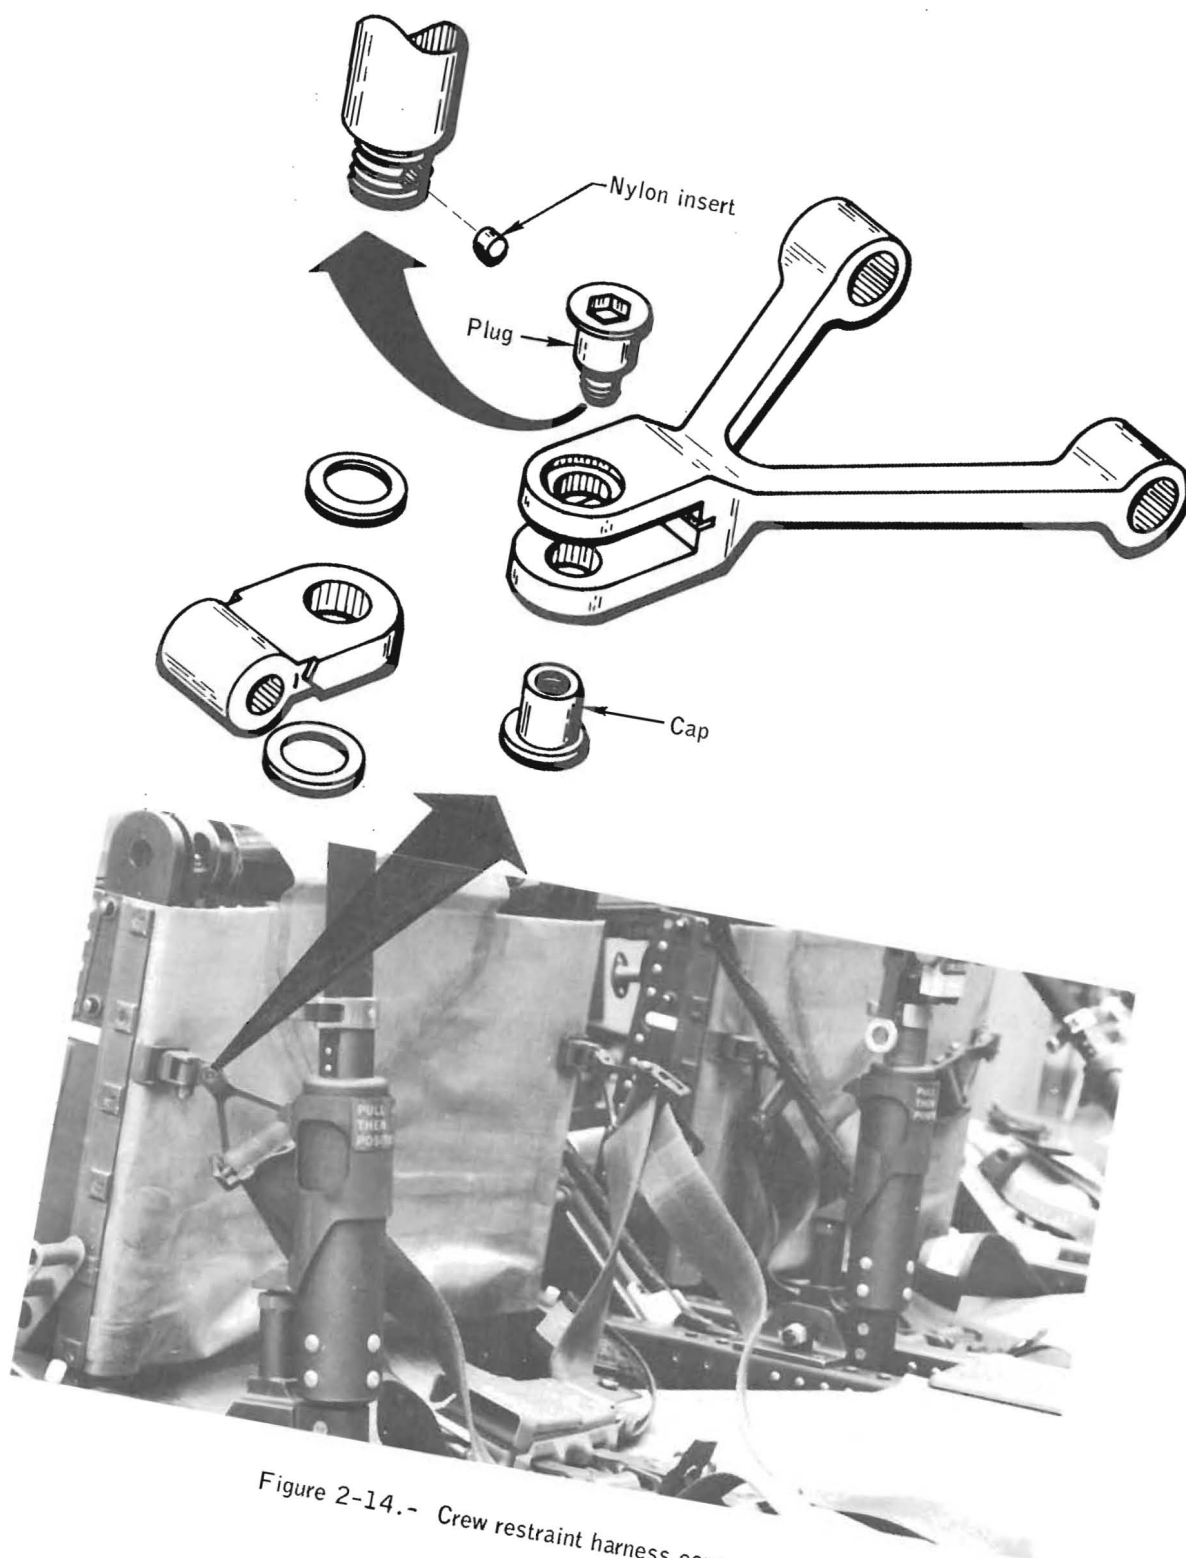
The plug-and-cap assembly (fig. 2-14), which is part of the universal assembly that attaches the restraint harness to the couch seatpan, separated. (There are a total of six plug-and-cap assemblies on the crew

couch, two per man.) The plug component (bolt) has a nylon insert in the threaded portion that acts as a locking device. Fore and aft rotation of the adjuster link can cause the plug-and-cap assembly to unscrew from each other. The locking insert appears to have marginal engagement.

Staking or use of a thread locking sealant is being evaluated to prevent the problem on future missions.

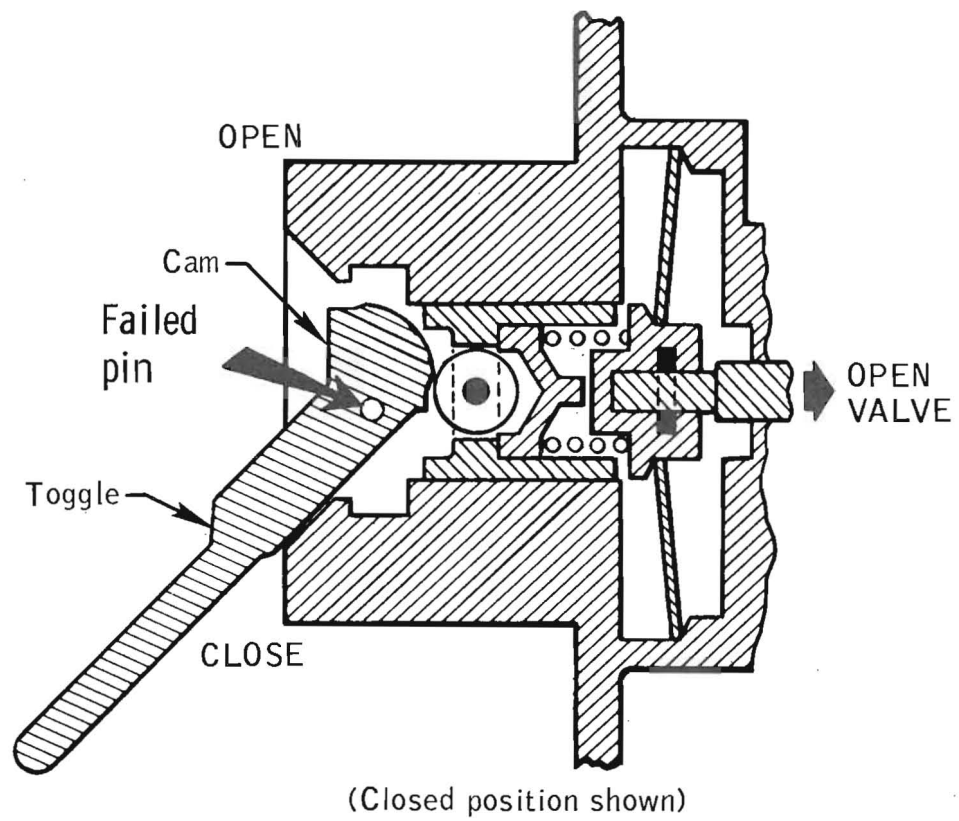
Figure 2-16.- Sheared pin on oxygen regulator shutoff valve.

The toggle arm pivot pin for the side-A shutoff valve of the main oxygen regulator (fig. 2-16) was found sheared during the initial actuation from the open to the closed position during postflight testing.

With the pin failed, the shutoff valve is inoperative in the closed position, thus preventing oxygen flow to the regulator.

The failed pin will be analyzed with respect to the material, its fracture characteristics, and the design.

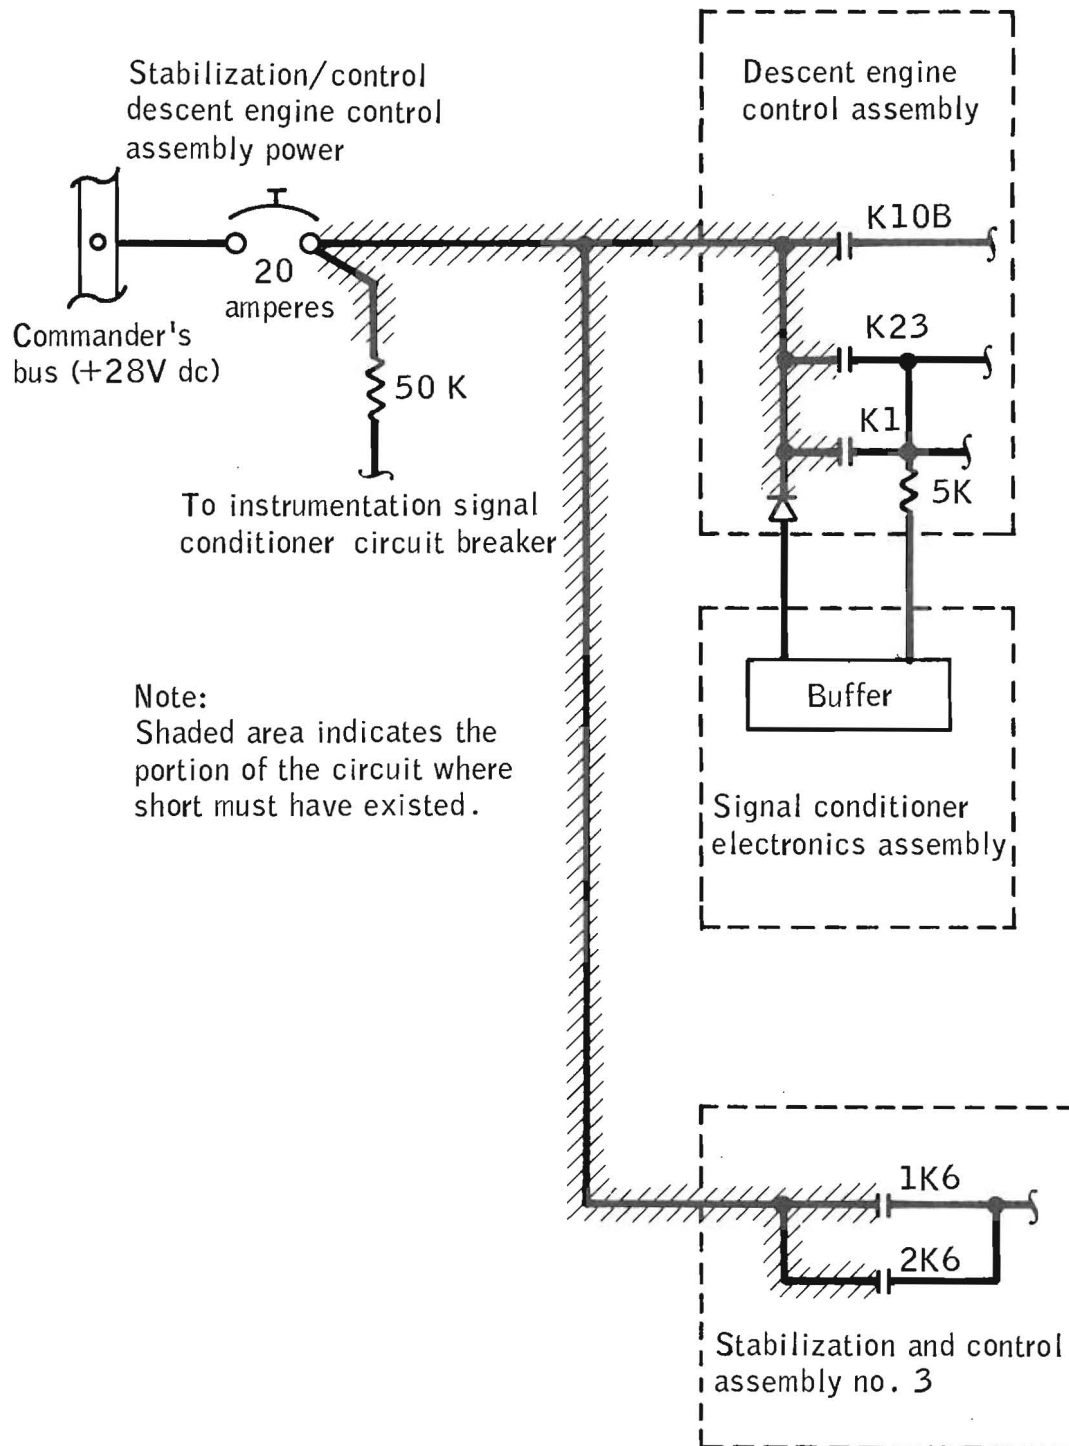
Figure 3-8.- Descent engine control assembly circuit breaker loads.

The crew stated that they may have left the circuit breaker open. If they did not, a short to ground of sufficient magnitude to open the breaker (fig. 3-8) would have to have occurred. To open the 20-ampere breaker, loads of 30 amperes for 1 minute up to 200 amperes for 1 second are required.

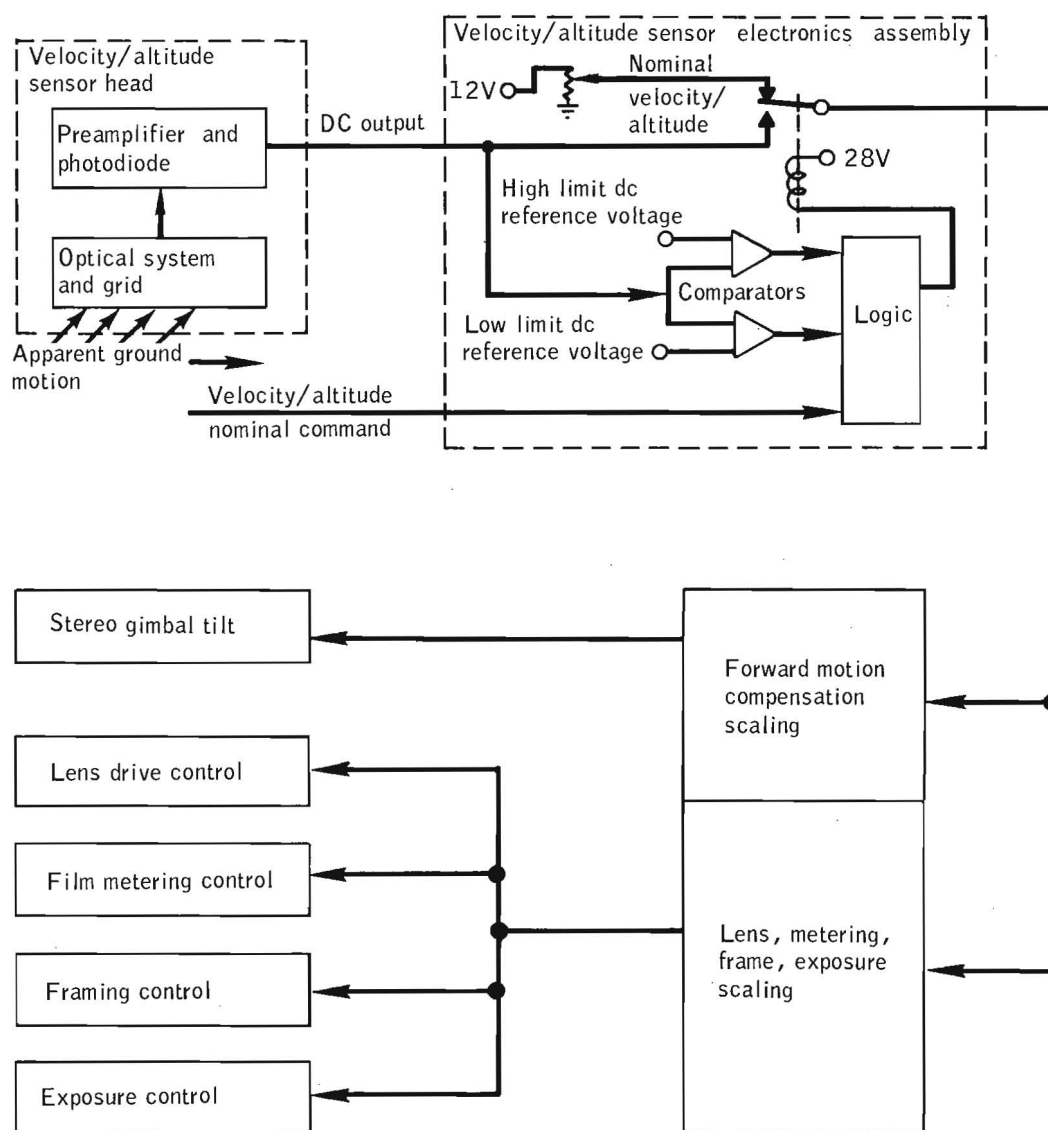
Figure 4-2.- Velocity/altitude output circuitry.

A circuit analysis of the velocity/altitude electronics (fig. 4-2) was performed in an attempt to isolate a component that may have been defective, but the results were negative. Breadboard testing is now in progress. In addition, tests were conducted in which an endless belt of lunar scene photography from Apollo 8 was passed in front of velocity/altitude sensors. Sensors from the prototype and qualification units, and flight unit number 1 were used. By varying the illumination level, sensor performance somewhat similar to the Apollo 15 anomaly could be obtained. Although the anomalous performance during the mission occurred with lunar scenes of both high and low contrast and high and low illumination levels, the possibility of a basic error in the velocity/altitude sensing concept is not being discounted. Therefore, further simulations utilizing Apollo 15 panoramic camera pictures are to be performed.

A manual override of the velocity/altitude sensor on the remaining flight units is being considered. By utilizing a three-position switch, two preselected velocity/altitude ratios could be provided, as well as the automatic function.

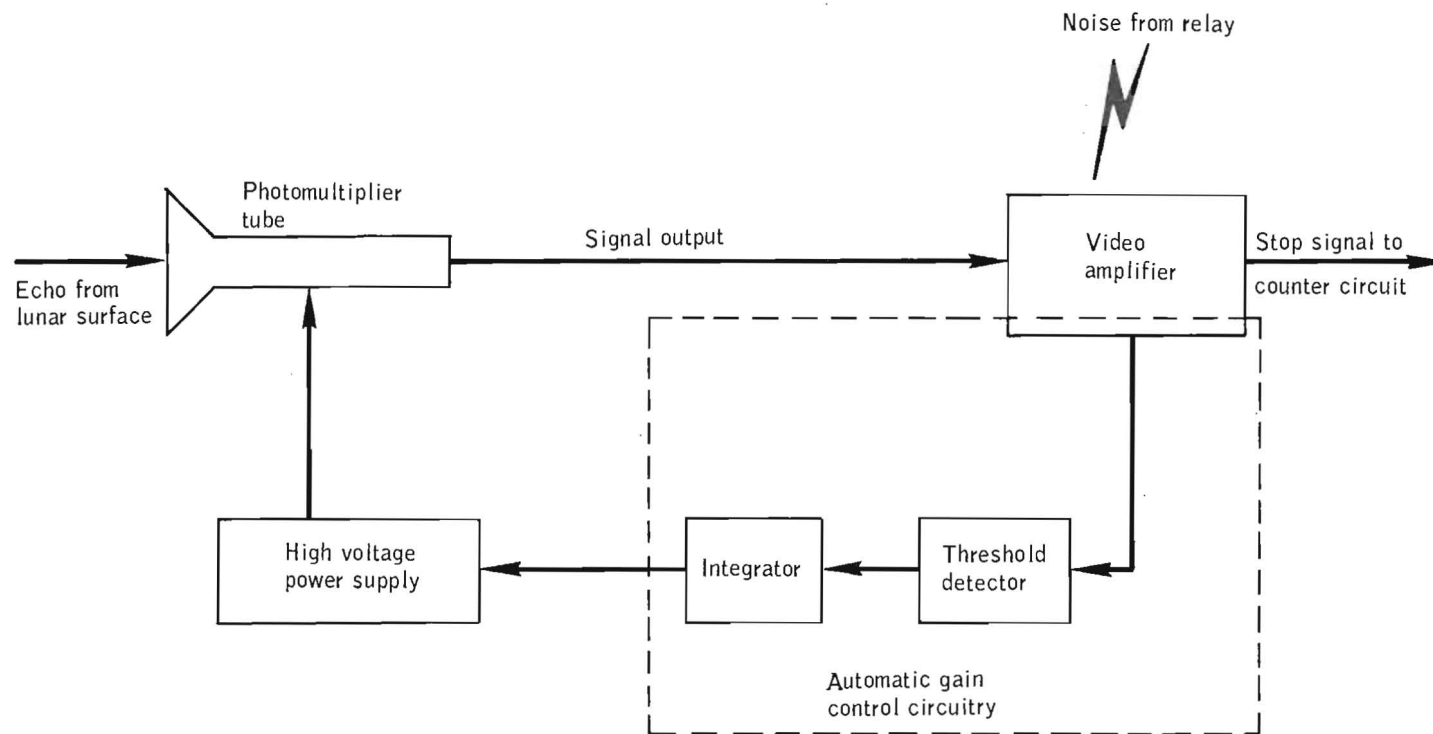
Figure 4-5.- Laser receiver circuitry.

It is suspected that the audible "buzz" is accompanied by electromagnetic interference that is coupled into the video amplifier in the laser receiver (fig. 4-5). The video amplifier is a principal element in the automatic gain control circuit which controls the output of the photomultiplier tube power supply. The electromagnetic interference from the relay can thereby result in the automatic gain control holding
