APOLLO 15

30-DAY FAILURE AND ANOMALY LISTING REPORT

SEPTEMBER 1971

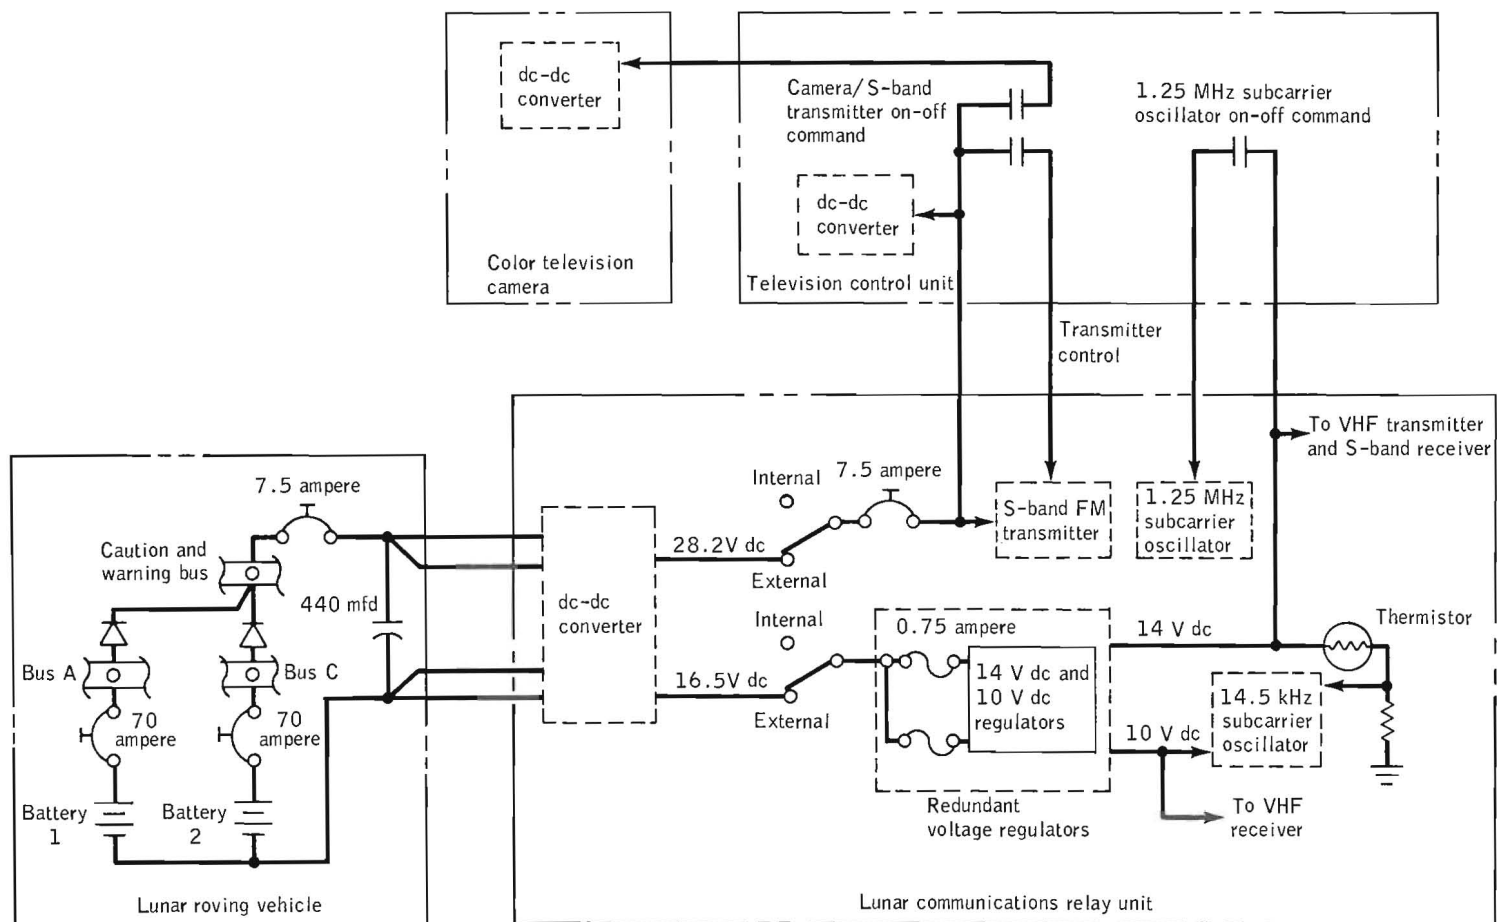
Figure 6-3.- Lunar roving vehicle/lunar communications relay unit/ground controlled television assembly power distribution.

In laboratory tests, numerous types of faults were induced into the lunar communications relay unit developmental unit and associated ground-controlled television assembly and lunar rover vehicle interfaces to determine whether the transient characteristics of the flight signal could be duplicated. The fault which duplicated the flight signal was the opening of the lunar roving vehicle power line prior to the 440-microfarad capacitor (figs. 6-2 and 6-3). The Tests, show that the decay time of the lunar communication relay unit 28-volt and 14-volt power is increased by discharge of the 440-microfarad capacitor. Other induced faults resulted in shorter power decay times, affecting the received signal accordingly. The temperature measurement output (see thermistor in fig. 6-2) is proportional to the decay in 14-volt power. Consequently, the 6-percent decay of the flight temperature signal corresponds to a 1.4-volt decay. This characteristic was exactly duplicated when the lunar roving vehicle power line was opened. The 28-volt power decayed to 21.8-volts dc when the 14-volt power decayed to 12.6-volts. The RF transmitter power at this voltage will be decreased by 6.4 dB, which accounts for total signal loss at this exact time since the ground receiver would be below its threshold. This characteristic was also duplicated with the flight data when the lunar

roving vehicle circuit was opened. In summary, the test shows either the 7.5-ampere circuit breaker popped, or a wire opened upstream of the 440-microfarad capacitor.

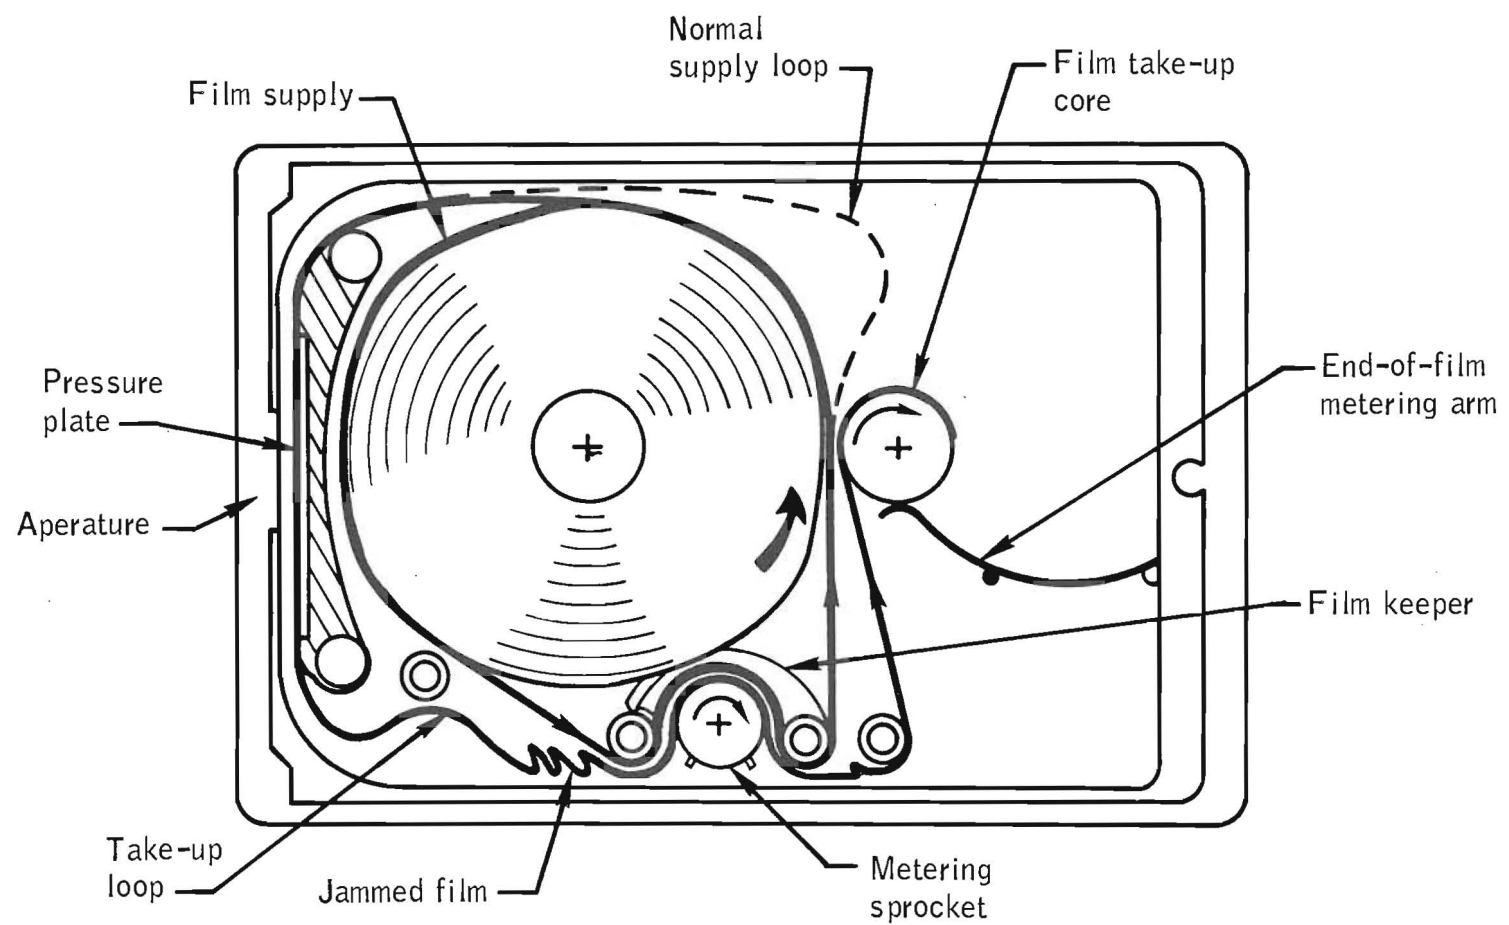
Figure 6-4.- Lunar surface 16mm camera magazine.

a. The first magazine installed showed, by damage to the magazine drive spline and scratches on the front face, that installation in the camera was improper and the magazine and camera were misaligned. Misalignment of the floating female spline of the camera with the male spline of the magazine was such that metal was removed from the brass male spline. The magazine spline shaft is attached to the metering sprocket (fig. 6-4). Mismatching results in depleting the film supply loop without allowing replenishment and takeup through the drive spline/metering sprocket mechanism. The lower, or takeup, loop becomes accordion folded, thereby jamming in the metering sprocket gate (fig 6-4). Two other magazines exhibited damaged drive splines, indicating that mismatching occurred on at least three occasions. Pictures taken of the lunar roving vehicle with photographs taken with the lunar surface 70-mm camera show that a strip of tape installed on the 16-mm camera magazine for latch stowage protection was not removed prior to installation of a film magazine. Leaving the tape strip in place does not allow the magazine latch to move down for normal magazine installation. Although the crew reported no problem with magazine installation in this condition, this could have contributed to the camera/magazine mismatching.

b. In the course of troubleshooting, the crew manually advanced the film in all remaining magazines prior to the second extravehicular activity and again prior to the third extravehicular activity. The amount of manual advancement varied from five to twenty-one frames in the several jammed magazines. The film supply loop (fig. 6-4) contains three to five frames excess. The normal procedure is to advance manually not more than one frame to verify perforation indexing. The excessive advancement depleted the film supply loops in all magazines, creating again the excessive takeup loop condition causing accordion folding and jamming in the metering sprocket (fig. 6-4).

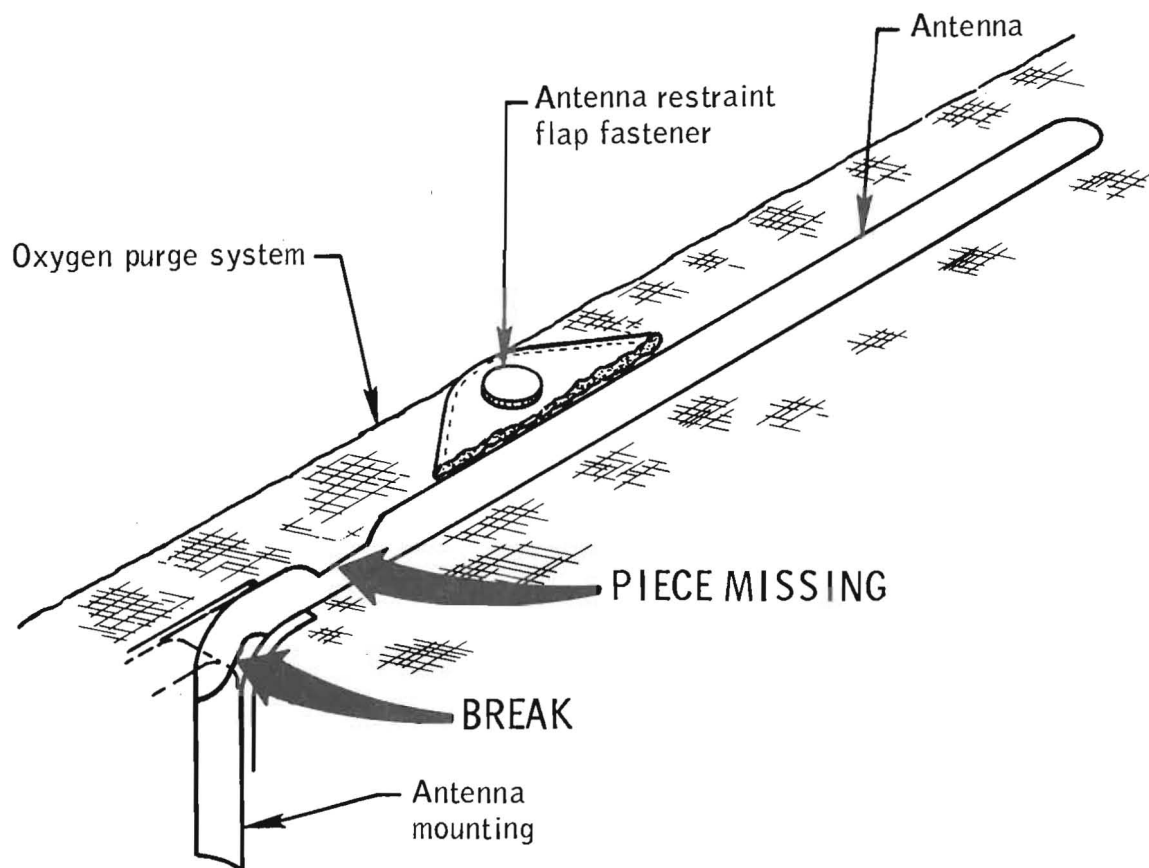
Figure 6-5.- Damaged antenna stowed on oxygen purge system.

Antennas broken in training have shown similar flexure breaks. Preliminary observation of the notch edges indicates the notch started as a partial break in flexure, followed by material removal by being torn out the rest of the way.

The material in the returned antenna is being tested for physical properties including brittleness which could account for easy breaking. Possible changes in deployment and stowage of the antenna are under consideration.
