**Aerospace
Systems Division**

54L ALERT
BxA Response Summary

ATM 1081

DATE 30 March 1972

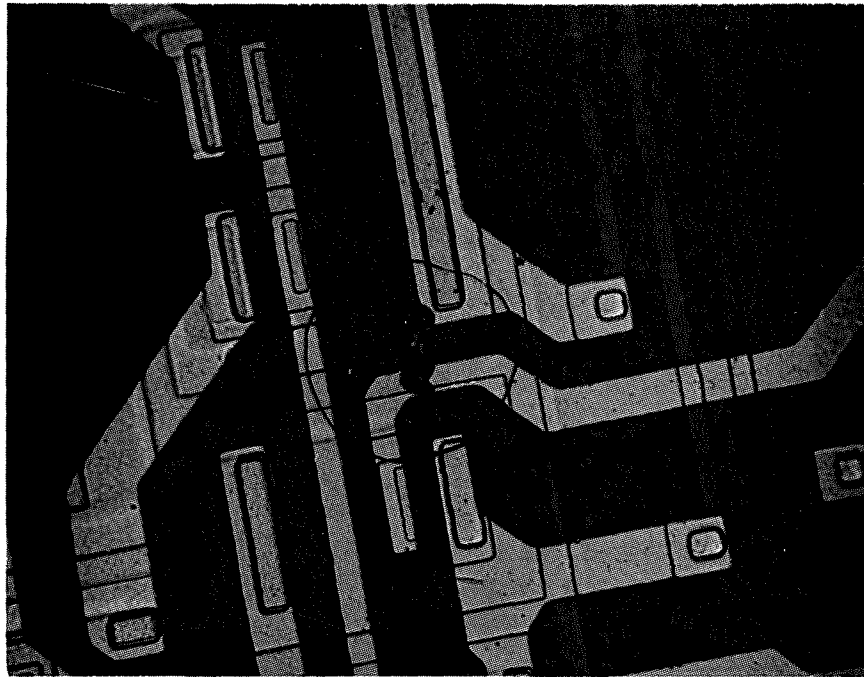
Figure 2 - Photo Micrograph of Iron Particle 320X

4. Both opened units were examined optically. The general appearance of both devices was good although the post bonds appeared to be slightly over bonded. One large (approx. 1.5 mils x .5 mils) particle contaminate was found in the failed part which could not be dislodged with a nitrogen blow. This particle was bridging two metal runs (see the attached photos).

6. The failed part was then analysed under a Microprobe for X-ray spectral analysis. The contaminant was determined to be at least 95% pure iron. No traces of gold, nickel, chromium, or cobalt was found. Therefore the contaminant particle could not have been introduced by opening the part.

The cause of failure has been positively identified to be an iron particle contamination introduced at T.I. prior to capping. The contaminant is now lodged so firmly that vibration cannot shake it loose.
