**Aerospace  
Systems Division**  
5-9-67

Prototype Experiment  
Pre-Integration, Integration  
& Crosstalk Test Results

NO.  
ATM 657

This ATM describes the test results of the Pre-Integration ,  
Integration and Crosstalk Tests performed on the Passive Seismic,  
Magnetometer and Solar Wind experiments, thru the period of March  
-April 1967.

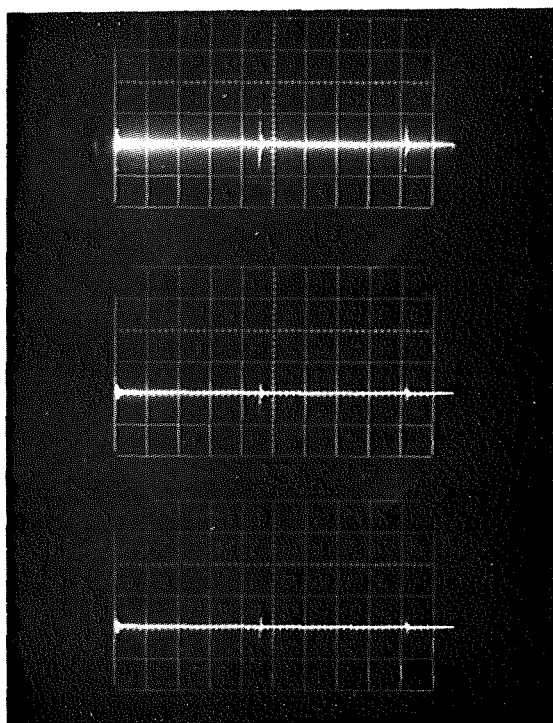
Figure 1.3.1 SWS +29 V Power Converter Noise

The integration tests for the SWS were also performed quite smoothly. Again no significant problem areas were noted. Of the three EM test discrepancies noted in ATM 618, only power line noise remained as an out of tolerance spec condition. Noise from the converter was greater than 400 mV peak to peak. Figure 1.3.1 depicts the noise photographed during subsystem tests. Noise on the timing and control and command lines not noted on the EM SWS was documented. For reference purposes, Figure 1.3.2 depicts noise created by the Central Station Data Processor with the SWS off line. Figure 1.3.3 depicts the shift pulse line with SWS converter noise of 300-400 mV of noise. The same type of noise is present on the data line as noted in Figure 1.3.4.

Out of  
Spec. Cond.

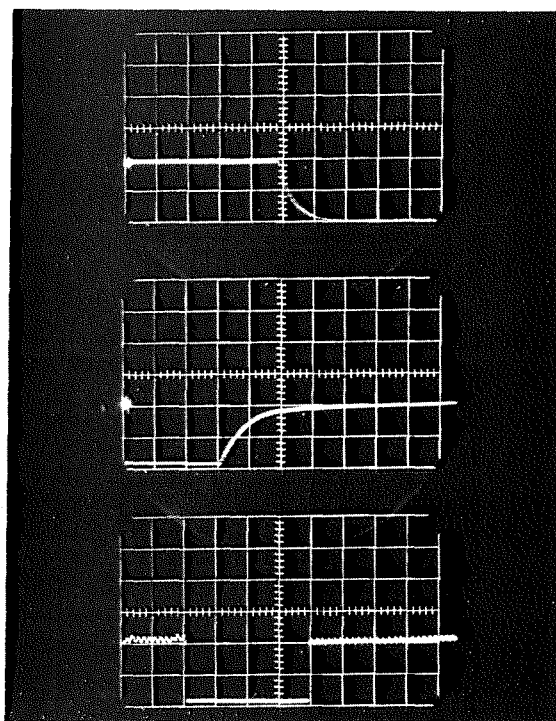
Figure 1.3.5 SWS Command Pulse, Rise & Fall Time  
with Shift Pulse Noise

Shift pulse crosstalk was noted on the command line. This type of noise is shown in Figures 1.3.5 and 1.3.6. Further investigation is under way to determine the source of the noise. Current noise was noted and  $di/dt$  of  $200 \times 10^6$  milliamp/millisecond was measured. This value, along with similar values measured on other experiments during EM testing indicates a more realistic specification greater than the 500 milliamp/millisecond spec value is in order. Figure 1.3.7 depicts typical current noise photographed during subsystem tests.

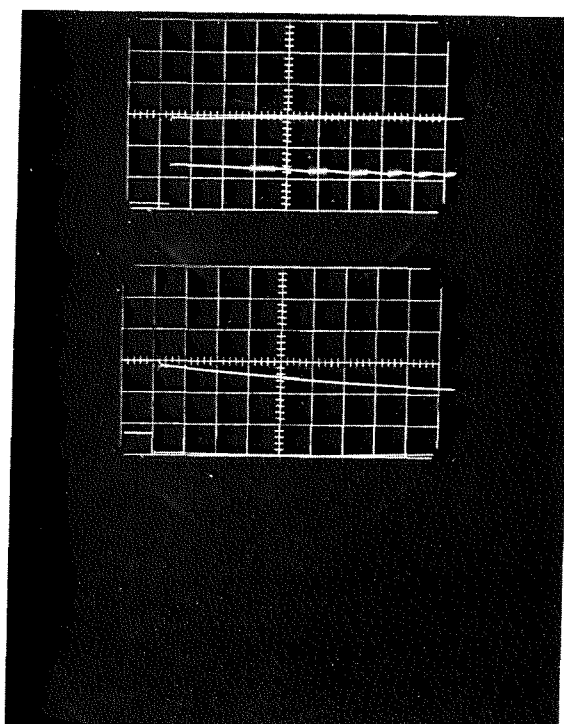
Figure 1.3.8 SWS Turn ON/OFF Voltage and Current  
Waveforms

Current noise which appears to be associated with the shift pulse was noted during investigation of the SWS turn-on. Figure 1.3.8 depicts the noise which will be investigated further. Finally, the turn-off voltage transient was recorded at approximately 60 v peak to peak in Figure 1.3.9.

Note Shift Pulse  
Current Noise  
During Turn-On

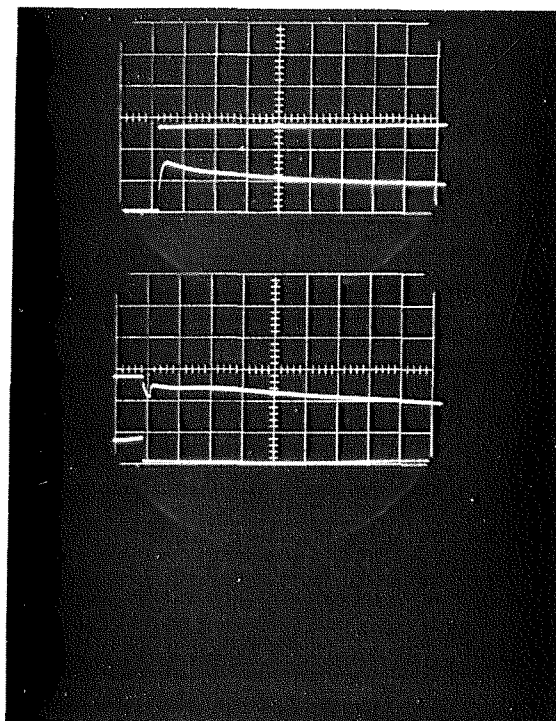
Figure 2.3.1 LSM Turn On/Off Voltage & Current

The turn-on voltage and current waveform is shown in Figure 2.3.1. This waveform had not been recorded previously since a 50 ohm surge supressor had been employed during turn-on previously. Figure 2.3.3 shows the Digital data waveform from LSM. Noise on top of the wave form was similar to the EM. Power Converter Noise was greater than that seen on the EM. Figure 2.3.3 thru 2.3.7 depicts this noise. Current ripple during normal operation is shown in Figure 2.3.8 for comparison with the Flip-Cal Motor Current Ripple shown in Figure 2.3.9 and 2.3.10. This ripple is greater than the 150 MV peak to peak (across a 2 ohm resistor) value specified in revision C of the ICS.

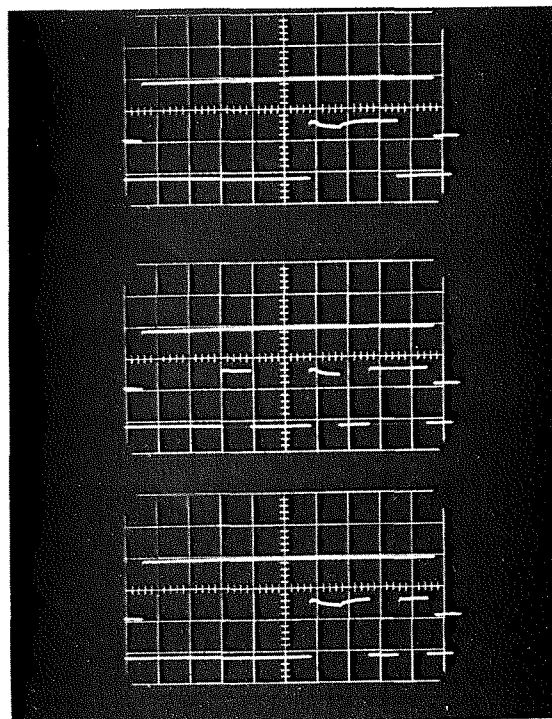
Figure 2.3.2 LSM Demand & Digital Data Signals

Note Noise  
on Data

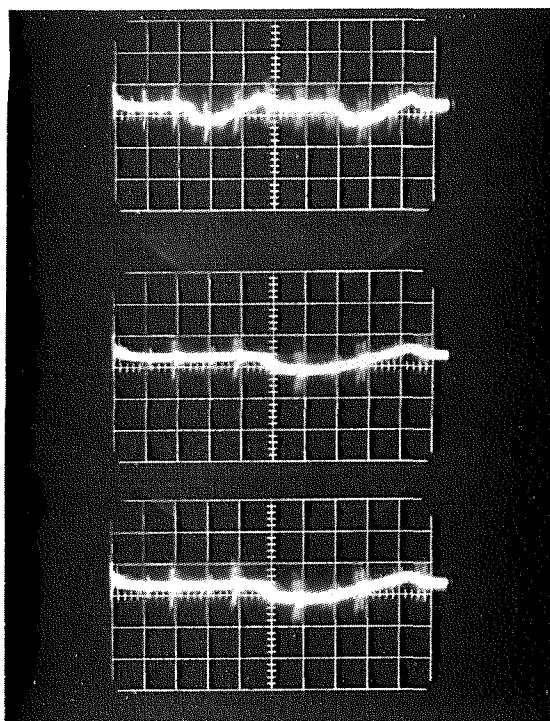
Figure 2.3.3 Power Line Noise

Out of  
Spec

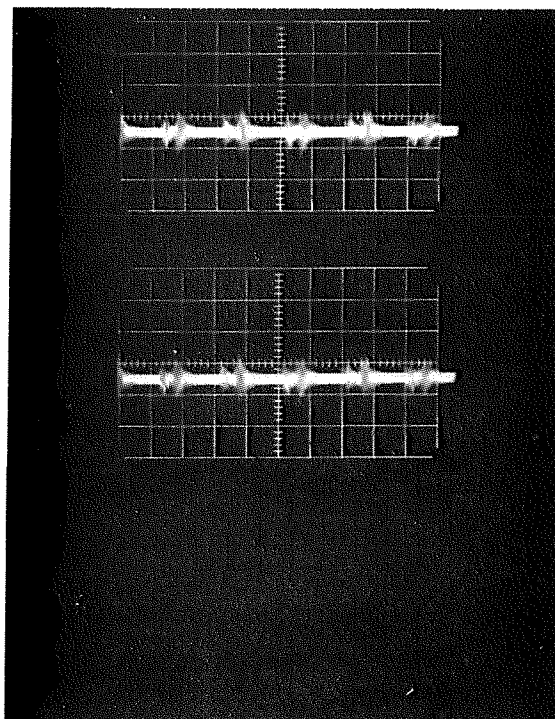
Figure 2.3.4 Data Line Noise

Out of  
Spec

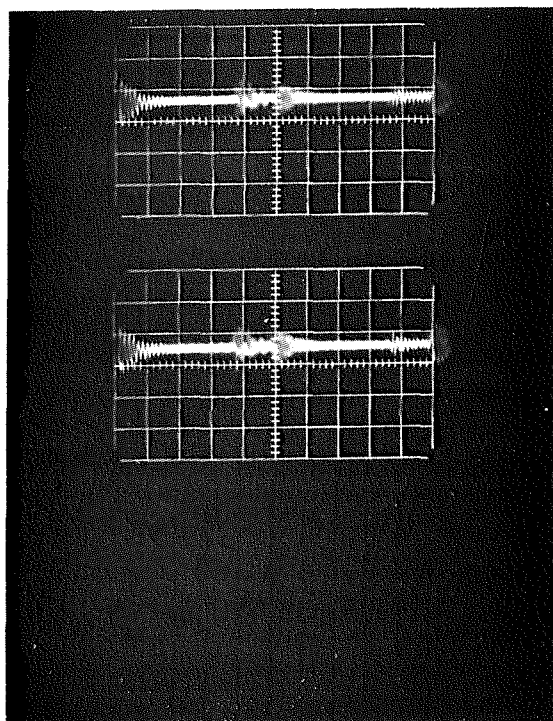
Figure 2.3.5 Shift Pulse Noise

Out of  
Spec

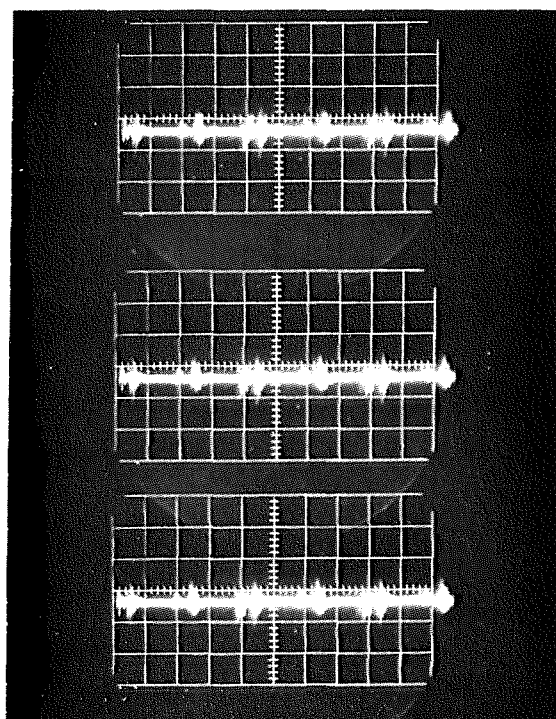
Figure 2.3.6 Command Line Noise

- 10) Engineering Data for words 4 and 12 unstable : Switches from 000-127, i. e. full scale oscillation.
- 11) Y and Z Data changed sign intermittently : Both channels tied together - change should not occur
- 12) Z offset cycle incorrect : offset sequence contained no positive offsets.
- 13) Engineering Data 16 Frame Sub Commutator stops, skips and jumps intermittently : occurred throughout tests - appears associated with science data glitches.
- 14) Logic and Power Switching unduly sensitive to EMI.
- 15) Channel 7 Engineering Data Jitter : Throughout test data shifted 1 Bit from 010 to 011.
- 16) Current ripple during flip cal with motors energized was greater than 75 MA for frequencies over 250 HZ. See figure 2.3.10.
- 17) Noise on the command and shift pulse line exceeded 100 MV peak to peak : up to 150 MV recorded, see figure 2.3.6.

Out of  
Spec

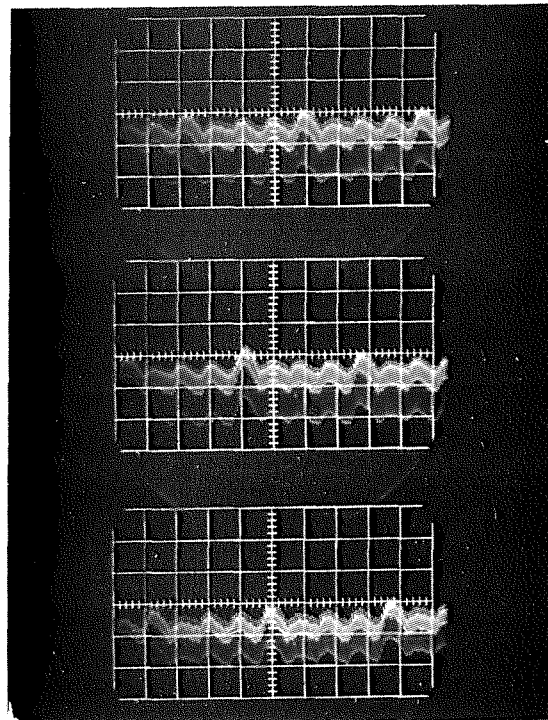
Figure 2.3.9 Flip-Cal Motor Current Ripple

<sup>L</sup>  
Out of  
Spec

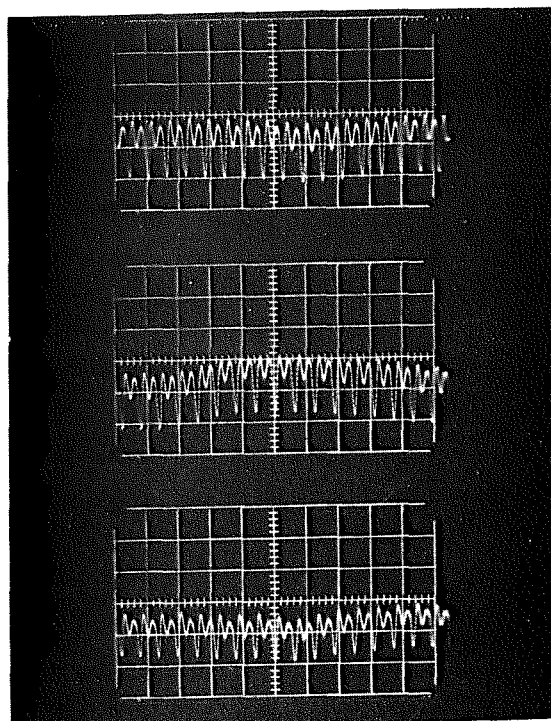
Figure 2.3.10 Flip-Cal Motor Current Ripple

Out of  
Spec

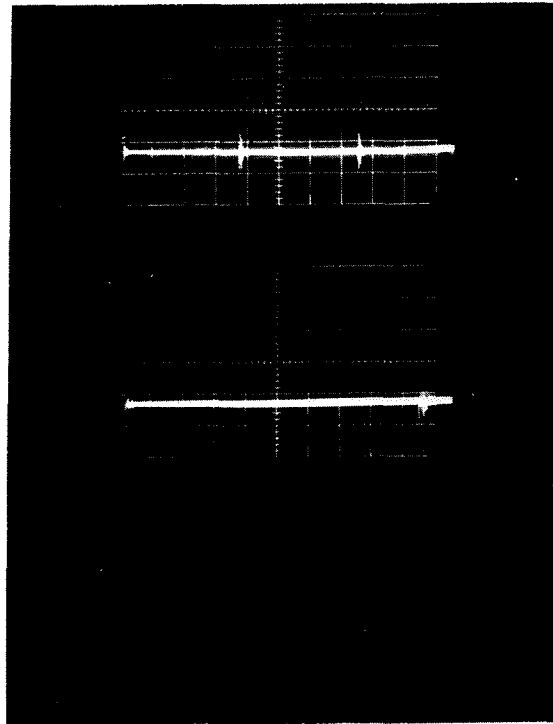
Figure 3.3.2 PSE 29V Noise, 24 April, After  
Crosstalk Tests

Figure 3.3.1 thru 3.3.3 shows the +29 volt noise measured on two separate days. This problem will be further investigated. PSE power converter noise on the timing, control, command and analog line appears greater than that noted on the EM. The turn-off transient shown in Figure 3.3.8 showed no evidence of a transient. The turn-on current transient contained high frequency components which appear as fog in Figure 3.3.9. Figure 3.3.10 shows the high frequency noise clearer. This noise was of too high a frequency to record.

Out of  
Spec

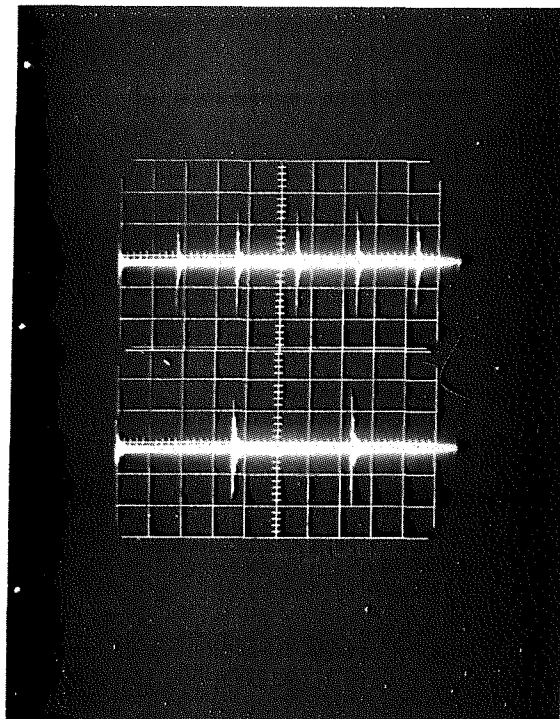
Figure 3.3.3 PSE +29V Current Noise 19 April

Out of  
Spec

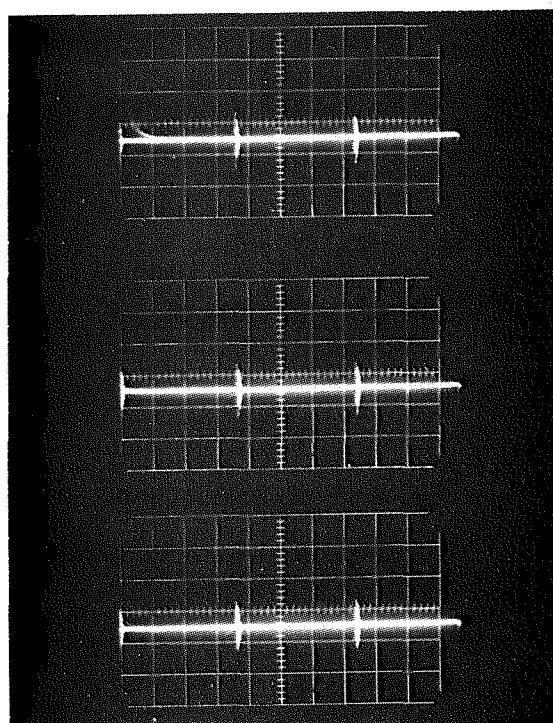
Figure 3.3.4 PSE Power Converter Noise on  
Timing Control

- a) Power converter noise of greater than 800 MV. Amplitude of noise is inconsistent. Photos showing noise up to 2V p.p. are included.
- b) Power converter noise on timing control and analog signal lines.

Out of  
Spec

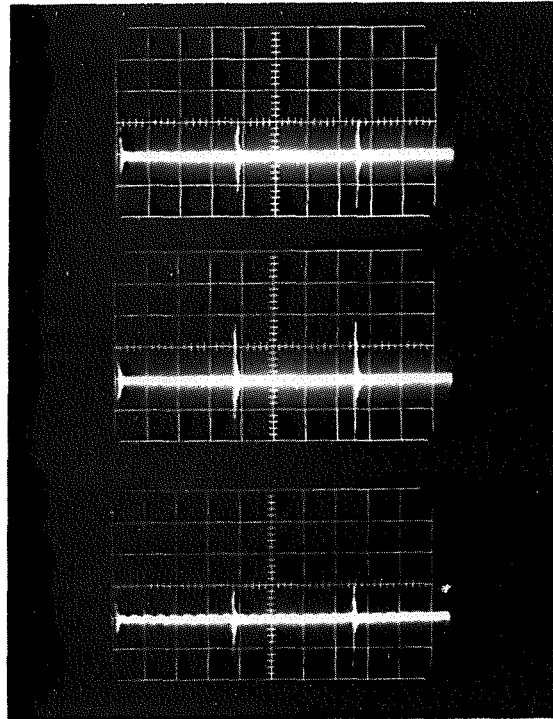
Figure 3.3.5 PSE Power Converter Noise on Analog Lines

Out of  
Spec

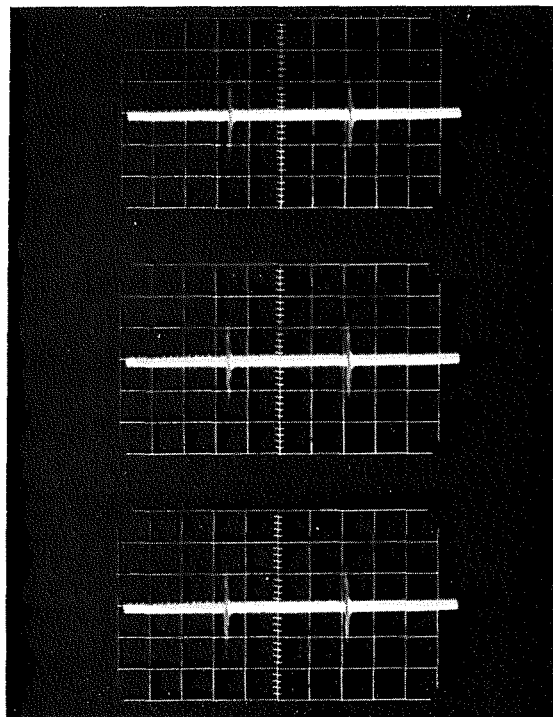
Figure 3.3.6 PSE Power Converter Noise on Command Lines;  
TP refers to SBOB Test Point

Out of  
Spec
