BENDIX SYSTEMS DIVISION ANN ARBOR, MICH.	NO. ATM-626	REV.NO.
- Bendix CONDARDADA	3/6/67	February Engineering Model Test Progress Report	PAGE 0	F PAGES

FEBRUARY ENGINEERING MODEL TEST PROGRESS REPORT

28 February 1967

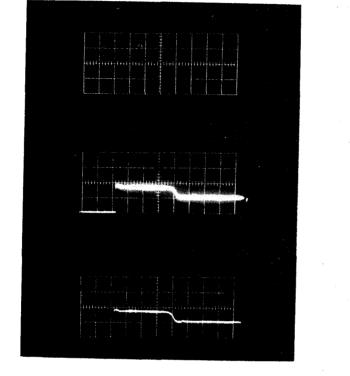
Figure 3.3.1-1 PSE Turn-On Transient

Category #2 test for PSE were completed in January and the results were published in ATM 618. During the month, the turn-on power transient was verified and is shown in Figure 3.3.1-1. Transients as high as 400 ma were noted.

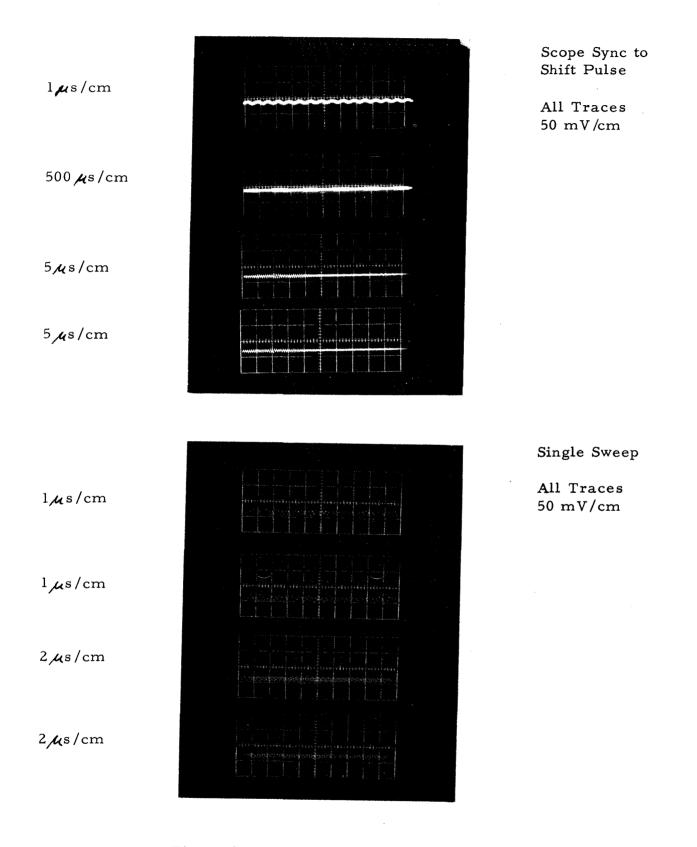
Figure 3.4-2 Central Station Noise, All Experiments Off, +29V Line

The interface timing signals between the Central Station and experiments were examined for excess noise with all experiments operating. No unacceptable noise levels were observed.

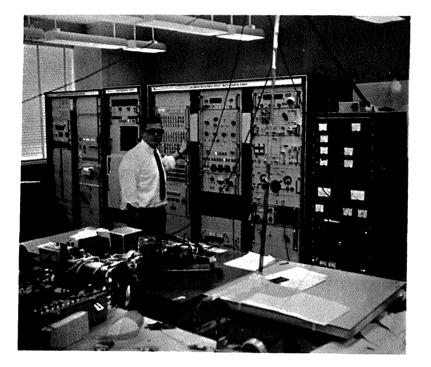
Figure 3.5-1 System Test Site In Use With Engineering Model

The integration of the STS, the Data Subsystem Checkout Program and EM Central Station occurred on 4, 6, and 7 February 1967. The purpose of the tests was to establish the hardware/software compatibility and to isolate any undetected problems. The STS hardware used in this test include the Data Units and the DPS 2000 Programmer - Processor. Figure 3.5-1 shows the STS in use with the EM.
