**Aerospace
Systems Division**

NO. ATM-1088	REV. NO.
PAGE _____ OF _____	
DATE 28 March 197

LSPE SAFE/ARM SLIDE
FAILURE EVALUATION REPORT

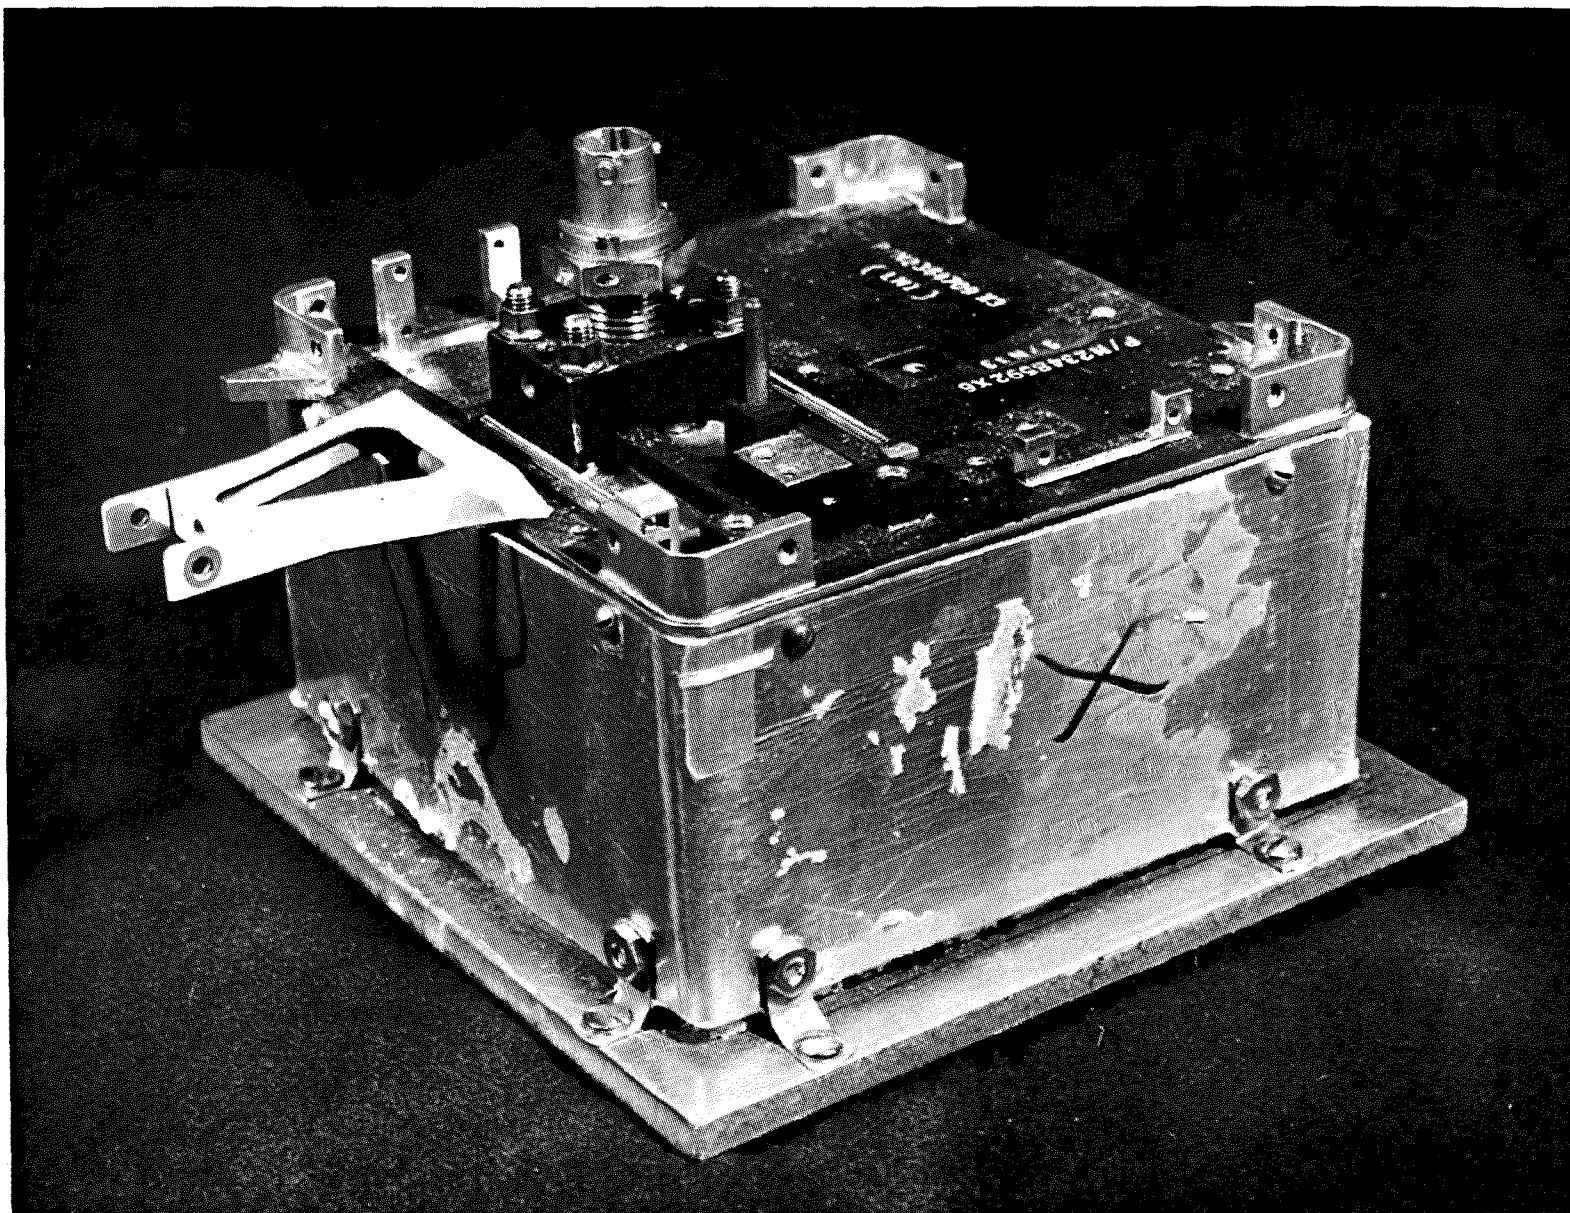
On 16 September 1971, the LSPE safety tests were conducted at the Naval Ordnance Laboratory on two test baseplate assemblies. These test baseplate assemblies (2364708) were intended to duplicate flight-type hardware and consisted of a baseplate (2348592X6), EDC housing (2348594X3), safe-arm slide (2348593X3), EDC (2348421-1), and lead (2364734). The explosive charges consisted of a 6-pound and a 1/8-pound charge and were mounted in simulated housings in the same manner as the LSPE design (see Figure 1). The safe-arm slides were set in the "safe" position and the EDC's were fired. Neither the charges nor the leads detonated but when the baseplate assemblies were disassembled from the explosive housing assemblies it was discovered that both the charges were fractured due to a slide failure.

Figure 1: NOL Safety Test Configuration 1/8 Lb Charge

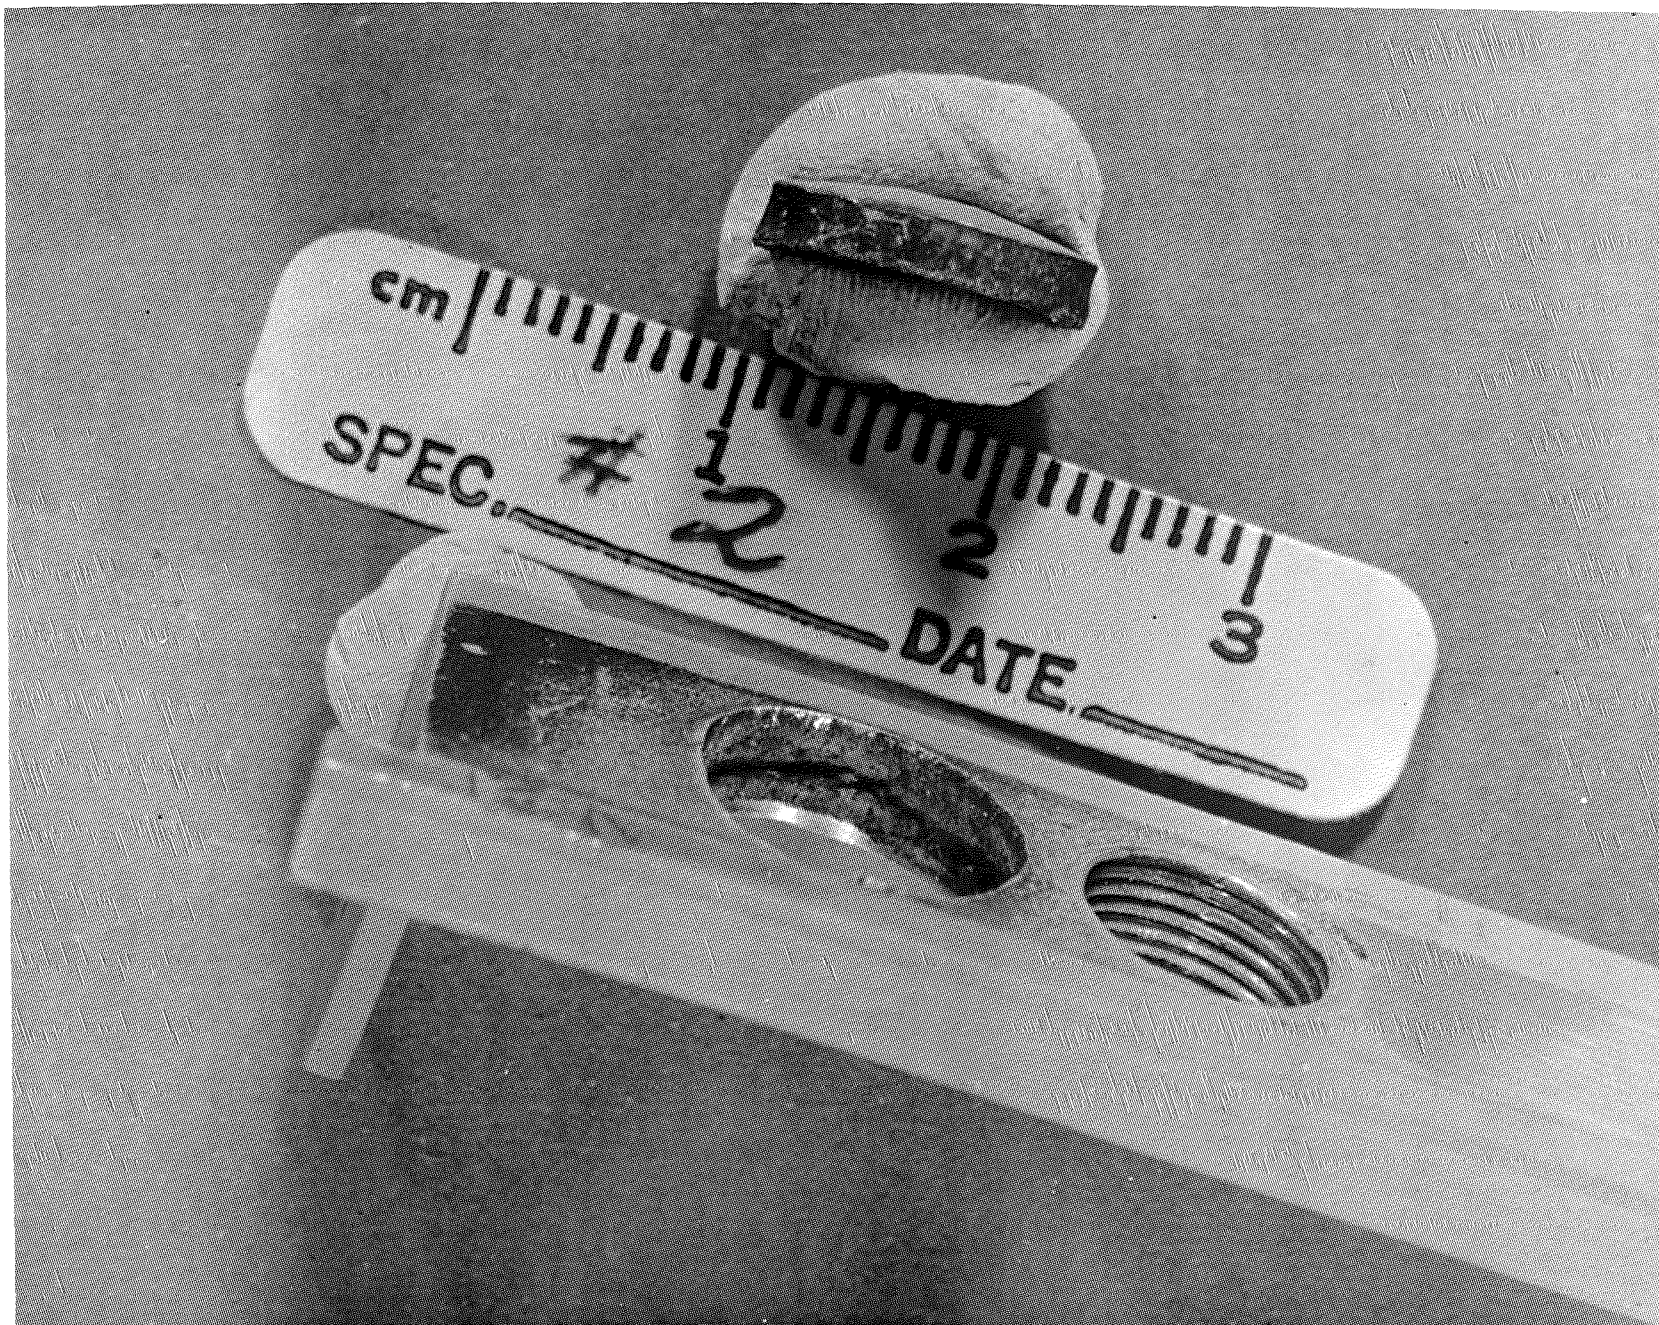
As shown in Figures 2 through 5, the slide failed in a manner such that a disk was coined-out and impacted the HE charges. The 1/8 lb charge was badly shattered, while the 6 lb charge was chipped and cracked by the impact.

Figure 2a: Failure Slide Showing Coined Disks (Top View)

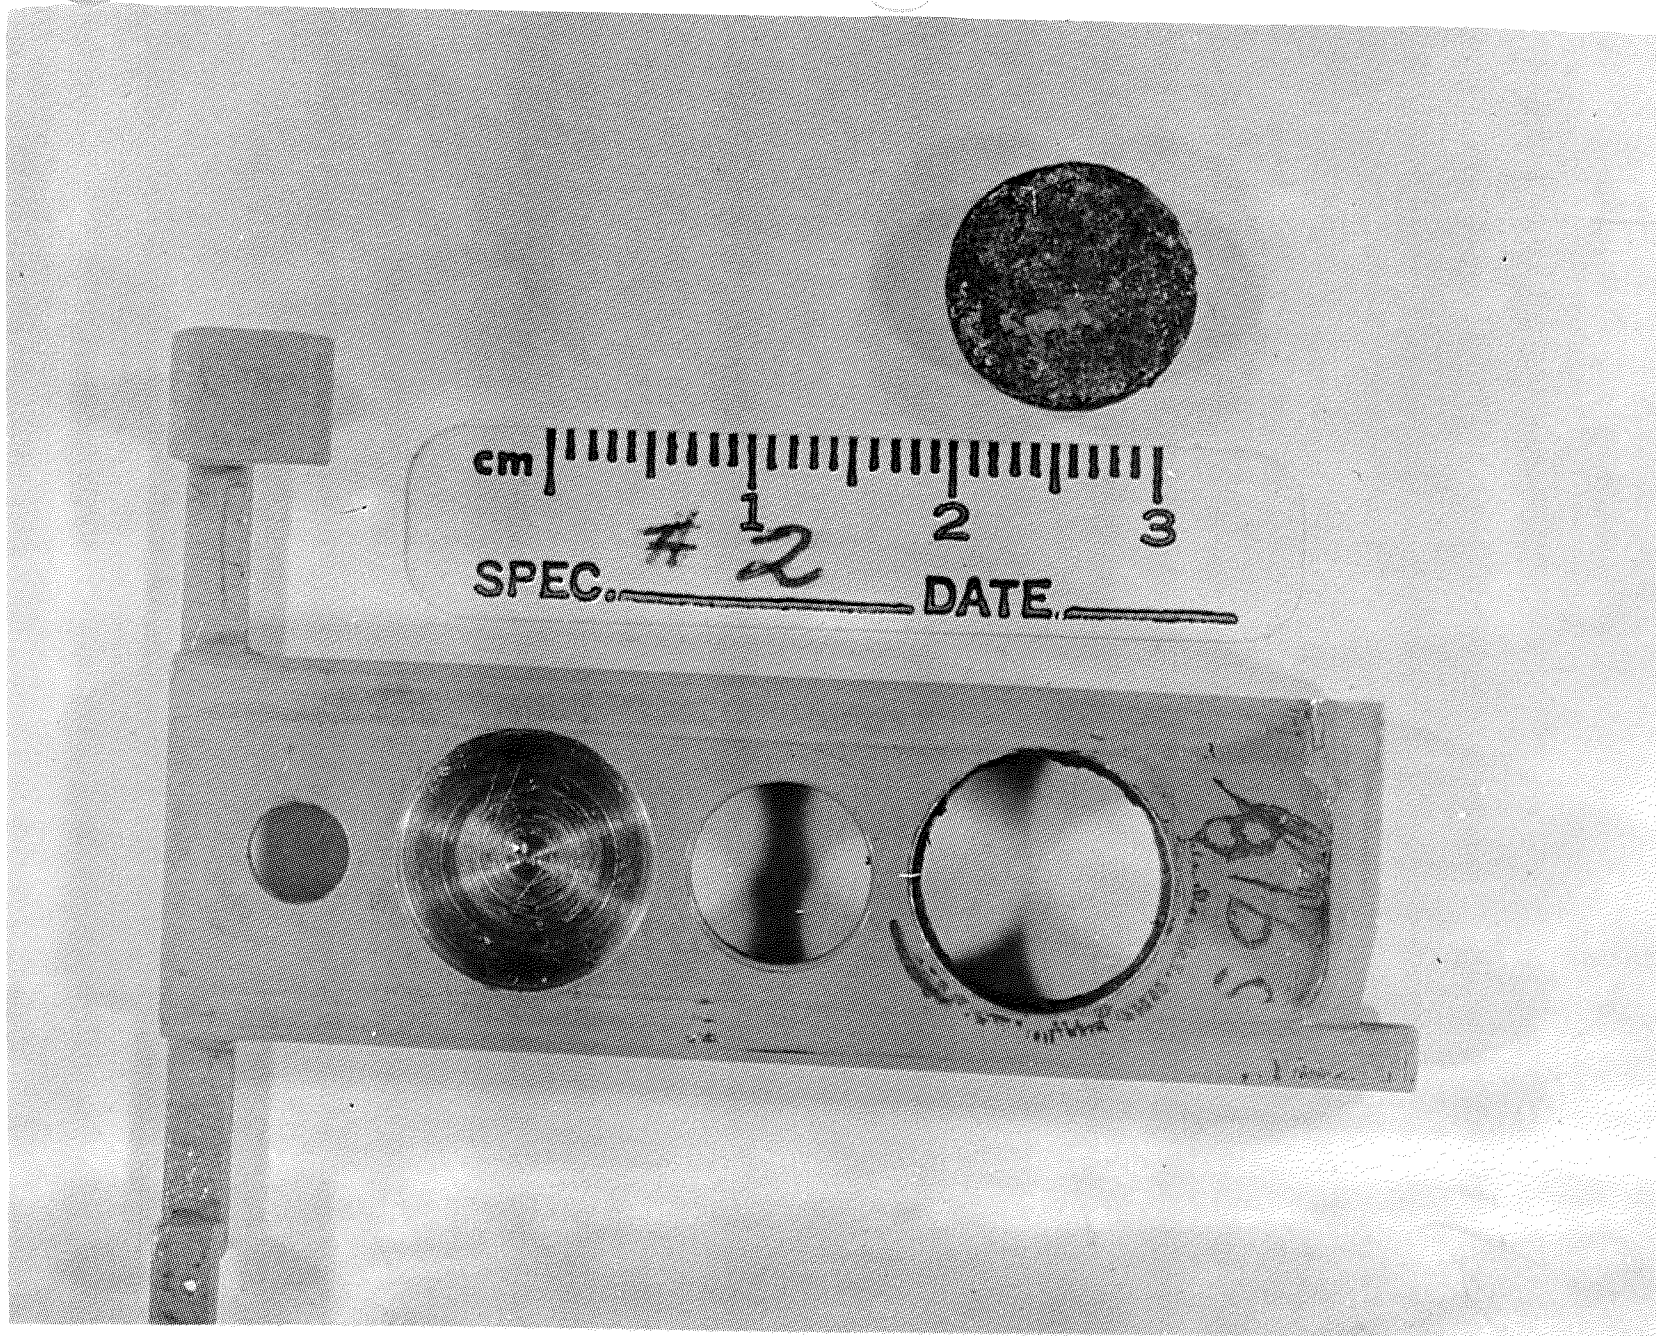
Figure 2b: Failure Slide Showing Coined Disks (Side View)

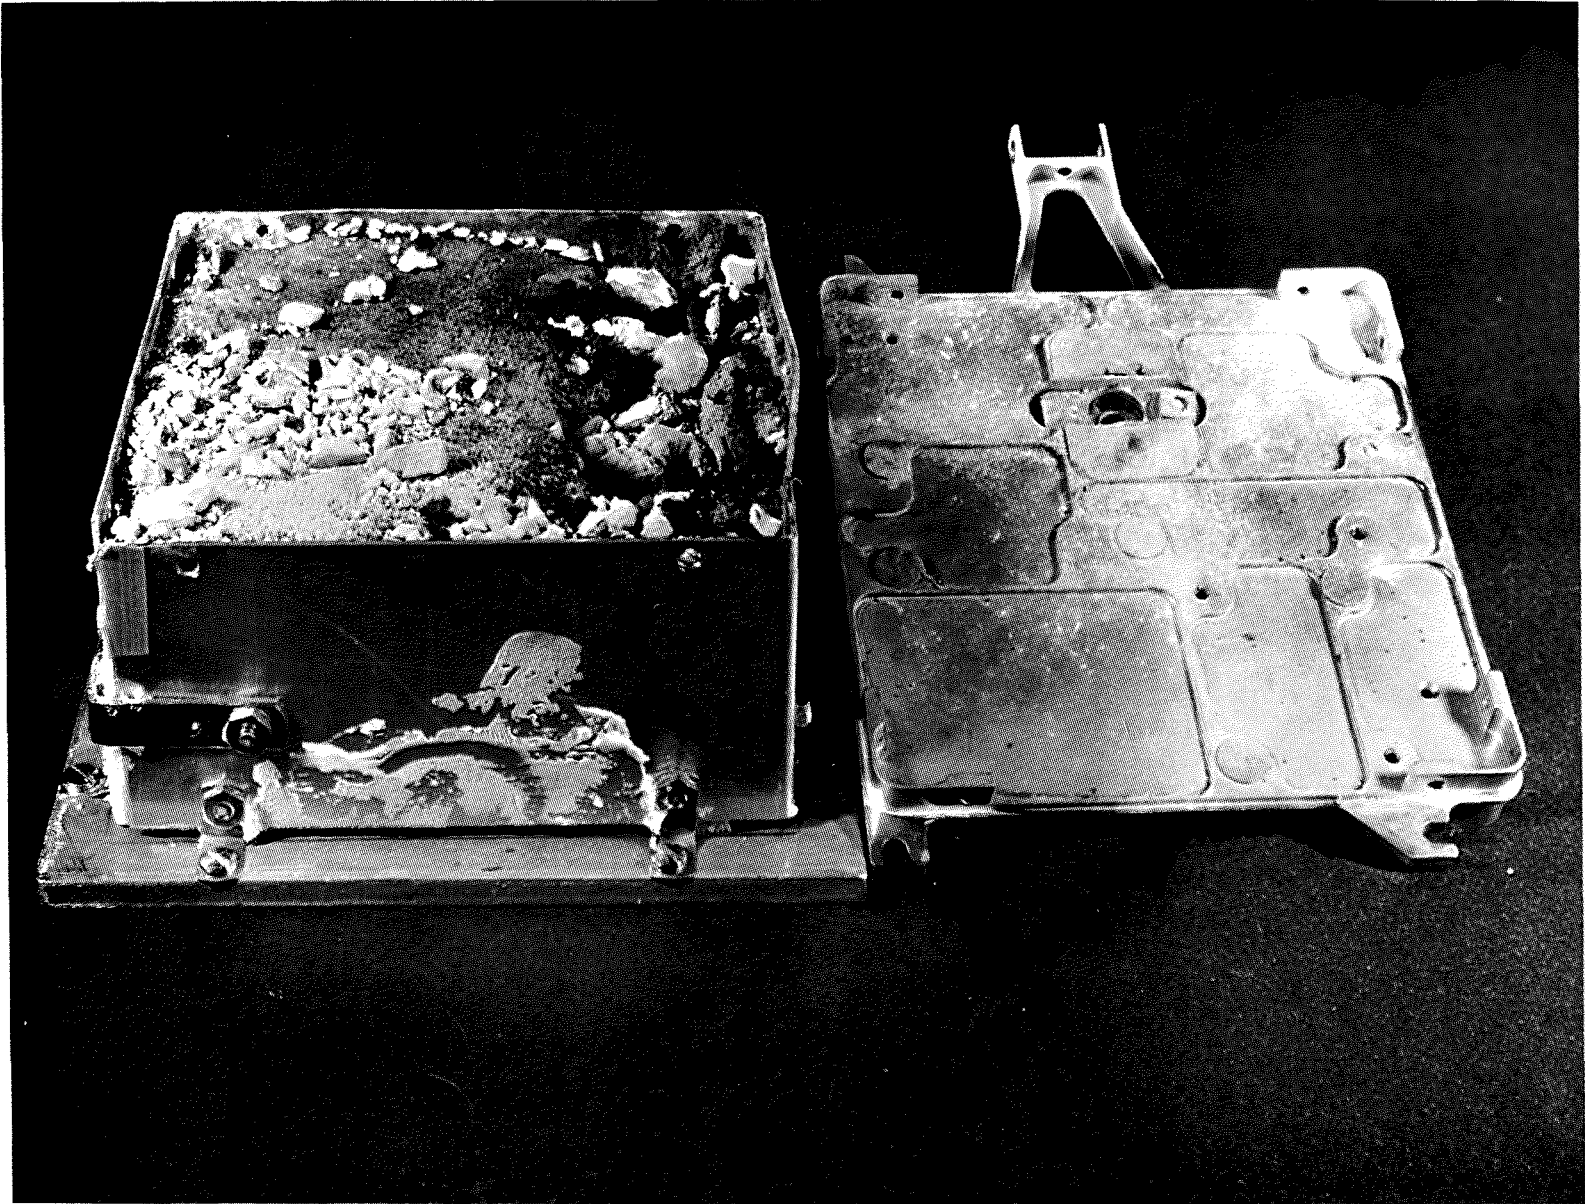
Figure 3: Shattered But Undetonated 1/8 Lb Charge After Test

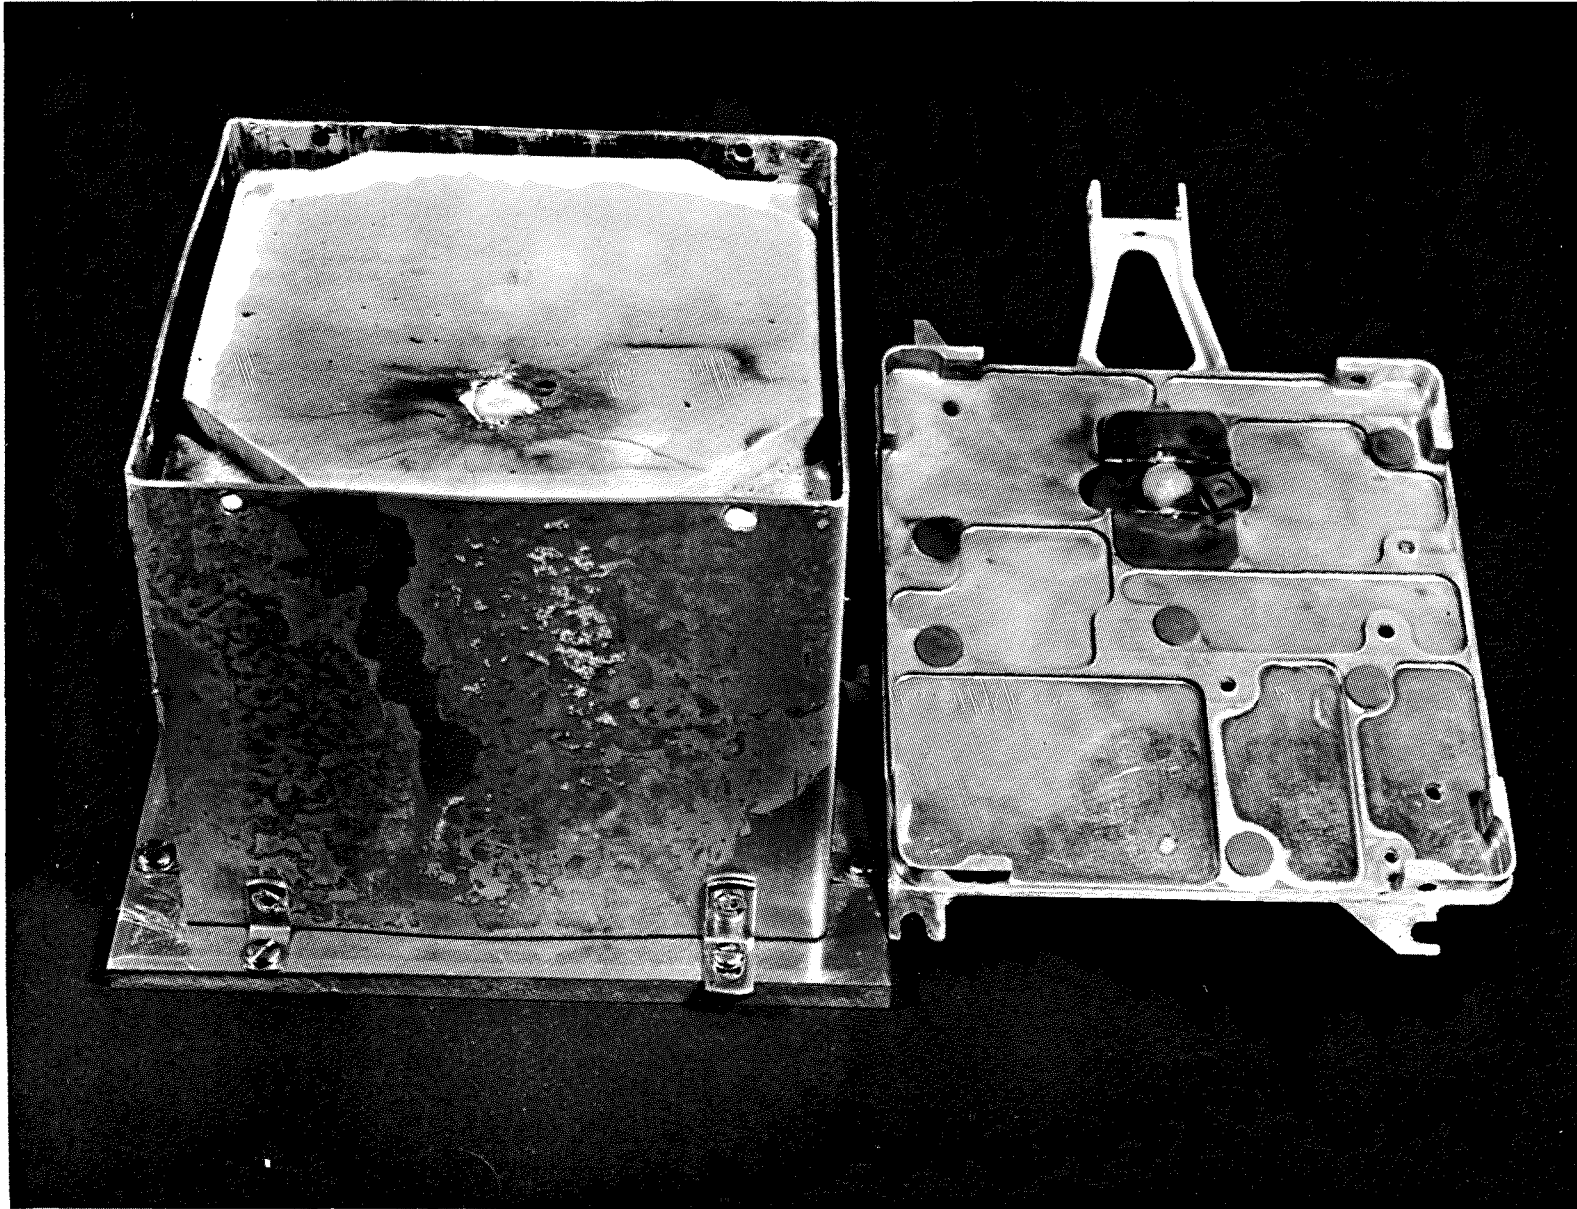
Figure 4: Damaged 6 Lb Charge After Safety Test

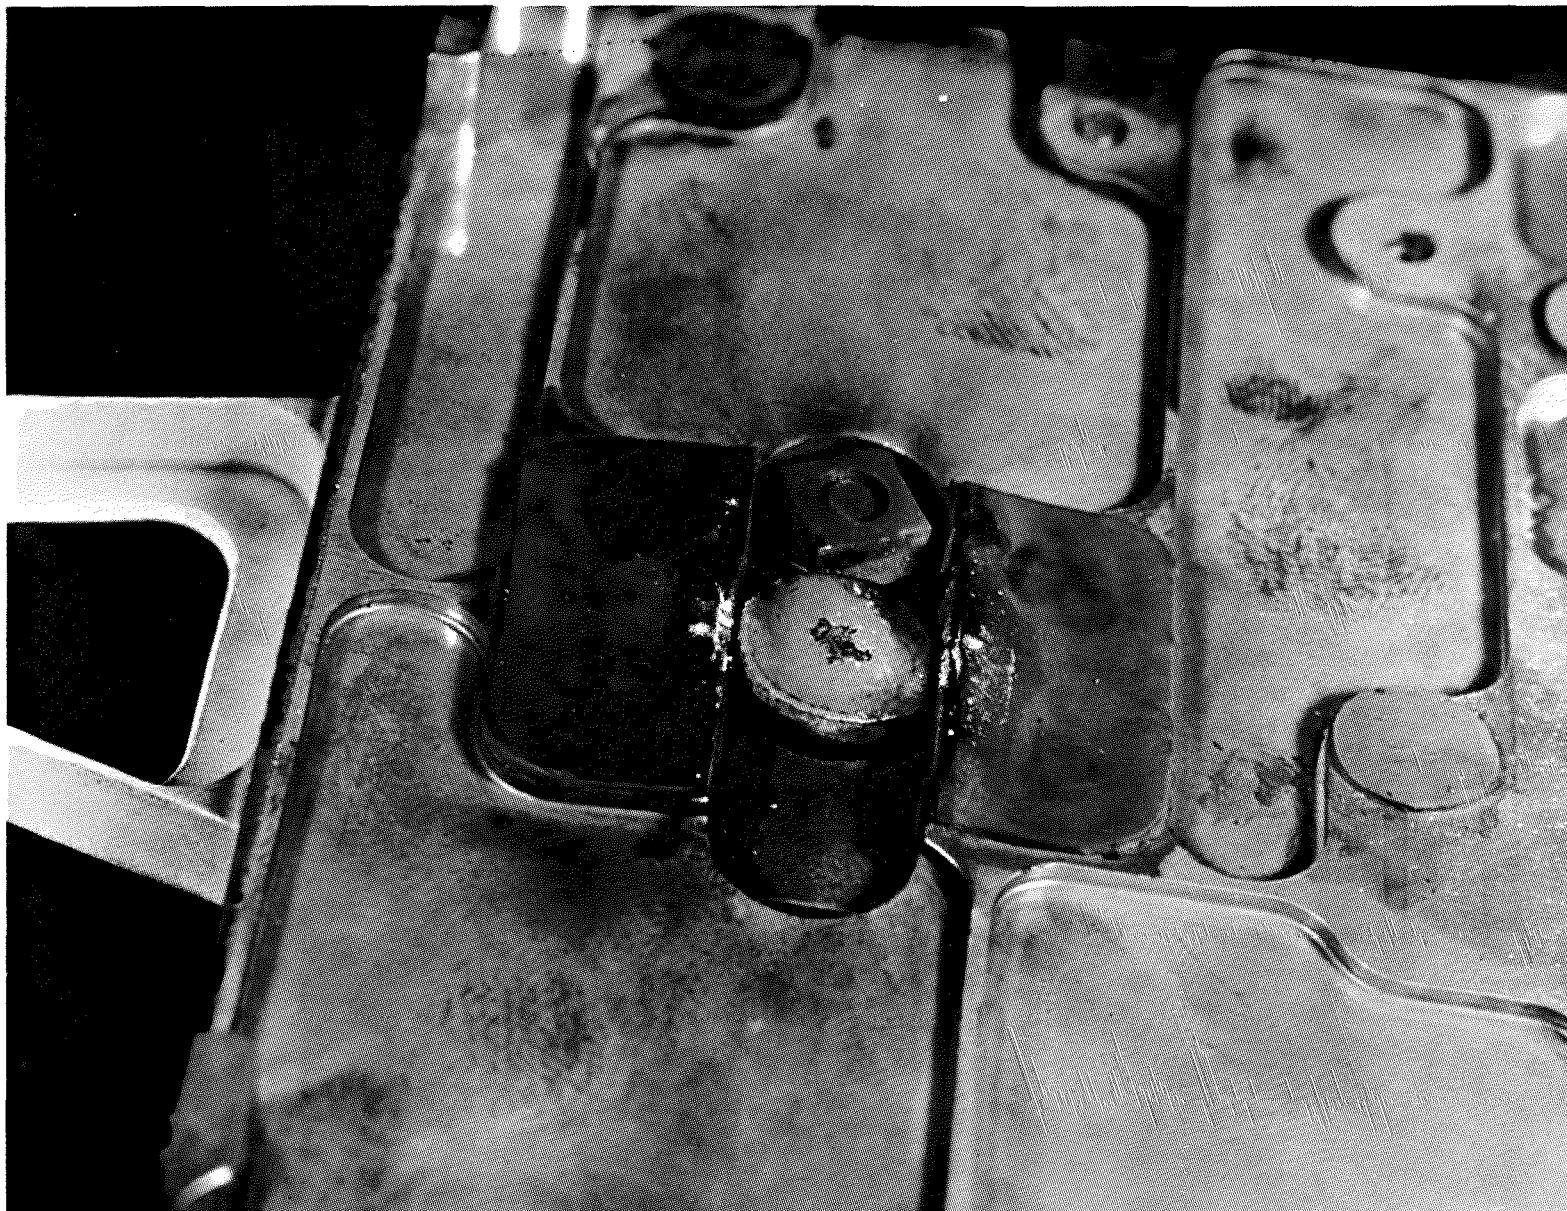
Figure 5: Coined Slide Material Wedged in Slot in Baseplate, 6 Lb Charge

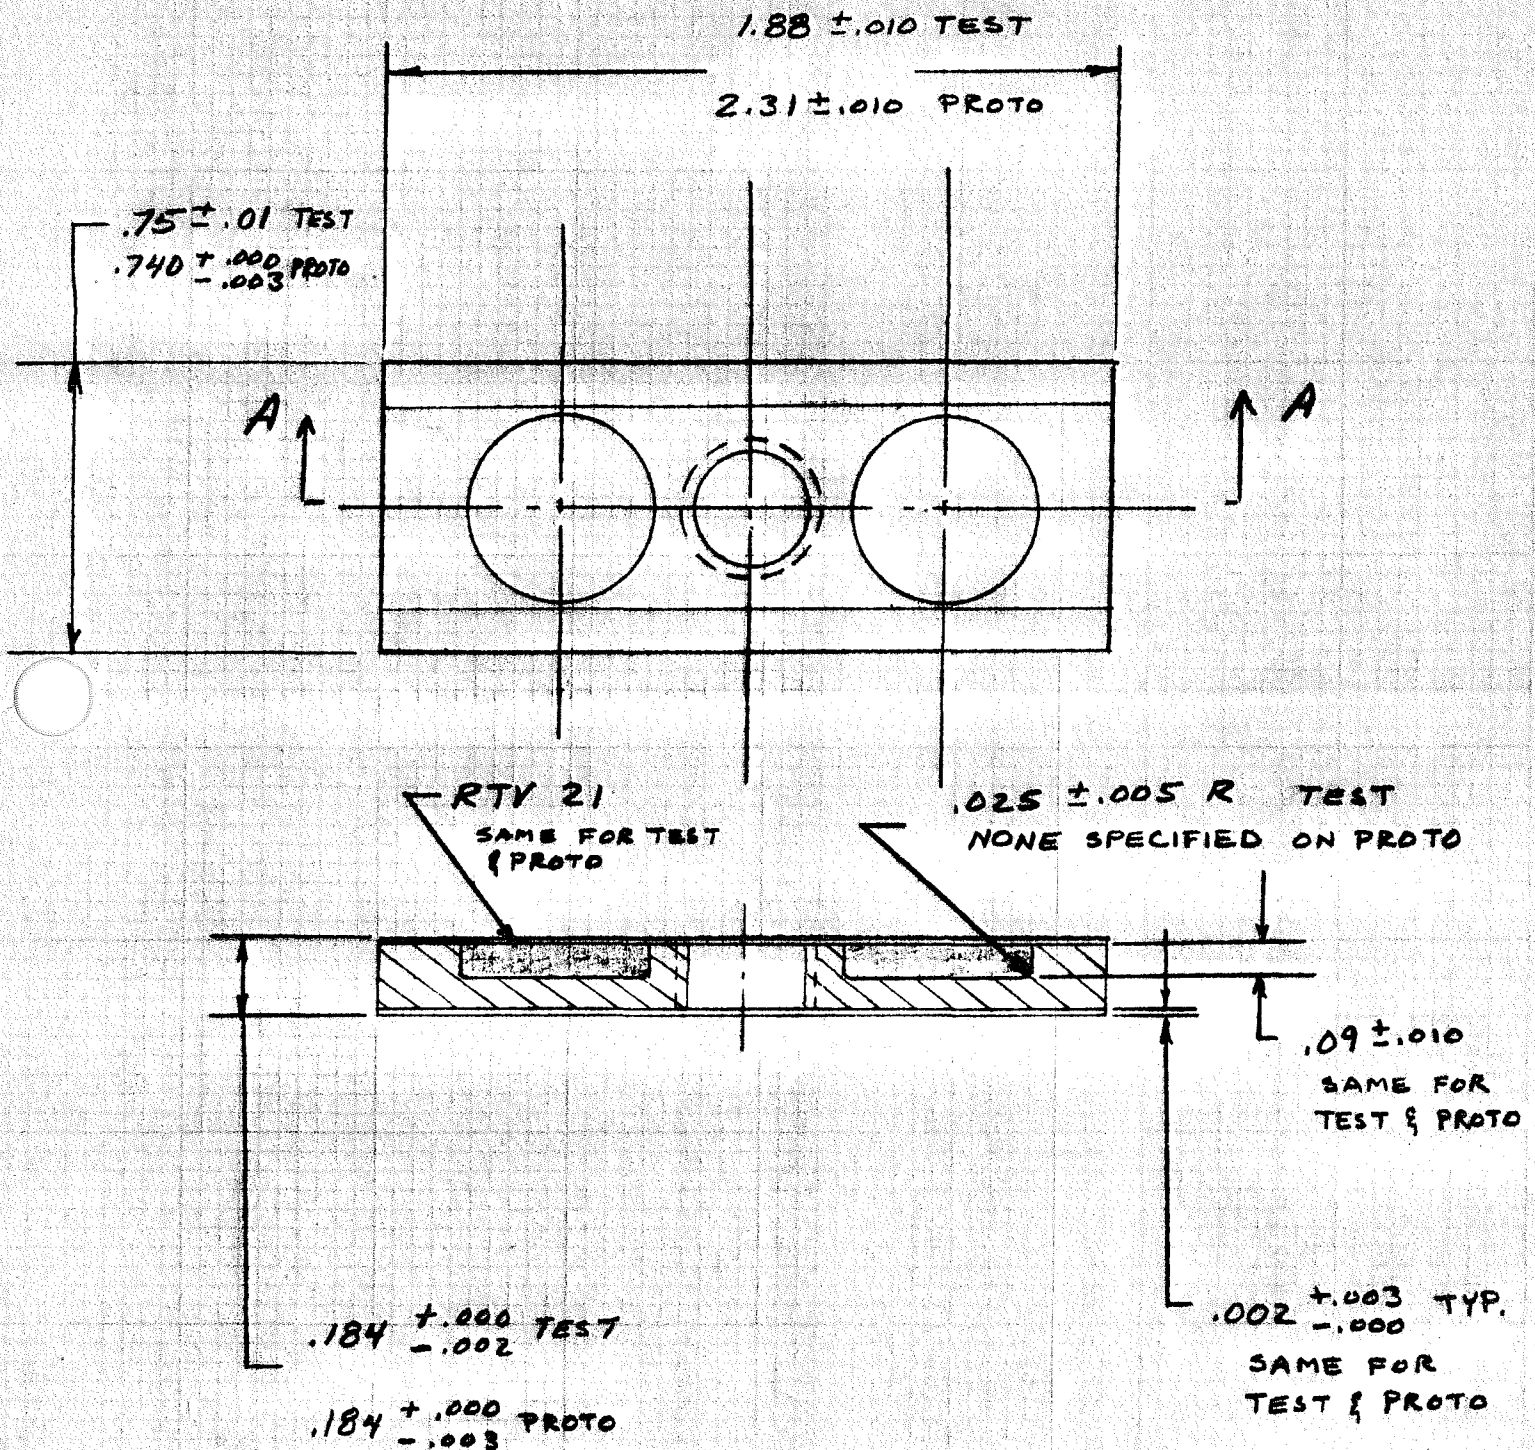
Figure 6: Critical Dimension Comparison of Test Slide and Proto Slide

Figure 6 compares the critical dimensions for the test slides (2348307) and the slides used in safety test (2348593X3). The only significant dimensional difference existed in the fillet radius call-out at the base of the RTV filled safety bore. A $0.025 \pm .005$ radius was specified for the test slide. By drafting error no radius was called out for the prototype, qualification, and flight model slides. Several prototype, qualification, and flight slides were selected and the RTV removed from holes and corner radius measured. Measurements indicated that corner radii in all cases were 0.005 in. or less

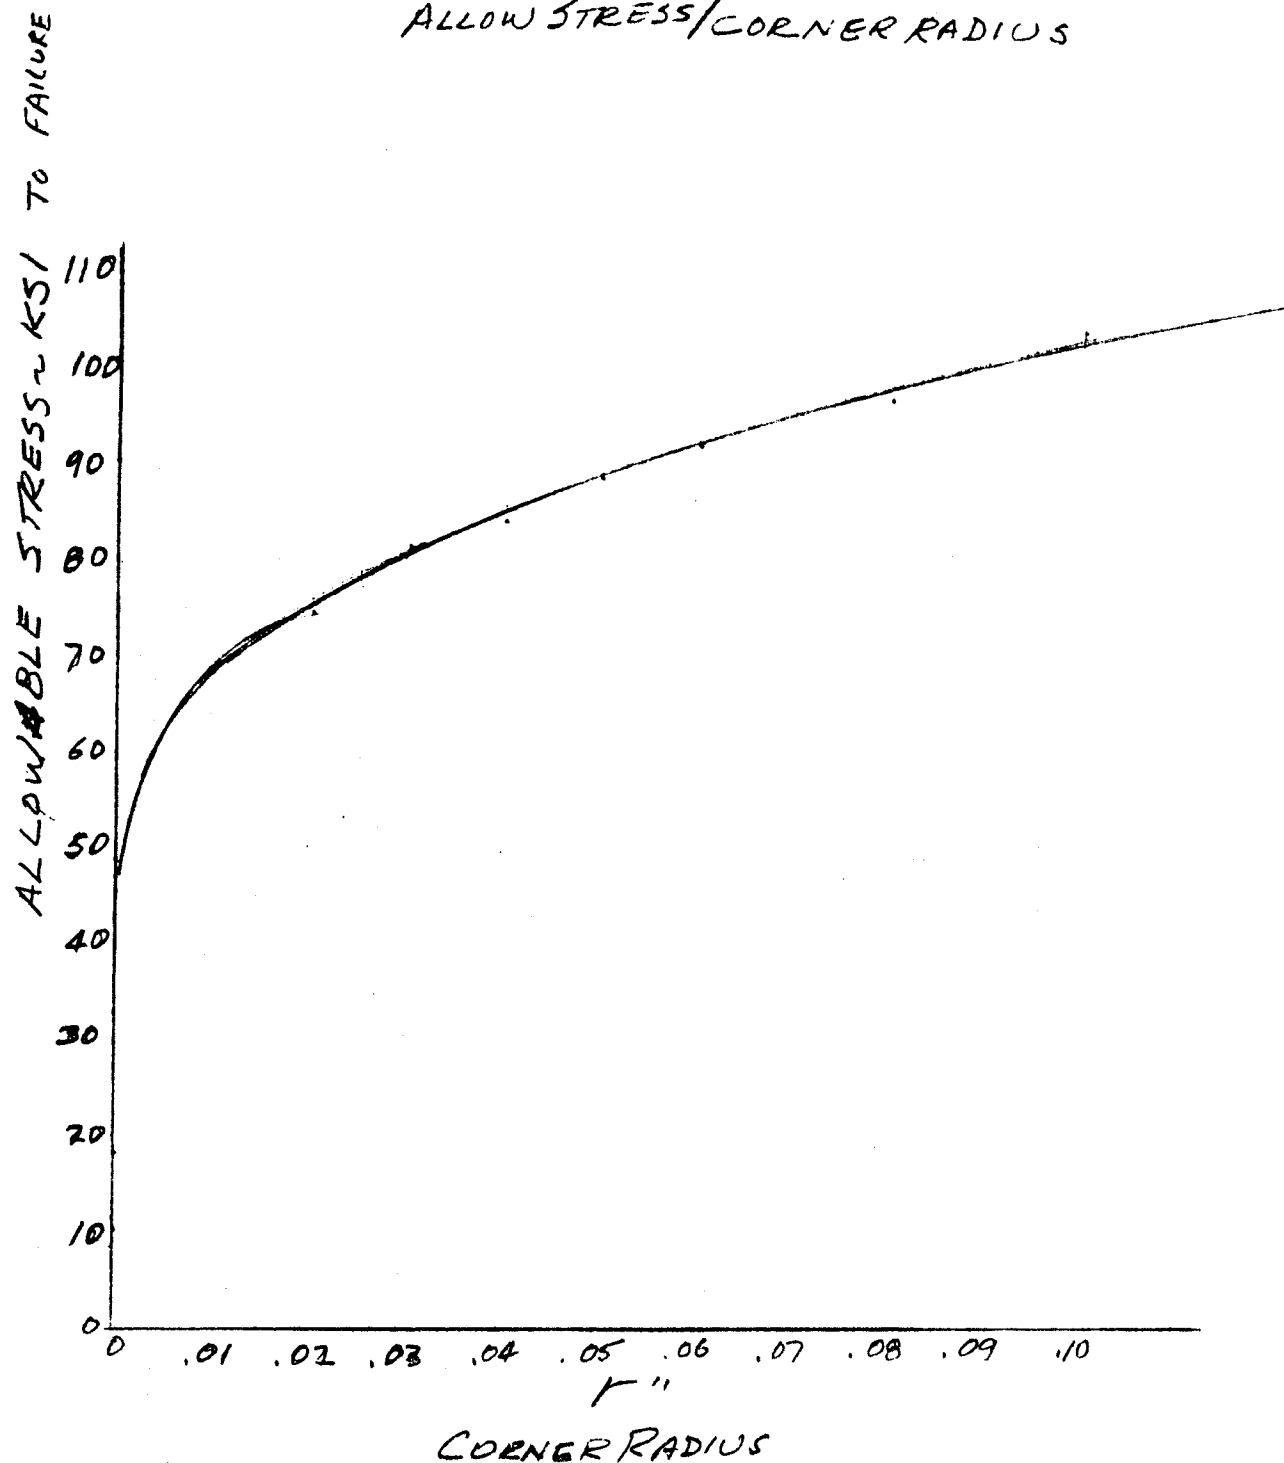
FIGURE 7

This evaluation shows that a loss of 25 percent in allowable stress to failure is associated with the reduction in fillet radius from .025 to .005 inch. Increasing the fillet radius over .025 inch continues to increase the stress to failure although the rate of improvement diminishes. For instance, at a radius of .040 inch the stress to failure is increased by 37 percent over stress for a .005 inch radius.

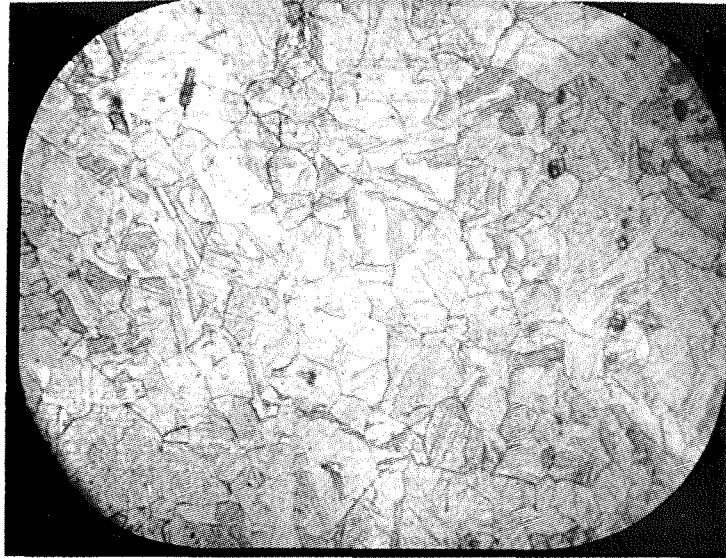
Figure 1 is a photomicrograph of as-received solution treated 17-4PH stainless steel taken at a magnification of 200X. The microstructure is predominantly martensitic with a small amount of retained austenite present. The acicular or needle-like structure characteristic of martensite is faintly discernable, although not well resolved at this magnification. The microstructure shown in Figure 1 is typical of what one would expect in a martensitic structure prior to age tempering by a precipitation heat treatment.

FIGURE 1 Photomicrograph showing micro-
structure of 17-4PH stainless
steel, solution heat treated
(200X).

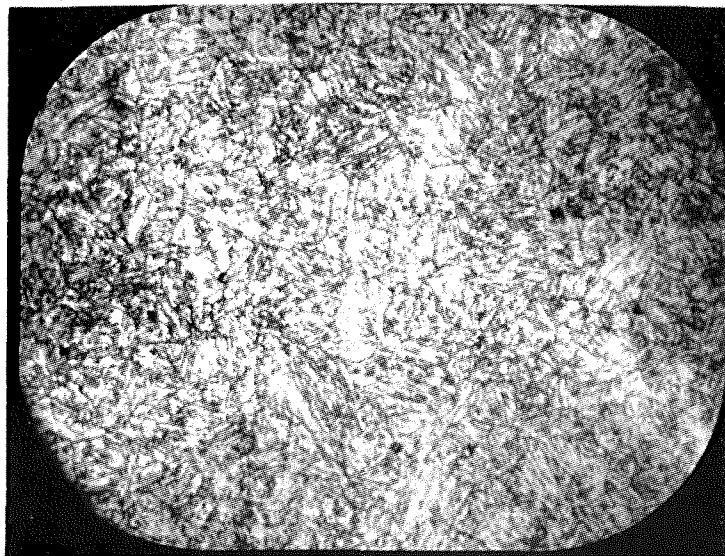
Figure 2 is a photomicrograph of 17-4PH stainless steel which has been solution treated and age-tempered at 1025°F for 4 hours. The dark areas represent the dispersed martensite phase, while the light areas indicate the ferritic matrix. There is also no discernable retained austenite. During the age tempering process, the retained austenite decomposes or transforms to bainite. This structure has a feathery or acicular appearance and consists of ferrite and carbides. Its hardness range will overlap that of the tempered martensitic structures. Since the original amount of retained austenite was quite small, no appreciable affects on mechanical properties will be observed.

FIGURE 2 Photomicrograph showing micro-
structure of 17-4PH stainless steel,
solution heat treated and artificially
aged at 1025° F for 4 hours (200X).
