TM-68

Date July 1975

APOLLO 14 ALSEP UPLINK ANOMALY

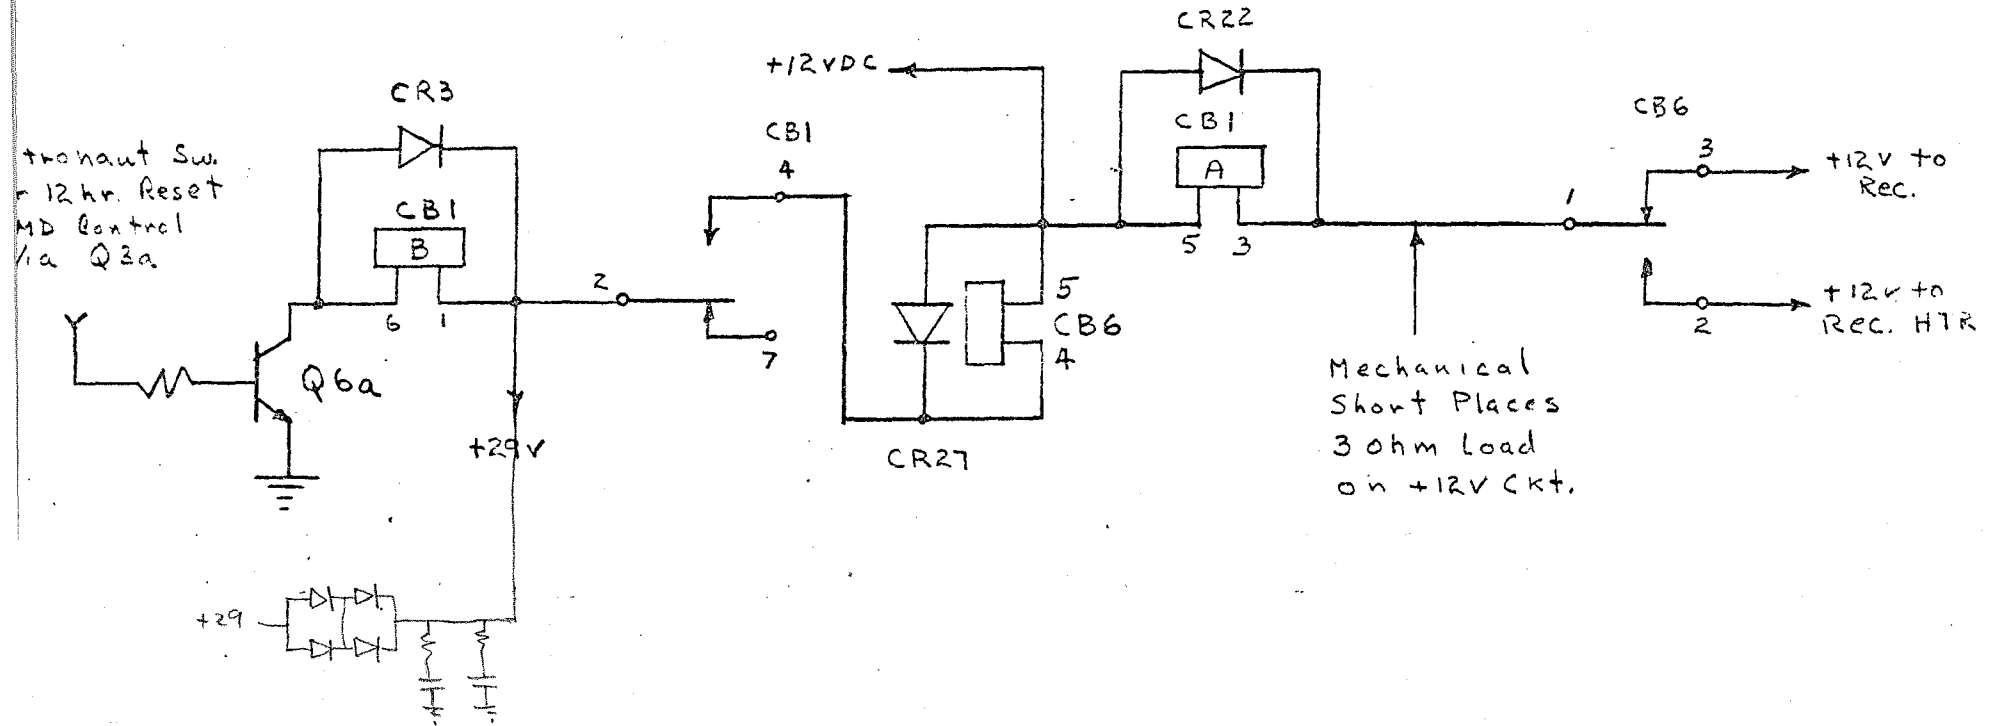
FIGURE 2

The receiver circuit breaker is located on Board 5, furthest from the temperature sensor, and is a possible heat source. The heat would be dissipated in the breaker if it failed to operate, or if a mechanical short developed between the circuit breaker sense coil and the switched receiver input power connection, pin 1 on circuit breaker CB6. The mechanical short would not require a dual failure of both the receiver and circuit breaker to occur and the load would not be relieved by operation of the circuit breakers CB1 and 6 as shown in Figure 2. X

ALSEP 14 Receiver Power Control Circuit

Such an event would switch off the receiver and power dissipation in the breaker itself would not be relieved until the short was eliminated, perhaps by the circuit breaker coil itself burning out. It is assumed diode CR22 would burn out and the circuit breaker is small (TO5 transistor case) and would dissipate approximately 25 watts with the 12V line pulled down to approximately 8.5 volts. The relay would therefore become extremely hot.

If the receiver circuit breaker were to fail many of the symptoms noted could be explained. The circuit was bread-boarded, using flight quality parts from inventory, as shown in Figure 2. The diode, CR22, - a IN645, as well as other diodes across the other coils shown, was included in the design
