**Aerospace  
Systems Division**

April Engineering Model  
Test Progress Report

ATM-661

APRIL 1967

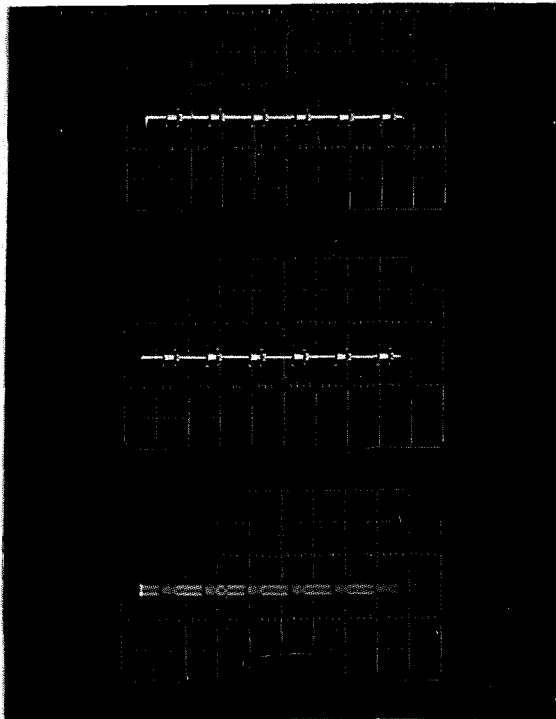
Figure 3.2-1 HFE Analog  
Line #1 Noise

No similar noise has been observed earlier on other experiment interfaces during Category #2 tests but there are two reasons for attributing the source of the noise to the analog multiplexer in the Central Station and therefore to some change within the multiplexer:

Investigations to determine the cause of the change in analog multiplexer behavior, and any effect of this on the downlink data are being pursued. No housekeeping data errors which might be attributable to the noise have been detected up to the time of writing.

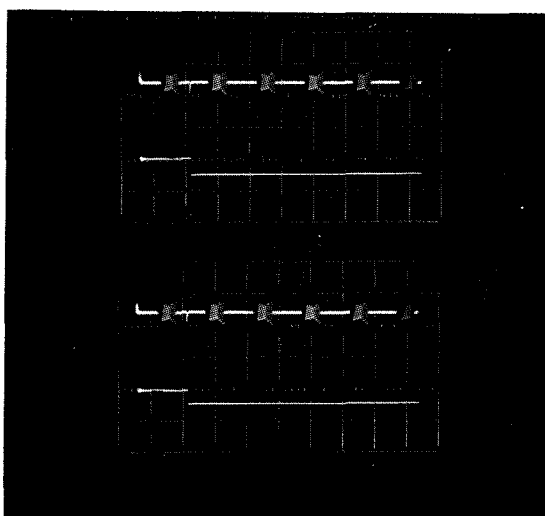
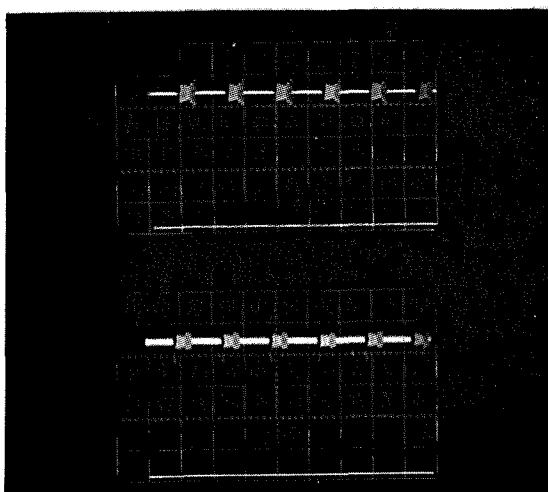
Figure 3.2-3 HFE Analog  
Line #5 Noise

Two forms of spurious noise signals were found to be present on these lines; one has already been discussed in Section 3.2, noise apparently being generated by the Central Station analog multiplexer; the other is experiment power converter noise crosstalk which has an amplitude of 400 to 500 mV peak-to-peak on the analog lines. This converter noise crosstalk is shown in Figure 3.4.3-11.

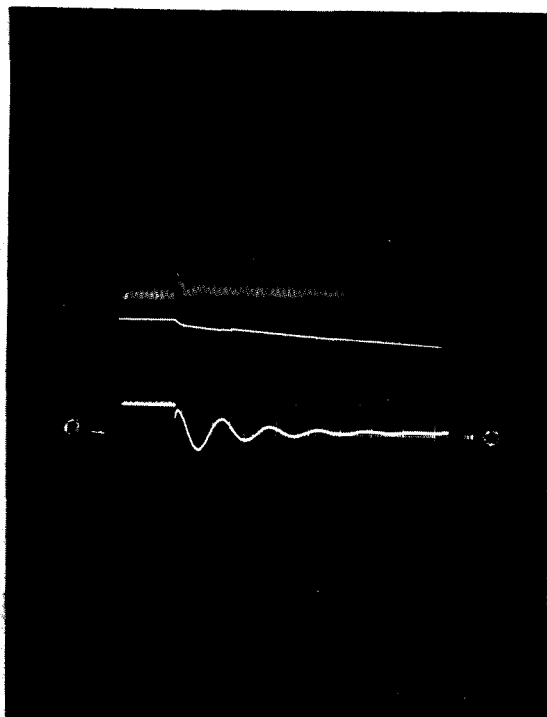
Figure 3.4.2-3 CCGE Turnoff Transients

The experiment input terminal voltage decayed smoothly at turnoff, and no overshoot or oscillatory transients could be detected. The turnoff power line transients are shown in Figure 3.4.2-3. The oscillation of the input current shown on this record after the Central Station relay contact has opened is the standby power on transient, and is observed because the current is monitored in the experiment power return line.

Note that the current trace is the sum of the operating power "Off" and the standby Power "On" transients. The oscillation is the standby on current.

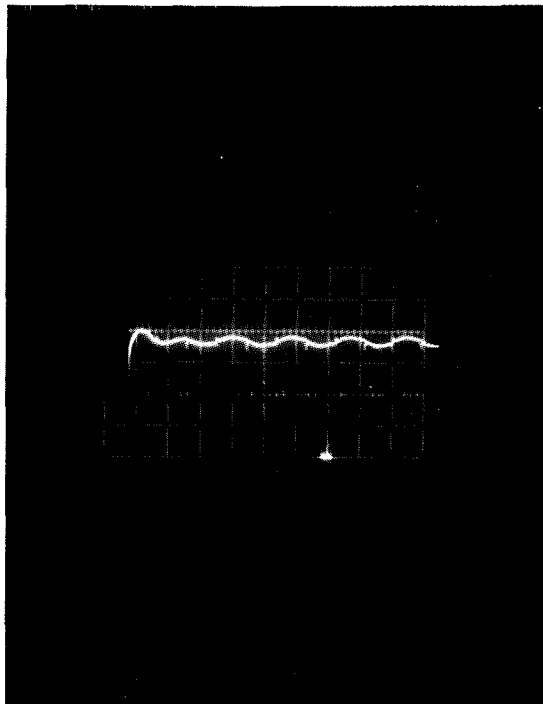
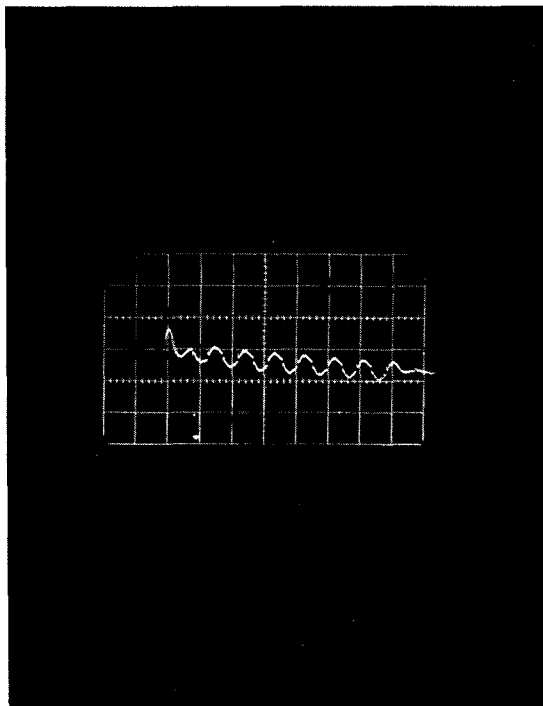
Figure 3.4.2-6 CCGE Data Line Noise

Detail oscillograph records were taken of all the waveforms, and these are available at BxA. The one discrepancy noted was the crosstalk from the shift onto the data line, the amplitude at the fall of the shift was 250 mV p-p. Also a small amount of ripple was present on the data line following the termination of a CCGE word, but this ripple is within the ICS noise limit of 100 mV p-p. The ripple is illustrated in Figure 3.4.2-6, and the shift crosstalk in Figure 3.4.2-7.

Note: Spikes coincides with rise  
and fall of shift pulse.

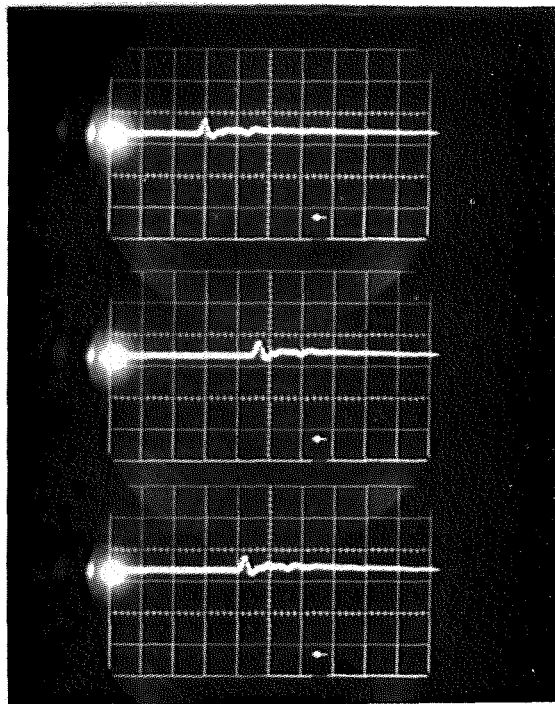
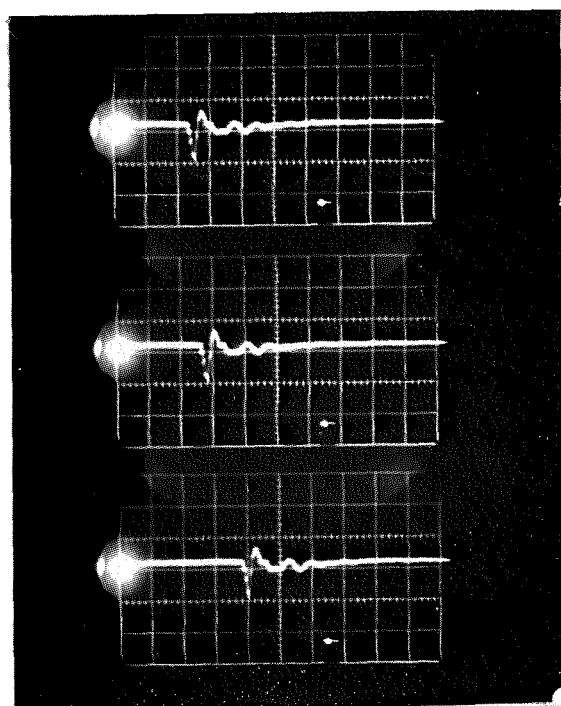
Figure 3.4.2-7 CCGE Line Noise/  
Crosstalk (Data Line Low)

There is evidence that the shift to data line crosstalk largely arose within the experiment, the SIDE BB was later connected to the Central Station in place of the CCGE using the same connector and SBOB to provide essentially the same interface as for the CCGE, and the crosstalk was re-recorded with the SIDE on, SIDE off and also with the SIDE disconnected, as shown in Figure 3.4.2-8. It will be observed that the inherent crosstalk in the system is less than the ICS level of 100 mV p-p, and that it is very little affected by the operation of the SIDE BB.

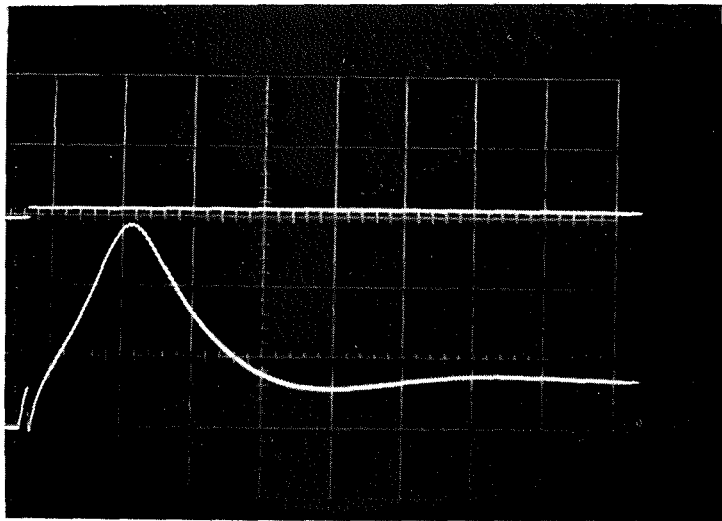
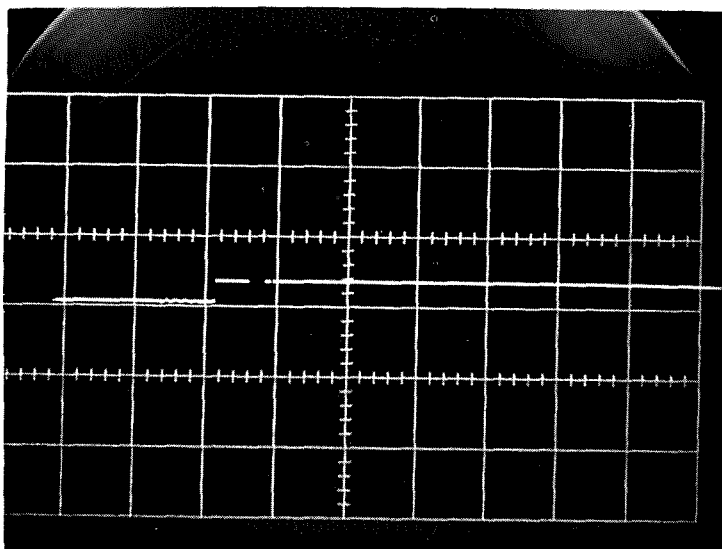
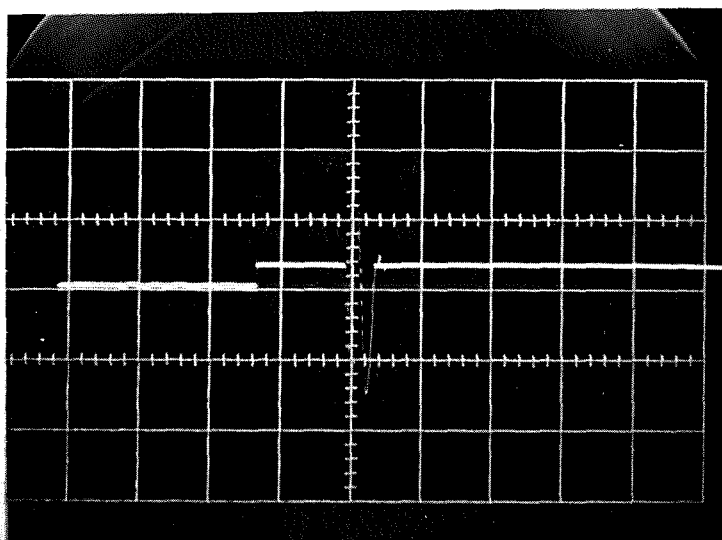
Figure 3.4.3-2 HFE Turn-On Transients

The power-line input current transient at turn on exceeded the Central Station breaker setting, the peak current recorded was approximately 600 mA, and the current exceeded 400 mA for more than 2 mS. Typical records for the experiment voltage and current at turn on are shown in Figure 3.4.3-2. The large oscillatory voltage transient, shortly after turn on, is caused by relay contact bounce and is effectively one form of experiment turnoff transient and will be discussed later. It was already known from the experiment subsystem test results that some means of limiting the turn-on current transient will have to be incorporated in the experiment.

3. Excessive turn-on transient.	3.2.3.3	450 mA	450 mA	3. Approximately 600 ma.
4. Excessive turn-off voltage transient.	Not specified		Between -60V to +120V	4. Ranges from -360 volts to +210 volt, contact arcing clearly observed.

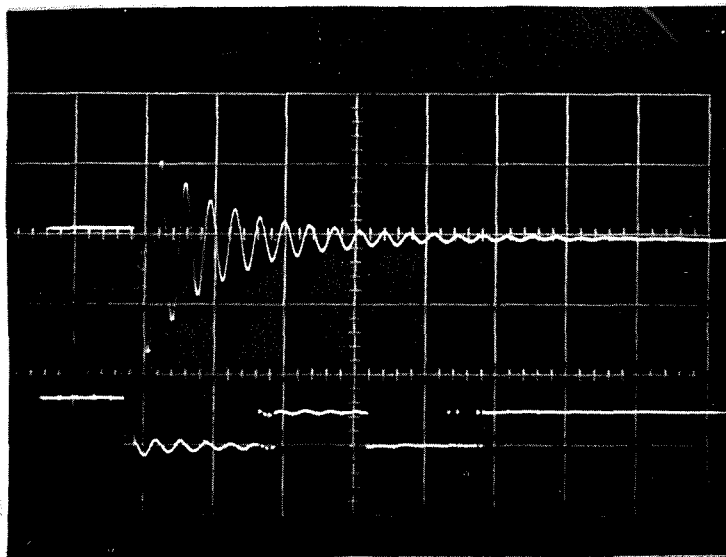
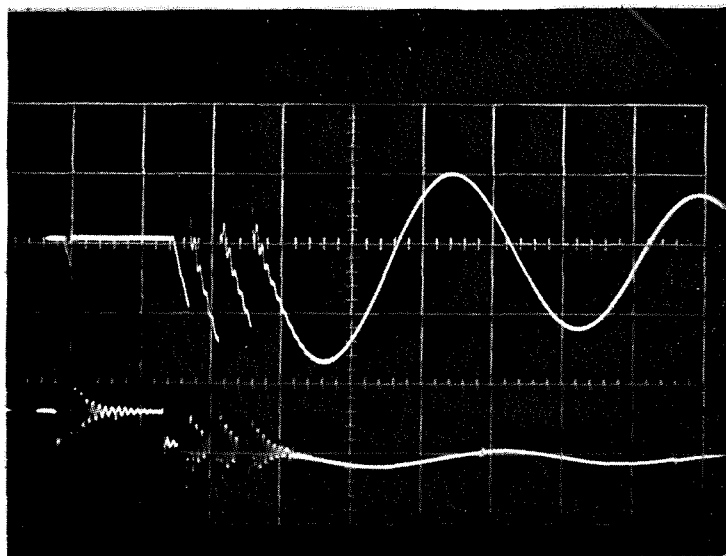
Figure 3.4.3-3 HFE Turnoff Transients

The experiment input power line voltage and current transients at turnoff are shown in Figure 3.4.3-3. It will be observed that a large oscillatory voltage transient follows the opening of the Central Station relay contact arising from the energy stored in the experiment input circuits.

The first negative-going swing has a somewhat indeterminate amplitude, and there can be little doubt that an arc is drawn between the relay contacts when these first break and before the contacts obtain their full separation; and the amount of energy lost in the arc is variable. On all the turnoff transients observed, the arcing could be detected. The amplitude of the transient after the arc was extinguished ranged up to peak values of -360V, +210V. The oscillatory voltage transient at turn on, associated with relay bounce, is essentially similar to and due to the same mechanism, as the turnoff transient. The current transient at turnoff was measured in the experiment power return line, and the standby power on current transient can also be seen in Figure 3.4.3-3 (b).

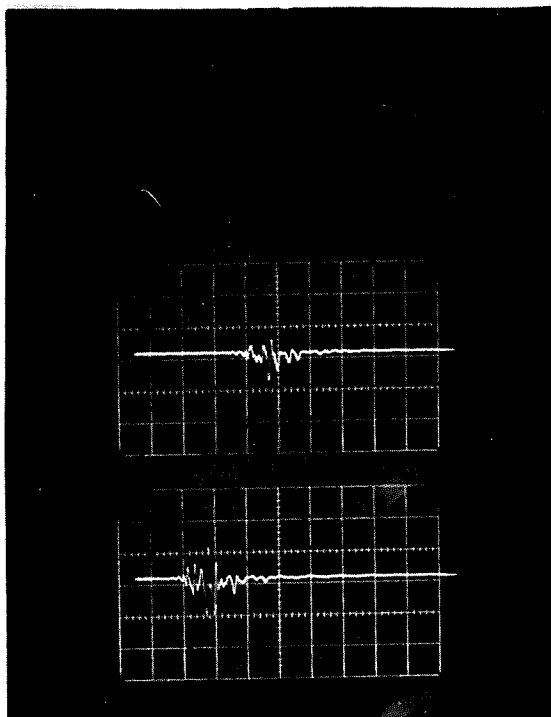
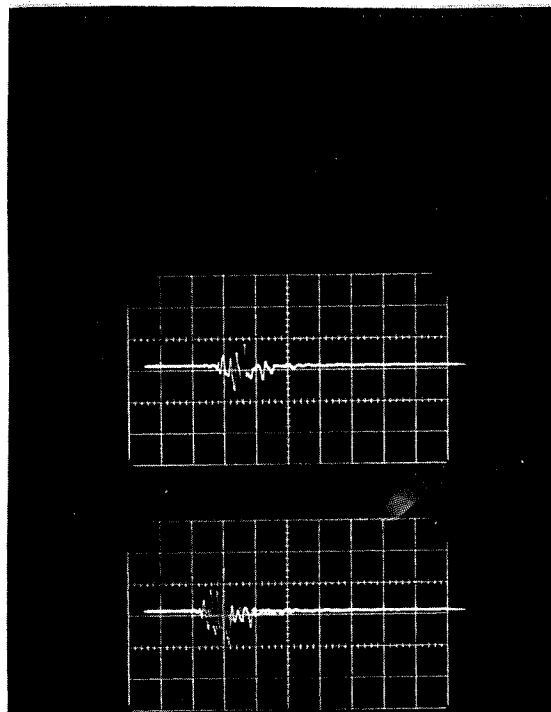
Figure 3.4.3-5 HFE - Command  
Line Noise, Channel 1. Detail of  
Large and Small Peaks

The command line interface waveforms indicated that the loading of the experiment circuits on the Central Station circuits was minimal. Power converter noise crosstalk could be observed on the interface lines, as shown in Figure 3.4.3-5, and the amplitude was sufficient to carry the logic "low" level beyond the ICS limits of 0 to +0.4V.

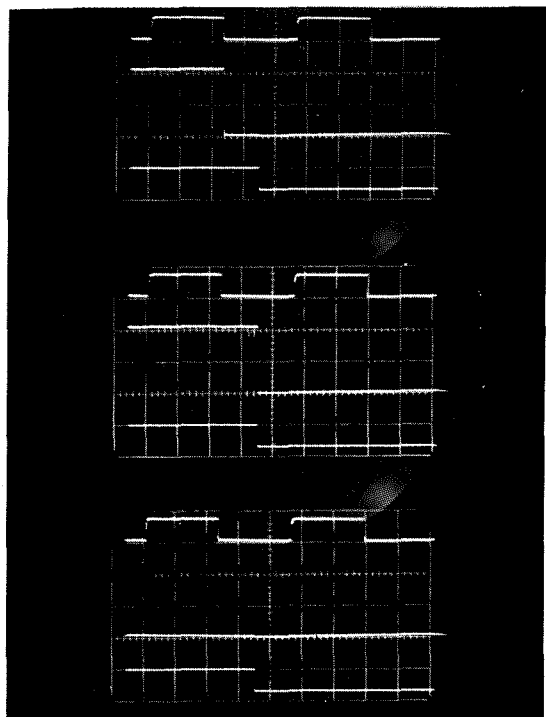
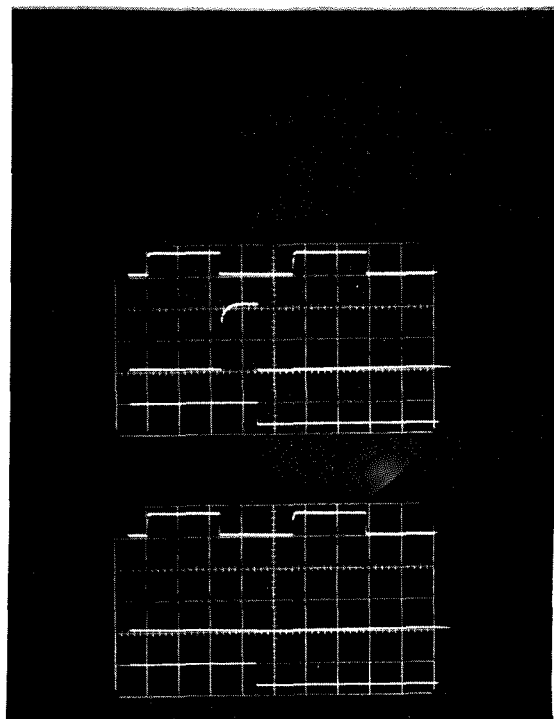
Figure 3.4.3-8 HFE Data-End  
of Data Word

5. Erratic termination of data word by HFE data programmer	NA	NA	NA	5. Word sometimes ends on fall of demand and on occasions a spurious half-data bit is seen after fall of demand. Under investigation to determine significance and cause.

The experiment output data waveform was normal and Figure 3.4.3-7 shows typical data waveforms for the HFE word #1, together with the corresponding shift and data demand signals. An anomaly was observed on clearing the last bit of a data word, normally the data line would fall to the low level at the fall of the shift, but on occasions the data line did not fall until the end of the data demand pulse. The four possible states are shown in Figure 3.4.3-8; last data bit "one", fall of data line with shift; last data bit "one", fall of data line with data demand; last data bit "zero", data line remains low through termination of data demand pulse; last data bit "zero" followed by a rise of the data line to a high level at the fall of the shift, the high level being terminated at the fall of the demand pulse. The significance and cause of the observed experiment data processor behavior are not clear and these are being further investigated.

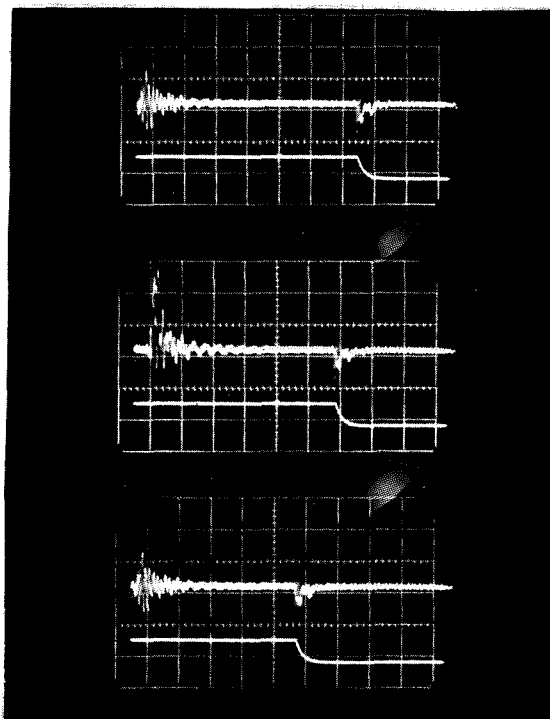
Figure 3.4.3-10 HFE Data Line Noise

Power converter noise crosstalk was evident on the data line. The magnitude of the crosstalk was found to be dependent on the shift signal level as shown in Figure 3.4.3-9, the noise amplitude being substantially higher when the shift signal was high than when the shift signal was low. The crosstalk from the larger and smaller converter noise peaks are shown in detail in Figure 3.4.3.-10, the larger transient when the shift is high, has an amplitude of 300 mV peak-to-peak, the smaller being 200 mV peak-to-peak. The crosstalk on the data line at the fall of the shift is also shown in the same figure, and is about 100 mV peak-to-peak.

- 1) Large & small convertor induced noise peaks, shift high
- 2) Crosstalk at fall of shift.

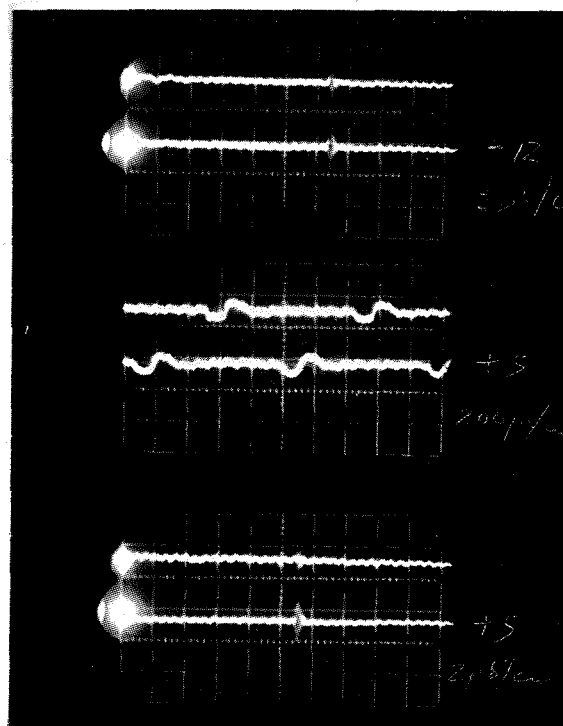
Figure 3.7-7 PCU Noise. Comparison  
Noise at PCU and ASE SBOB

Ripple on Middle Trace is Caused by EM GSE
