Apollo 12 Preliminary Science Report, NASA SP-235, Washington, D.C., 1970, pp. 217-223.

RESULTS OF EXAMINATION OF THE RETURNED SURVEYOR 3 SAMPLES FOR PARTICULATE IMPACTS

B. G. Cour-Palais, R. E. Flaherty, R. W. High, D. J. Kessler, D. S. McKay, and H. A. Zook

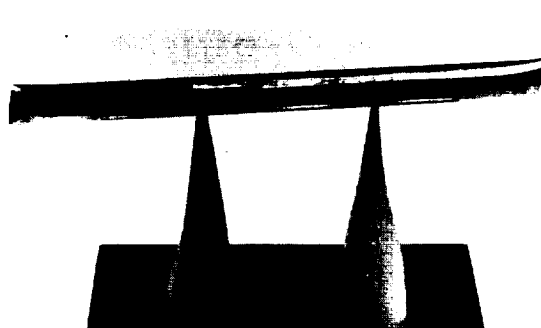
FIGURE 9.—Polished aluminum tube section obtained from the Surveyor.

The polished aluminum tube section obtained from the Surveyor 3 spacecraft was cut from the radar altimeter and doppler velocity sensor (RADVS) support strut adjacent to leg 2 using a pair of long-handled shears (resembling pruning shears) with curved, overlapping blades. The cutting action partially flattened the ends of the tube, as may be seen in figure 9. An increase in contamination also can be seen toward the left end of the tube. This contamination appears brown to the unaided eye. Under a microscope, it also appears brown and seems to be composed, at least partially, of crystals ranging in size up to a few micrometers. As the tube is rotated, there is variation in the amount of the contamination observed.
