Apollo 12 Preliminary Science Report, NASA SP-235, Washington, D.C., 1970, pp. 217-223.

PART E

RESULTS OF EXAMINATION OF THE RETURNED SURVEYOR 3 SAMPLES FOR PARTICULATE IMPACTS

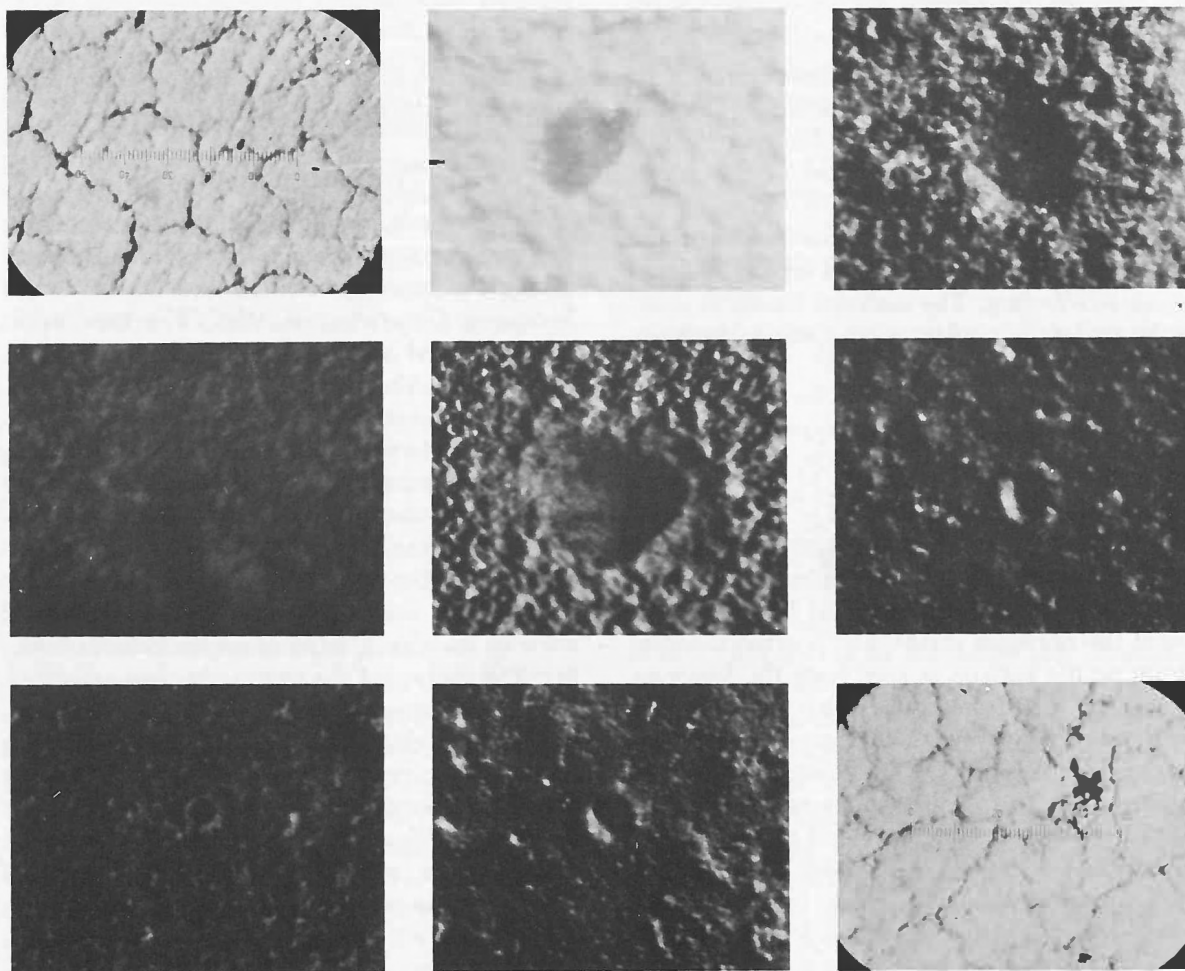
Typical surface effects and suspected impact craters are shown in figure 2. It is interesting to note that the paint surface differs around the periphery of the housing. On the side closest to the Surveyor centerline, the surface appears grainy; on the parts facing outward, the surface is cracked like a dry river bed. Several holes and popped craters appear at the junction of cracks or along the cracks, and these were not included in the total of suspected impacts. There also was

evidence of a large number of shallow white craters covering the housing with definite concentration occurring around the periphery. The craters were obviously fresh because the original white painted surfaces had been discolored to a sandy brown and the original color was being displayed. This effect is discussed in greater detail later in this article, as the cause is probably not of meteoroid origin.

The craters identified as of possible meteoroid impact origin because of their hypervelocity also are shown in figure 2. There were five such craters ranging in size from 130 to 300 μm in diameter. However, it is likely that not all of these were caused by meteoroids. This is especially

true when it is considered that three of the suspected impacts occurred on the flat mirror gear-box housing, about 25 cm^2 in area. If the five craters were considered to be of meteoroid origin, then the flux, allowing for lunar shielding ($1/2$) and spacecraft shielding ($1/4$), would be $1.49 \times 10^{-6}/\text{m}^2/\text{sec}$. Allowing for the gravitational attraction of the Earth which, at 20 km/sec, is 1.74, this is a near-Earth flux of 2.62×10^{-6} . The mass associated with the smallest crater found, 150 μm wide, is about $10^{-8.75}$ g using a crater-diameter-to-meteoroid-diameter ratio of 10. The 95 percent of upper and lower limits for five impacts is 11.7 to 1.6 according to reference 3. If this spread in flux is associated with a spread in

FIGURE 2.—Evidence of impacts on Surveyor 3 camera housing.

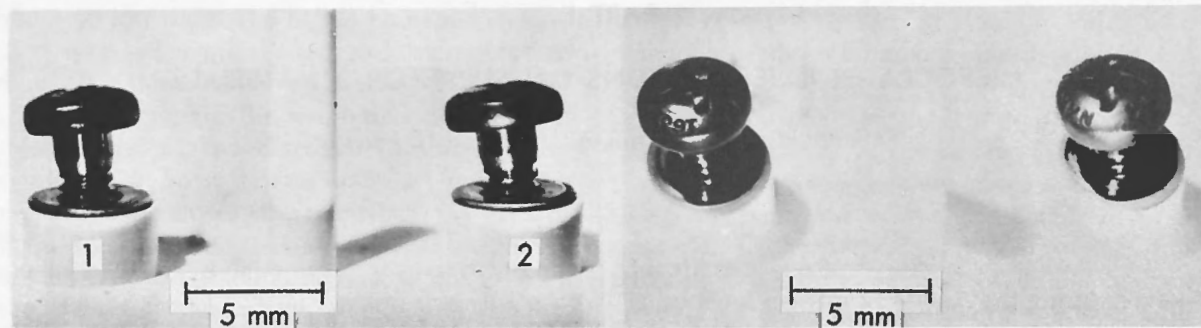
Figure 2 shows the two screws including the washers. The investigations were made using a scanning electron microscope (Stereoscan). The scanning magnification was chosen to be $5000\times$, which allowed the identification of craters down to about $0.5\text{ }\mu\text{m}$ in diameter.

The original surfaces of the screws and washers were not specially prepared in any way for scientific investigations. They are rough and probably inadequate to yield reliable results. On screw 2¹ (see fig. 3), strange features could be observed. Figure 4 shows six interesting objects on screw 1; these objects can be considered as impact phenomena.

FIGURE 2.—Surveyor 3 screws with washers.

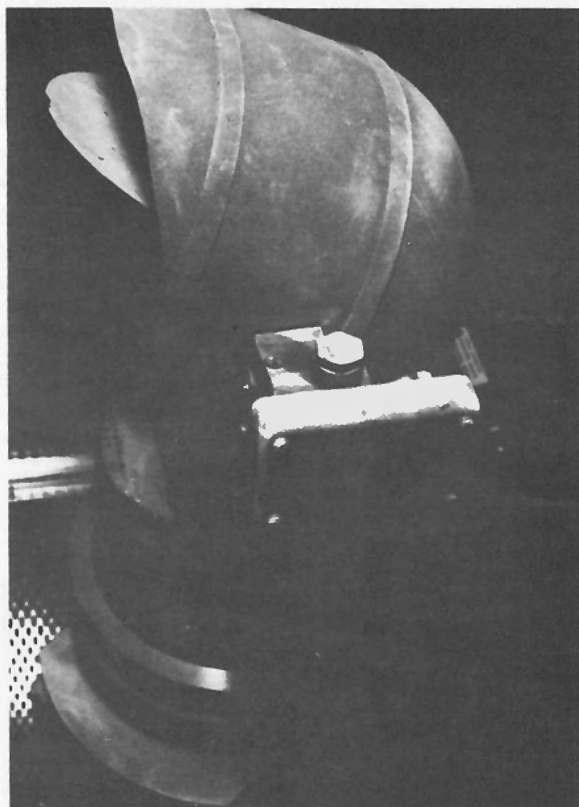
FIGURE 5.—Evidence of particle impact shadows on the camera housing.

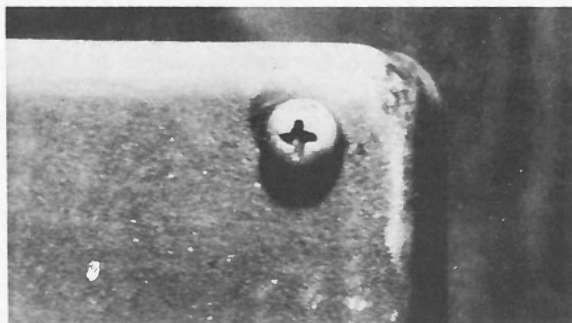
FIGURE 6.—Evidence of particle impact shadows on the camera housing.

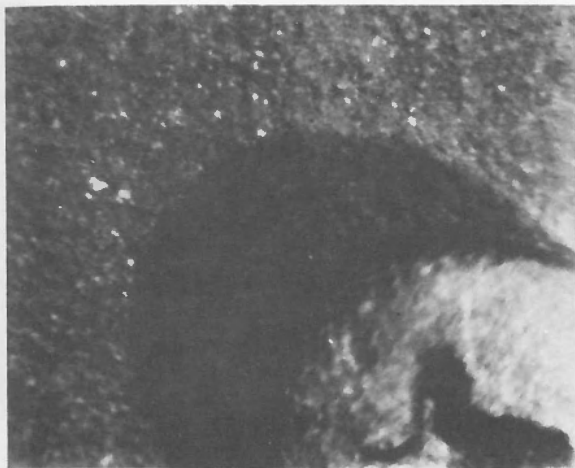
FIGURE 7.—Evidence of particle impact shadows on the camera housing.

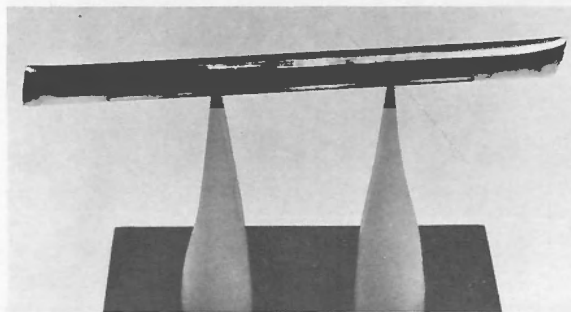
The polished aluminum tube section obtained from the Surveyor 3 spacecraft was cut from the radar altimeter and doppler velocity sensor (RADVS) support strut adjacent to leg 2 using a pair of long-handled shears (resembling pruning shears) with curved, overlapping blades. The cutting action partially flattened the ends of the tube, as may be seen in figure 9. An increase in contamination also can be seen toward the left end of the tube. This contamination appears brown to the unaided eye. Under a microscope, it also appears brown and seems to be composed, at least partially, of crystals ranging in size up to a few micrometers. As the tube is rotated, there is variation in the amount of the contamination observed.

FIGURE 9.—Polished aluminum tube section obtained from the Surveyor.

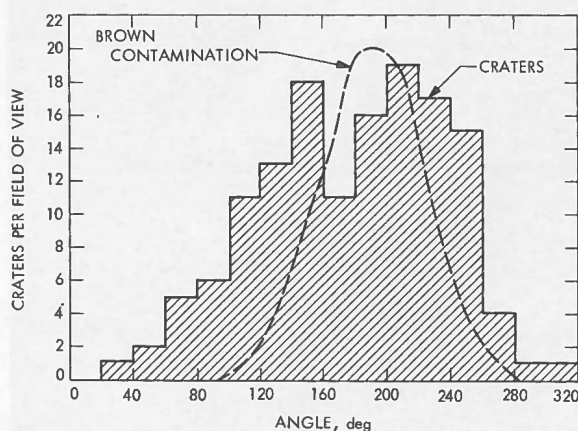
Figure 10 shows the number of craters with diameters of $20\text{ }\mu\text{m}$ and larger that were observed in the field of view of an optical microscope at $100\times$ magnification (corresponding to an area of about 1 mm^2). Counts were taken as a function of angle around the tube from the scribe line, which had been ruled along the tube before cutting. This histogram is an average of two trials on section B of the tube. Very high pit densities (up to 40 per field of view) were obtained in two places, but were obviously associated with scratches and so are not included in figure 10. The reduced count rate about 170° from the scribe line is not considered significant.

Also shown in figure 10 is a measure of the relative amounts of brown contamination on section B as a function of angle around the tube. This curve was obtained by photographing the

tube at each angular position, as the tube was rotated and the lighting held constant. The contamination stood out in the photographs between the angles of 100° and 280° and seemed to peak at about 190° . Outside of these angles, section B was relatively clean. The relative heights of the ordinate of the contamination curve in figure 10 are not quantitatively significant. A high ordinate means that the photograph indicates "high" contamination relative to an angular position with a ordinate. It is immediately evident that there is a close association between the pitting rate and density of the brown contamination.

FIGURE 10.—Distribution of brown contamination and of impact craters.

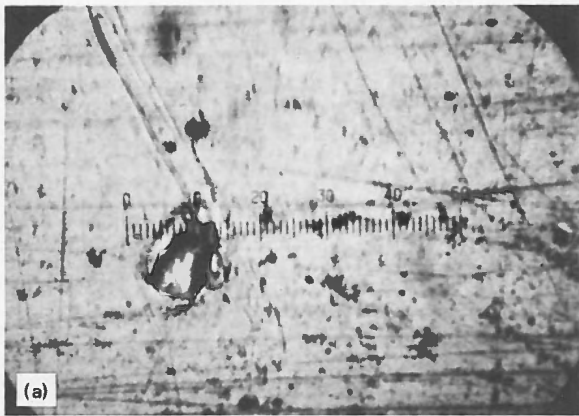
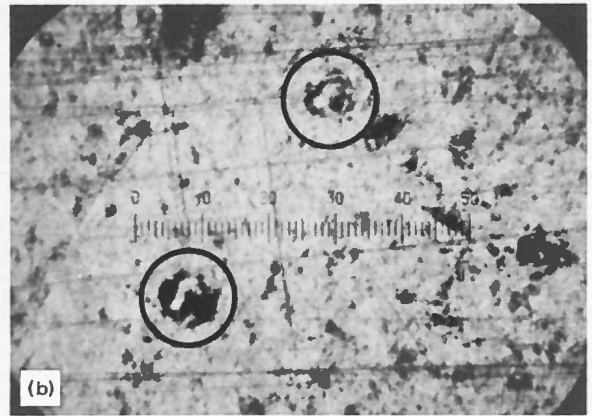
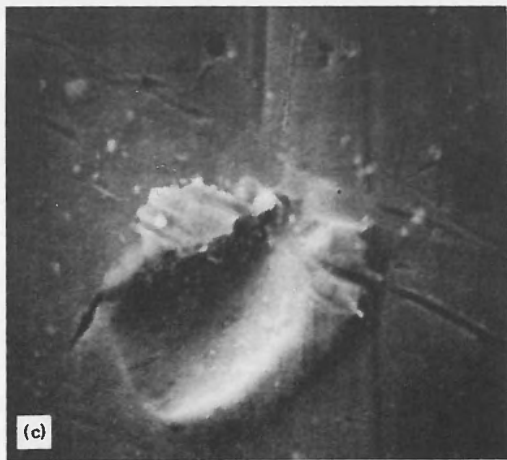
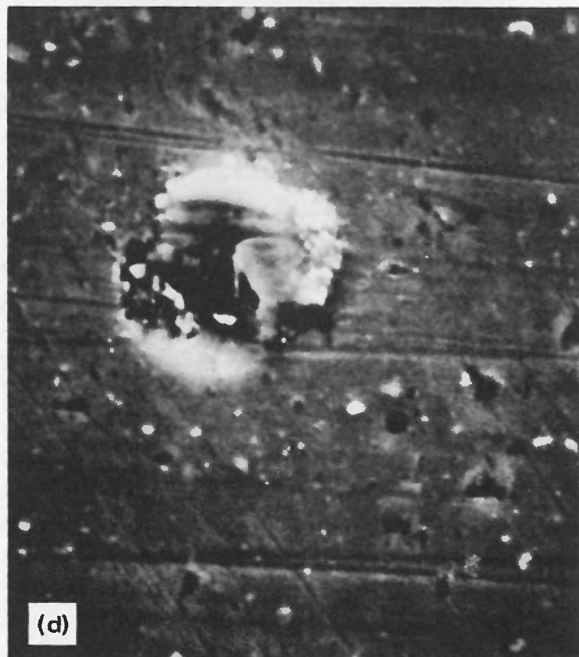
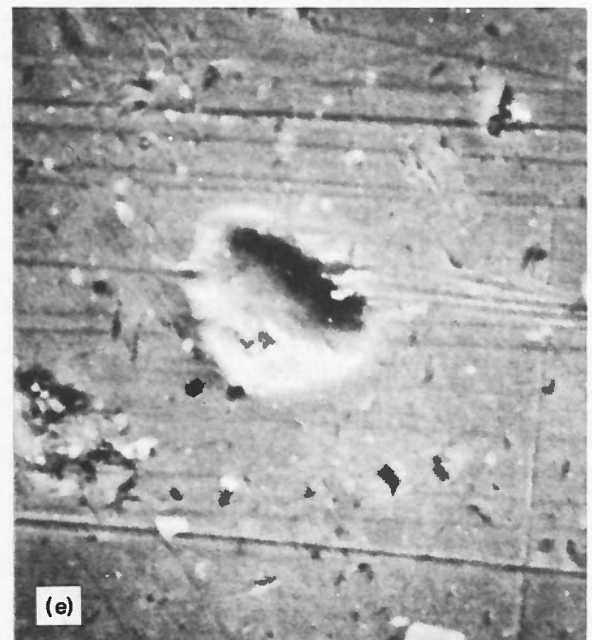
FIGURE 11.—Optical microscope and SEM views of typical impacts on polished tube section B. (a), (b) Optical microscope views. (c), (d), (e) SEM views.

Figure 11 shows SEM photographs of three craters on section B, located 280° from the scribe line. The craters obviously are not due to a hypervelocity impact; e.g., there is no smooth, raised lip entirely around the central indentation. However, it is clear that material at relatively low velocity, perhaps a few hundred meters per second, has impacted from the lower left in this photograph. The largest crater is about 30 μm wide, and material is still in the crater. An X-ray pulse height analysis of this material showed it to be composed of silicon, calcium, and iron with significant traces of chromium and titanium.

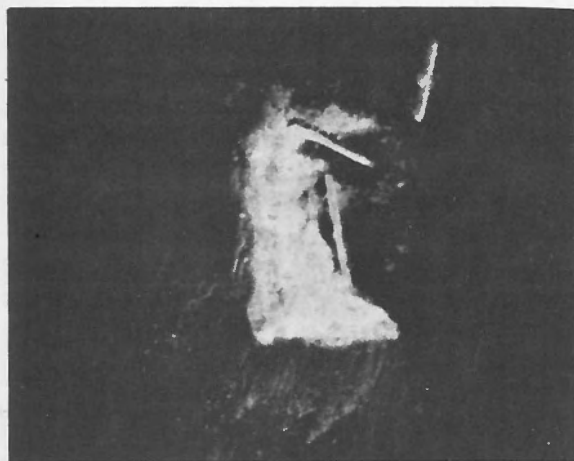
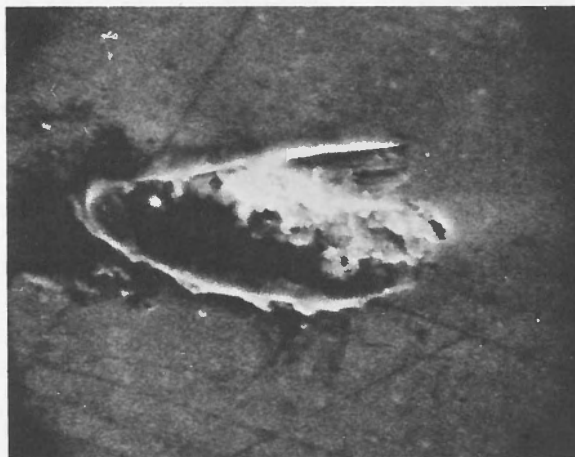
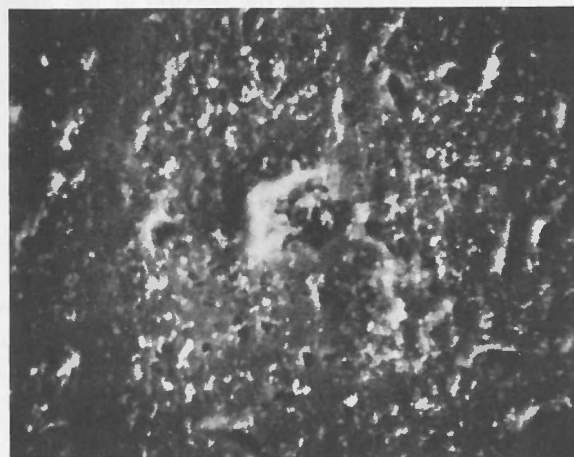
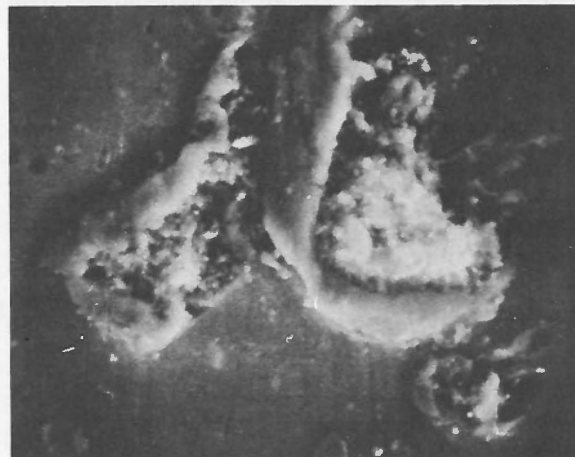
Figure 12 shows a region of high pitting density at 220° from the scribe line on section B. The

FIGURE 12.—Evidence of typical impact debris found on sections B and C of the Surveyor 3 polished tube.

crater in the center is about $8\ \mu\text{m}$ in diameter; the material in this crater has as major components silicon, iron, calcium, and titanium. Titanium was also found in another crater on this tube. Because only six craters were extensively analyzed by SEM non-dispersive X-ray analysis, the significant amounts of titanium found in three of them are indicative of a lunar origin. From the mineralogical standpoint, at least three phases are present:

A crater that gave us some difficulty is the one shown in figure 12 at 170° from the scribe line. Its size is about 80 by $110\ \mu\text{m}$ and is one of the largest craters on the tube. The reason for the difficulty was the surprising appearance of "rods" in the crater, which looked very much like glass fibers under an optical microscope. The SEM analysis showed them to be identical in composition to the glass fibers in the astronauts' outer garments and in the back pack in which the Surveyor 3 parts were stowed. Experiments at MSC have shown that it is possible to break a few fibers by jamming the end of a strand of beta-fiber into a crater of this size.
