GENESIS CONCENTRATOR TARGET PARTICLE CONTAMINATION MAPPING AND MATERIAL IDENTIFICATION. M.J. Calaway¹, M.C. Rodriguez², and J.H. Allton³: (1) Jacobs (ESCG) at NASA Johnson Space Center, Houston, TX; (2) Geocontrol Systems (ESCG) at NASA Johnson Space Center, Houston, TX; (3) NASA, Johnson Space Center, Houston, TX; michael.calaway-1@nasa.gov.

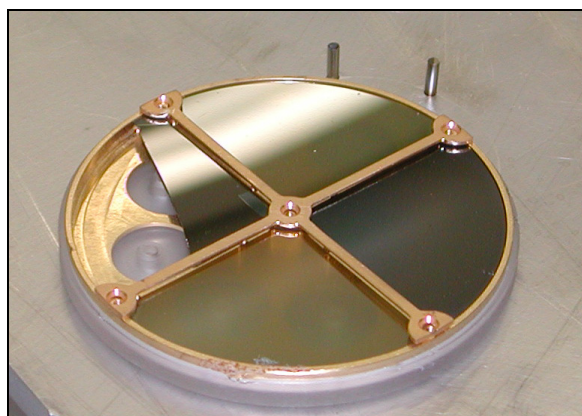
Figure 1 shows that all three targets imaged in this report are fully intact and do not show any signs of material fractures. However, due to the SRC hard landing, each target has experienced varying degrees of impacts, scratches, and particle debris from the spacecraft and Utah impact site. In addition, previous ellipsometry results and overview imaging of both flown SiC targets show a solar wind irradiation gradient from the center focal point to the outer edge [3, 4].

Fig. 1: Genesis Concentrator Target after Landing. In the above image, SiC target quadrants are on the top and bottom (60001 and 60003 respectively). The CVD target (60002) is on the right and the partial DOS target fragment is on the left.

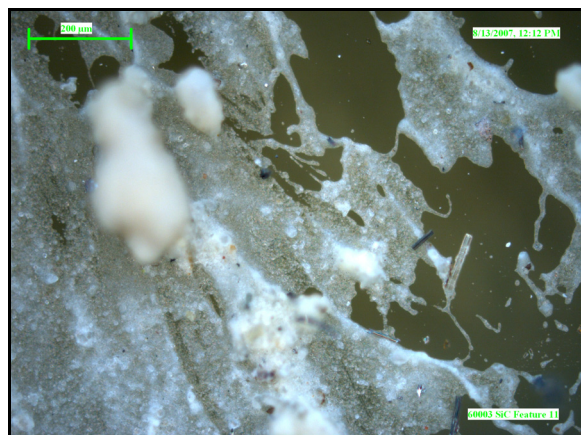
with a Leica DM6000M automated microscope using 5X, 10X, and 50X objective lens. Feature locations were then mapped to an overview mosaic image. Figure 2 shows an image example of a salt deposit on SiC target 60003. The salt deposit is probably a dried mixture of halite and other sediments from the lacustrine environment at the Utah Test and Training Range. Black carbon-carbon fibers, Al fragments, and other SRC materials can be visibly identified mixed within the salt matrix. Figure 3 shows an example of microsphere contamination, most likely from the super-light ablator (SLA) material from the SRC.

Fig. 2: SiC 60003 salt feature using a 10X objective lens. Scale bar is 200 μ m.

Chemical cleaning techniques with Xylene and HF in an ultrasonic bath are currently being investigated for removal of small particles by the Genesis science team as well as ultra-pure water megasonic cleaning by the JSC team [5]. Removal of organic contamination from target materials is also being investigated by the science team with the use of UV-ozone cleaning devices at JSC and Open University [6].

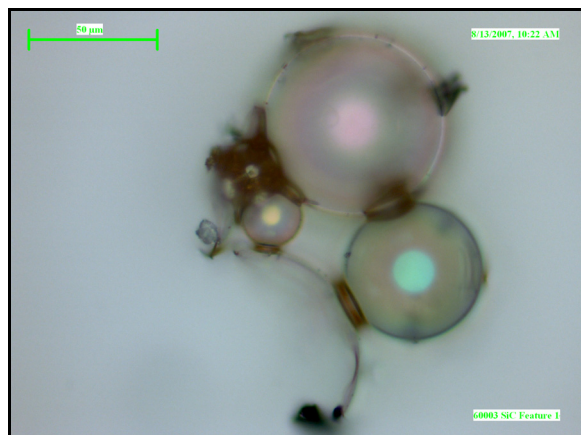
Fig. 3: SiC 60003 microsphere feature at 50X objective lens. Scale bar is 50 μ m.

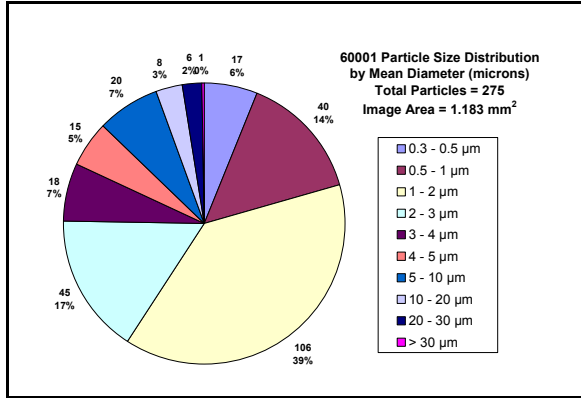
Fig. 4: SiC 60001 above target graph shows that 88% of the particles are < 5 μm in diameter and 59% are < 2 μm in diameter.

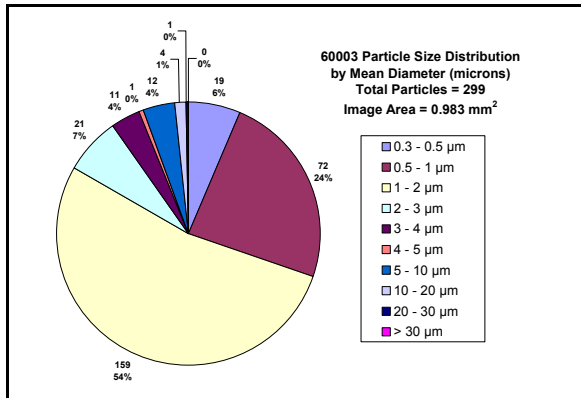
Fig. 5: SiC 60003 above target graph shows that 95% of the particles are < 5 μm in diameter and 84% are < 2 μm in diameter.

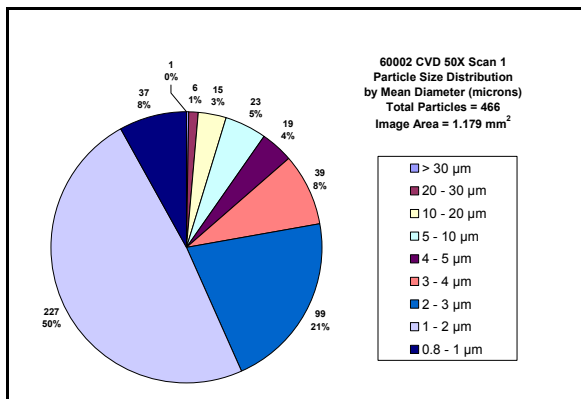
Fig. 6: CVD 60002 above target graph shows that 91% of the particles are < 5 μm in diameter and 58% are < 2 μm in diameter.
