**STEREOMICROSCOPE INSPECTION OF POLISHED ALUMINUM COLLECTOR 50684.0.** M. C. Rodriguez<sup>1</sup>, M. J. Calaway<sup>2</sup>, J. H. Allton<sup>3</sup>; <sup>1</sup> Geocontrol Systems- ESCG at NASA/Johnson Space Center, Houston, TX 77058; [melissa.rodriguez-1@nasa.gov](mailto:melissa.rodriguez-1@nasa.gov), <sup>2</sup> Jacobs- ESCG at NASA/Johnson Space Center, Houston, TX 77058, <sup>3</sup> NASA/Johnson Space Center, Houston, TX 77058.

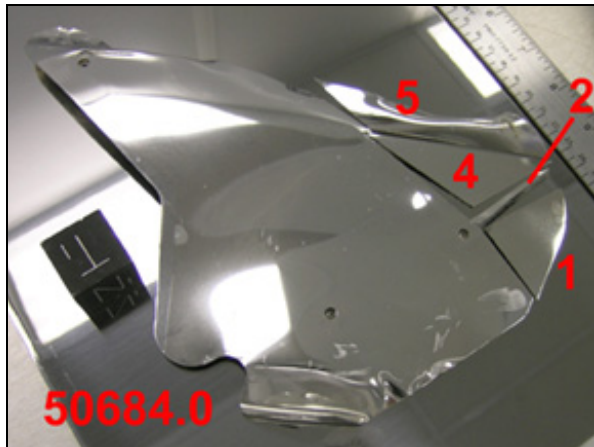
Fig. 1. Polished aluminum collector after subdivision in 2005. Portions 1, 2, 4, and 5 were previously imaged. Imaging of portion 50684.0 is in progress.

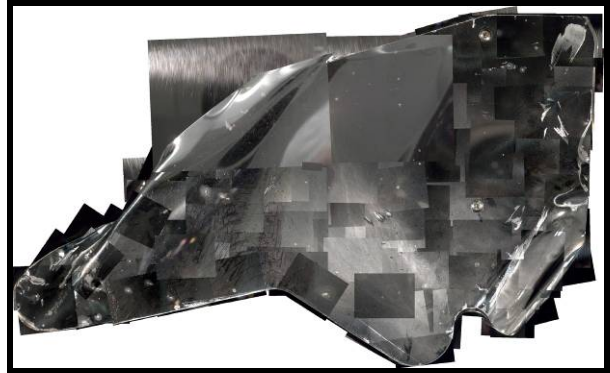
Fig. 2. Overview image of remaining polished aluminum kidney, 50684.0.

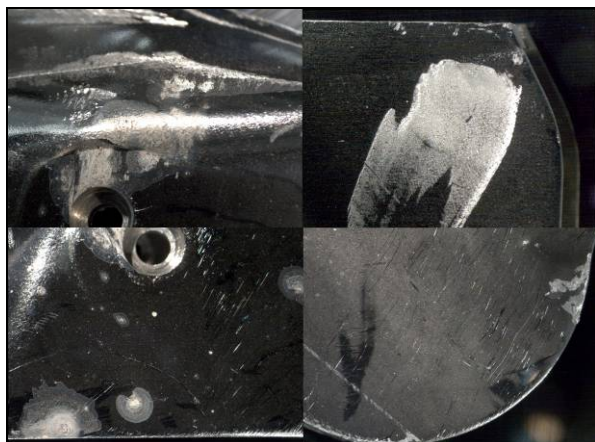
**Stereomicroscope Observations:** Post-flight characterization shows that the collector area has remained intact and did not fracture during impact. However, the Al collector was distorted and bent from the original dimensions. Mud and salt evaporite contamination from the Utah lakebed landing site is observed on the outer edges of the collector (Fig. 3) in smears and dried droplet formations. An extremely fine layer of particulate contamination is also present on the interior, flatter portions of the collector, recording evidence of physical movements of fragments during the hard landing (Fig. 4). Examples of hypervelocity impact craters, found on the right-hand portion of the image, are shown at higher magnifications in Fig. 5. All of the crater shapes appear to be uniformly round diameters at the collector surface and have unevenly splayed protruding edges. The interior “pit” bases also appear to be consistently rounded. Various gouges and scrapes from the hard landing have also been imaged; these are markedly different from impact cratering features and also appear near collector edges (Fig. 6).

Fig. 3. Four examples of Utahogenic contamination near collector edges at 0.63X.

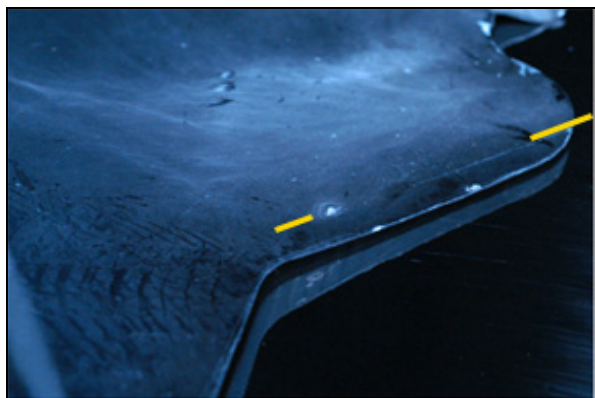
Fig. 4. Patterns in extremely fine material coating the polished surface shows evidence of physical movement of fragments during hard landing.

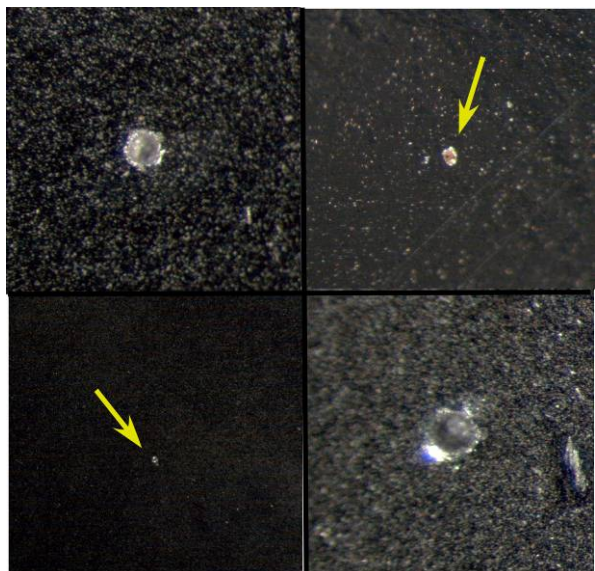
Fig. 5. Examples of microcraters on polished aluminum surface. Image on lower left has not been positively identified.

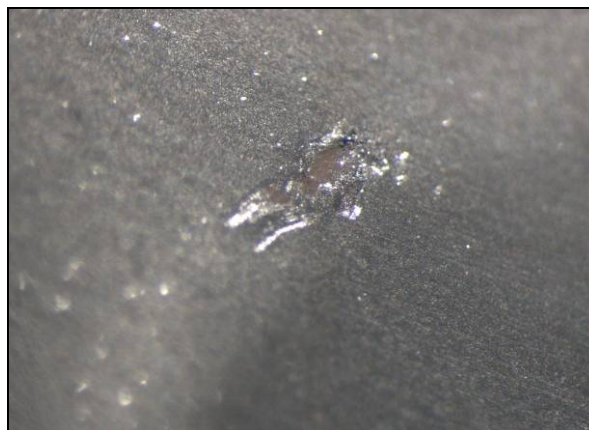
Fig. 6. Irregularly shaped gouge on aluminum kidney surface.
