**Aerospace
Systems Division**

Spurious Status Changes in Array E

NO.	REV. NO.
ATM-1096	
PAGE <u>1</u>	OF <u>20</u>
DATE	5/10/72

During the C/S Verification Test (TP 2368960) on the Array E Qualification Model, several changes of status occurred at turn-on, PC changeover or following other power interruptions. These discrepancies were documented in DR AC 5068, 5069, 5071, 5072, and 5082.

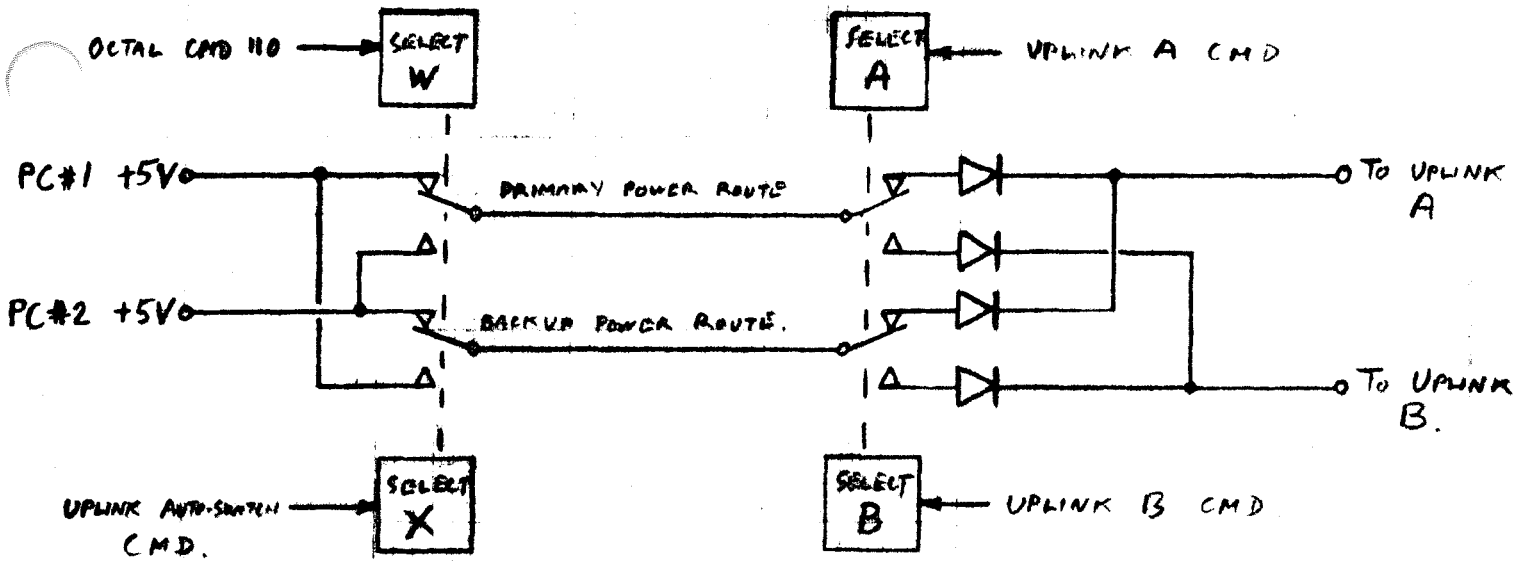
FIGURE 1 :- UPLINK +5 VOLT SWITCHING.

Figure 1 shows the uplink +5 volt switching circuit. The relay which Command 110 controls selects redundant power routes to the main Select Uplink A/Select Uplink B relays, the redundant routes being necessary to prevent a possible single point failure mechanism in the main relays. Normally the W/X relay will be flown in the W position and will remain there for the whole mission. If an automatic uplink switch does take place, then the W/X relays and the Uplink A/B relay will change simultaneously. Only then will it be necessary to consider transmitting Octal Command 110 with the intention of causing an actual relay changeover, back to the original position. (An Octal 110 command may be transmitted immediately after station turn-on in order to ensure that the W/X relay really is in the W position. However, since no magnetically latched relay has so far changed position due to mechanical causes, and since telemetry channel HK 26 indicates the position of this relay, it is unlikely that Command 110 will need to be transmitted. Even if it is, the only result should be a CVW, with no change of status).

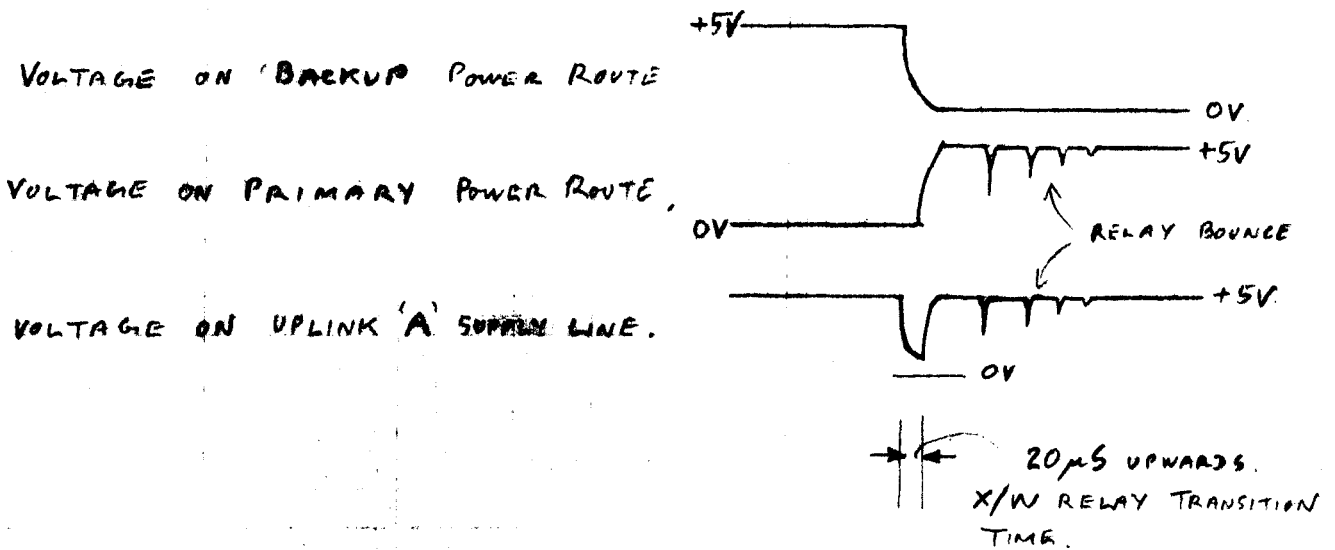
FIGURE 2 :- TYPICAL EFFECT OF CMD 110.

The typical effect of the X/W relay changeover is shown in Figure 2. The +5 Volts is switched from one redundant power route to the other, and while the relay is in transition the Uplink, and in particular the Command Decoder, is effectively unpowered. The individual PC board decoupling capacitors in the Decoder will discharge very rapidly, and it is quite possible that the +5 Volt V_{CC} line will drop below the critical level. Once the V_{CC} has dropped below 1.5 Volt to 2.5 Volt, depending upon temperature, the subsequent recovery state of any flip-flop will be indeterminate, unless reset by some external input. This lack of memory in symmetrical flip-flops following loss of power is not peculiar to Array E, but in this case it is accentuated by the inability of the TTL 54L gates to function correctly once the V_{CC} is below the relatively high critical level. (See Reference #6). During a normal turn-on, or an Uplink changeover, the Decoder power - reset circuits will operate to initialize all flip-flops in predetermined states; in the case of Cmd 110 the power interruption is too short to trigger the power resets.

Although only a DP to LSPE formatting change has been observed so far, any of the following spurious operations are theoretically possible: -

There are four ways in which this problem could be overcome: -

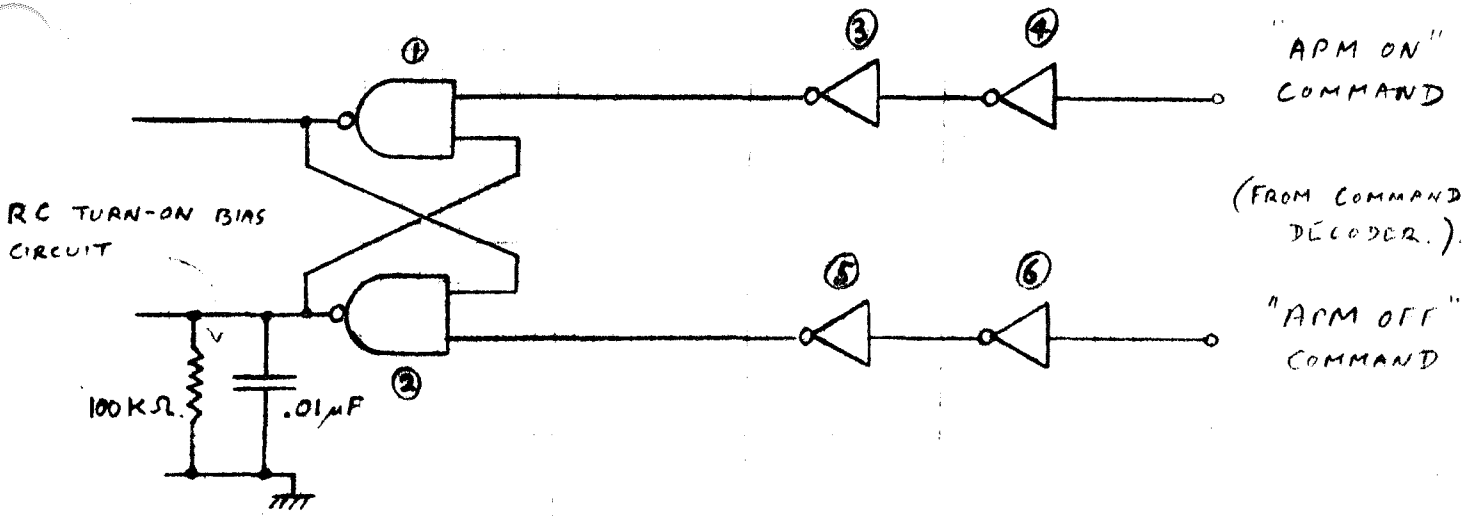
FIGURE 3:- DETAIL OF APM CONTROL FLIP-FLIP.

This has been conclusively shown to be caused by a 0.1 millisecond spurious command from the Command Decoder during turn-on. Although a relay would not respond to such a short pulse, (and all PDU relays are in any case protected by the new +5 Volt (Z) switch), it is far in excess of what is required to toggle a flip-flop. Figure 3 shows the relevant circuit details. Although the flip-flop does have a RC power-reset circuit, it has a very short time constant (~ 1 millisecond) and it can do nothing to overcome the effect of a spurious command which occurs several milliseconds after the application of power to the PCU. The only guaranteed solution in this particular case would be a much improved power-reset circuit. Even if the spurious command from the Decoder was completely eliminated, the PCU inverters 3) and 4), and 5) and 6) in Figure 3 are potentially capable of generating spurious commands themselves, although it is possible that in this case they would be swamped by the effect of the existing RC power reset circuit.

The problem of eliminating all spurious commands from the decoder will be considered later. Assuming for the moment that spurious commands to the PCU will continue to be a possibility, the most likely response is the APM status change already observed; it could theoretically occur at initial turn-on or during a PC changeover. Changes of status of the PC Select and PC Autoswitch Select relays are also theoretically possible,

The normal operational rule will be to leave the APM enabled at all times, and it is possible to produce a fairly strong rationale for locking the APM command flip-flop into the "Enable" state, and eliminating the APM commands.

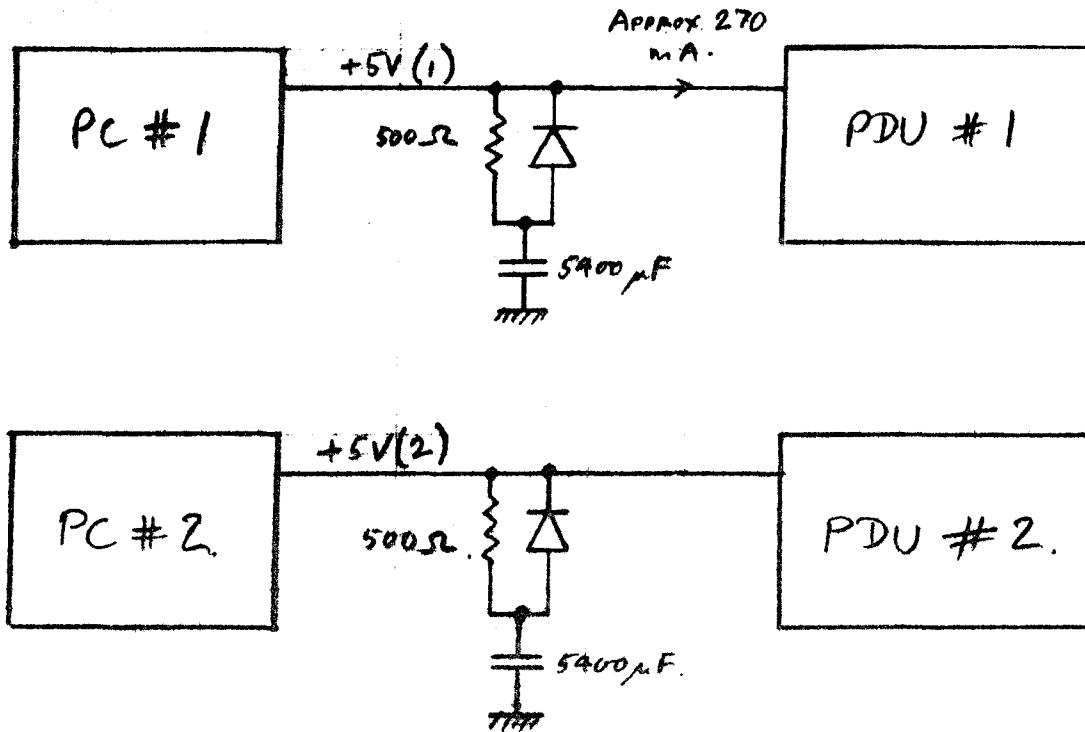
FIGURE 4:- CAPACITIVE HOLD-UP CIRCUIT.

HOLD-UP CIRCUIT CHARGES SLOWLY, WITH NEGLIGIBLE EFFECT UPON NORMAL OPERATION. CAPACITOR DISCHARGES RAPIDLY THROUGH DIODE, LIMITING MAXIMUM DROP IN 35 MILLISECONDS TO 2.25 VOLTS, INCLUDING FIXED DIODE DROP.

- a) Hold up the +5 volt supply from the PCU to the PDU with capacitors during a PC changeover, such that the +5 volt (Z) switch does not operate, nor do any gate V_{CC} fall to the critical level. Figure #4 shows the proposed circuit. Because of the limited availability of capacitors it would be necessary to restrict the hold-up circuit to the PC #1 to PDU #1 +5 volt line. The very large capacitance value leads to a noticeable weight penalty, of about 0.7 lbs per capacitor module.

This circuit eliminates only those Central Station problems which occur during a normal 35 millisecond PC changeover

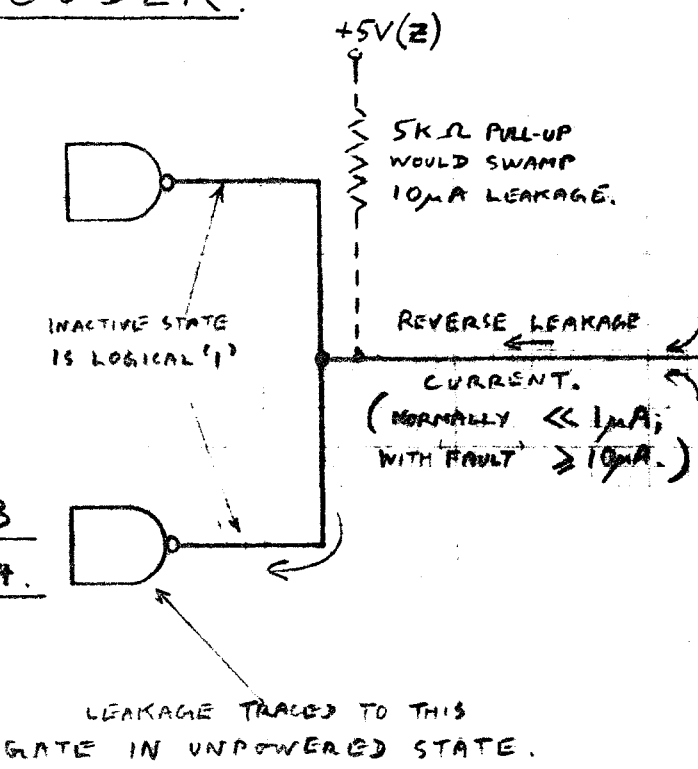
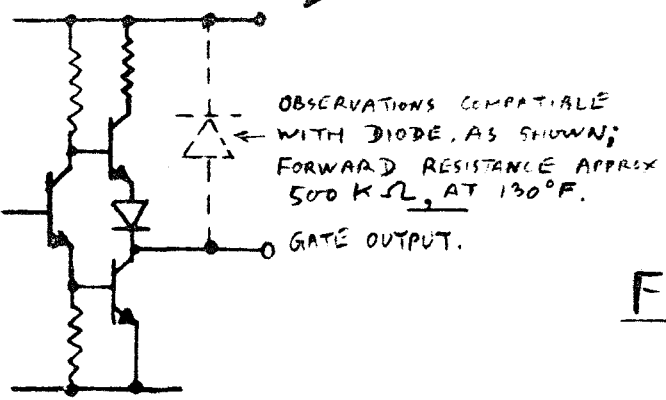
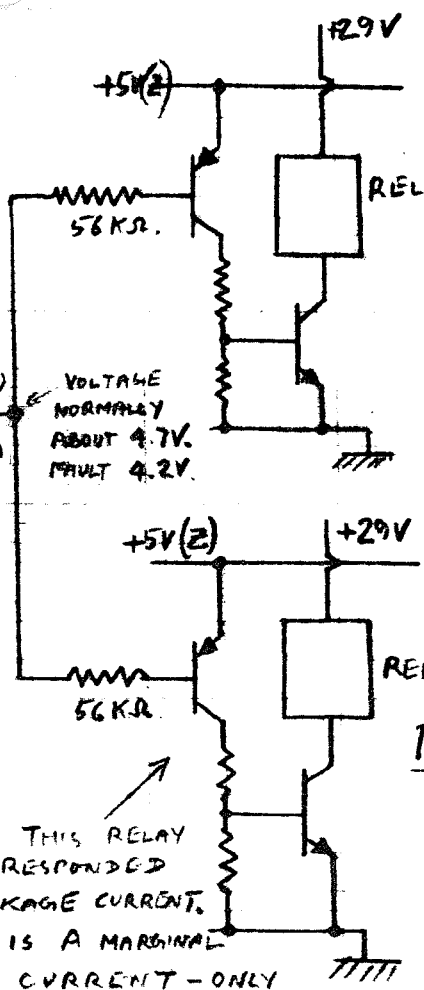
FIGURE 5: SUMMARY DIAGRAM OF REVERSE LEAKAGE PROBLEM.

the state of Uplink A had no effect. The problem therefore appeared to lie inside the "Experiment #2 OFF" command gate, in the 'B' side of the Command Decoder.

Tests at card level consisted of connecting the outputs of the unpowered command gates to +5 volts, through a 50,000 ohm resistor, and measuring the leakage current at various temperatures. Starting at approximately 200 nanoamps at room temperature, the leakage current into the suspect gate increased with temperature, approximately doubling every 10 degrees Centigrade, until at 110°F - 120°F several microamps were flowing. The remaining "good" gates showed leakage currents which followed the same doubling law, but which were at least one order smaller.

LEAKAGE TRACED TO THIS GATE IN UNPOWERED STATE.

POSSIBLE MODEL FOR FAULT MECHANISM

Having definitely traced the cause of the problem to the command gate, the relevant chip was replaced. Further investigations into the reasons for the unusually high leakage current are still in progress, and will be reported separately. It is relevant to note at this point that reverse leakage into the logical '1' output of a powered or unpowered TTL 54L gate is not a parameter which the manufacturer formally tests or specifies, nor, it appears, has any knowledge of. In the early stages of the PDU design it was realized that such leakage could be a potential problem, and initial proposals incorporated base-emitter resistors, as in the current PDM dump drivers, in order to desensitize the system. However, low measured leakage currents, and reliability parts-count trades off, led to their removal.

Assuming that permanent elimination of high leakage currents by selection cannot be guaranteed, the ideal solution would be to modify the designs of the PDU relay drivers so as to make them compatible with the specified logic '1' and logic '0' voltage levels of the TTL 54L gates, when the problem of leakage effects would automatically disappear. This is clearly impracticable because of the program impact. A less elegant, but a simple and effective expedient is to add a 5 Kilohm pull-up resistor from the +5 volt (Z) line to each susceptible command line.
