Array E Action Item 604 -
Ripple on +5 volt line

NO.	REV. NO.
ATM-1098	
PAGE <u>1</u>	OF <u>9</u>
DATE 5/12/72

Action Item 604 required an investigation into the apparently unique nature of the ripple on the Array E Qual Model PC #1 +5 volt output. This ATM shows that no fault condition existed and it provides a rationale for accepting occasional uneven ripple, within specification peak-to-peak limits, as normal PCU behavior.

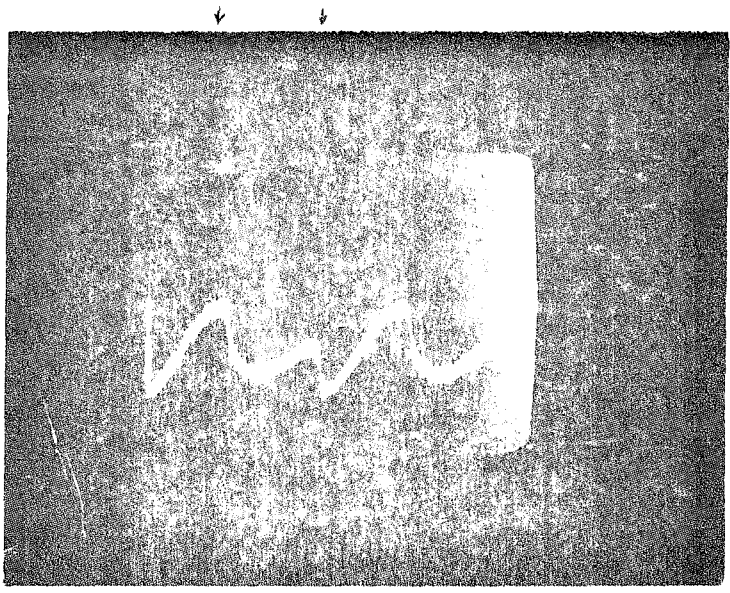
PC-1
5 VOLT line
20 MV/cm
20 μ sec/cm

The only remaining problem, and the reason for Action Item 604, was the uneven ripple waveform on the Qual PC #1 +5 volt output, as compared with the regular ripple waveforms on all the other power lines of the Qual model, and on the two +5 volt lines of the DVT model. (See Figure 1). The uneven waveform was not in itself unacceptable, and it could not affect the system adversely, but in view of its apparently unique nature it raised the questions of the reason for it and whether it was indicative of imminent part failure.

2.3 As a part of the response to Action Item 604 the ripples on the outputs of the Flight, DVT and spare modules were examined, for comparison with the supposedly faulty Qual module. It was now observed that the Qual Model PC #1 +5 volt output was definitely not unique in having an uneven ripple waveform. It was undoubtedly worse than any other output in this respect, but depending upon the working conditions it was possible to produce similar unevenness on nearly all the other outputs.

Even the original photographs, upon which the Action Item was based, when re-examined closely showed traces of unevenness on the previously "regular" waveforms.

3.2 The ripple variations can be most easily and satisfactorily explained as the combined results of several random inputs. Being random, the net result would tend to a norm of zero (or at least small) i.e., even ripple half-cycle to half-cycle. Very occasionally, however, the contributions will have the same sign, leading to marked unevenness on the relevant output.

It is recommended that uneven power line ripple, half-cycle to half-cycle, of the type shown in Figure 1, be accepted as an occasional but normal characteristic of the PCU, provided that the maximum peak-to-peak ripple limits are not exceeded.

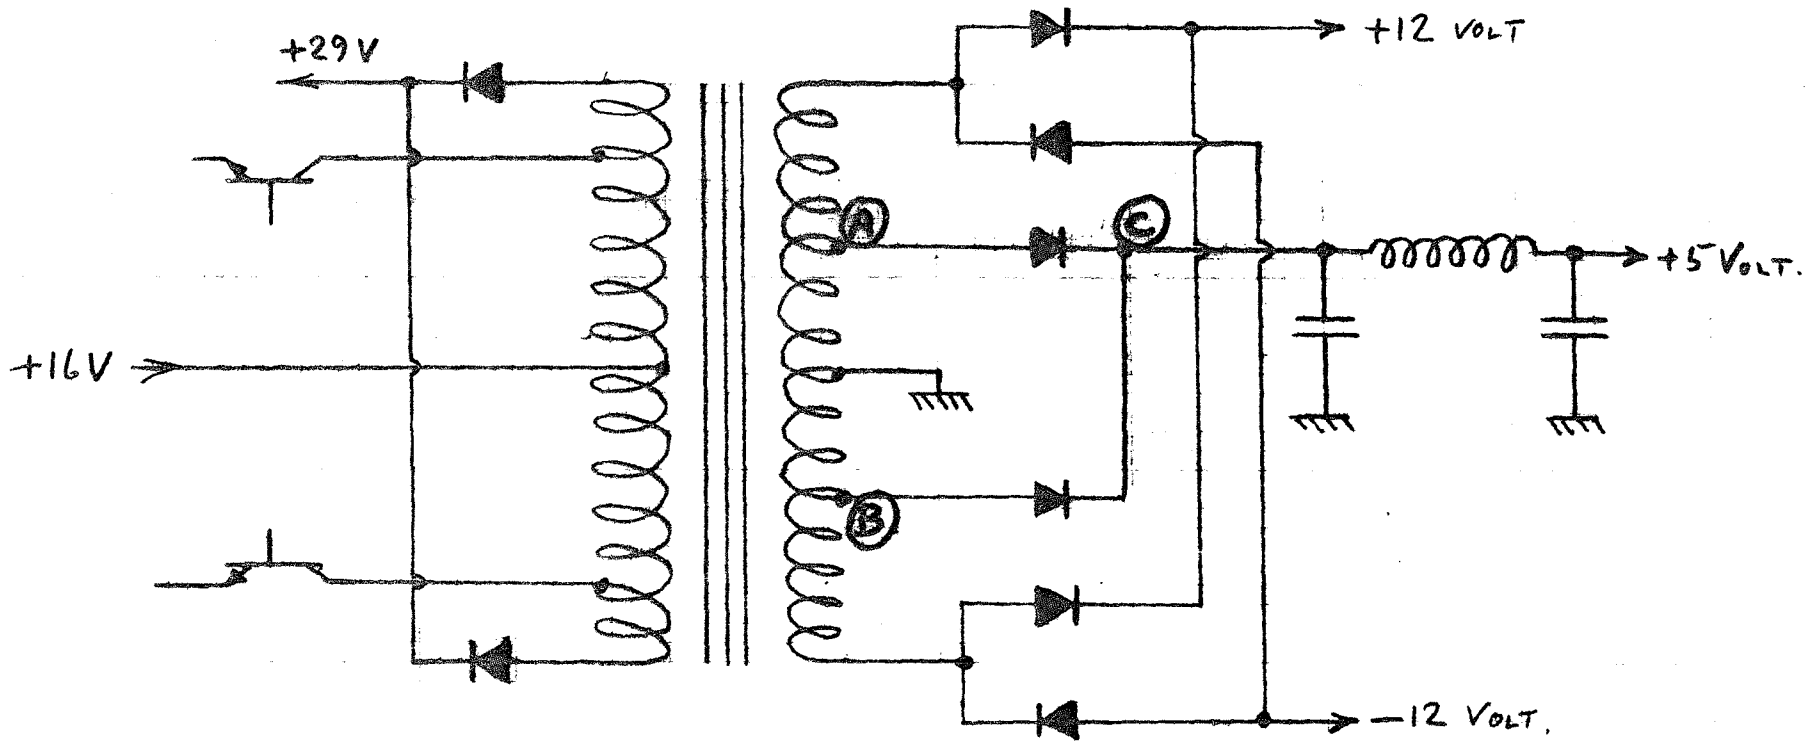
FIGURE 2 : SIMPLIFIED TRANSFORMER AND RECTIFICATION CIRCUIT.

2.1 Figure 2 shows a simplified diagram of part of the converter transformer and rectification circuit. Since the original measurements apparently showed no unevenness on the +12 volt and -12 vblt lines and since the +5 volt filter is common to both half cycles of rectification, the cause of the uneven ripple was assumed to lie at or between the points A, B and C. These parts of the PC circuitry are all contained within the Transformer/Rectifier Module.

- 2.2 The obvious possible causes were: -
- a. Transformer tapping error.
 - b. Unequal lead (printed circuit) resistances, due to geometry, badly soldered joints or a PC production fault.
 - c. Medium-impedance sneak path(s) to ground on one side, due to solder and/or PC whiskers.
 - d. Unmatched diodes.

Possibility (a), the tapping error, could be eliminated immediately, since it would have produced an imbalance approximately one order greater than observed.

Having eliminated all other possible causes, only diode mismatch remained. Once the diodes have been incorporated into a module it is extremely difficult to measure the extent of any mismatch, but reference to the initial selection records showed that the whole batch from which the pair in question were taken had a very small spread, and that even if random interchanges between diode kits had occurred matching to within about 10 millivolts should have been retained.
