**Aerospace
Systems Division**

Failure Investigation -
Multiple Grenade Launching

NO.	REV. NO.
ATM-743	
PAGE <u>1</u>	OF <u>16</u>
DATE 18 March 1968

This memo presents the results of the simultaneous grenade launching failure investigation. The failure investigation includes tests made in the field at El Mirage, California, laboratory tests made at BxA to determine the exact cause, and tests made to verify the effectiveness of corrective action implemented.

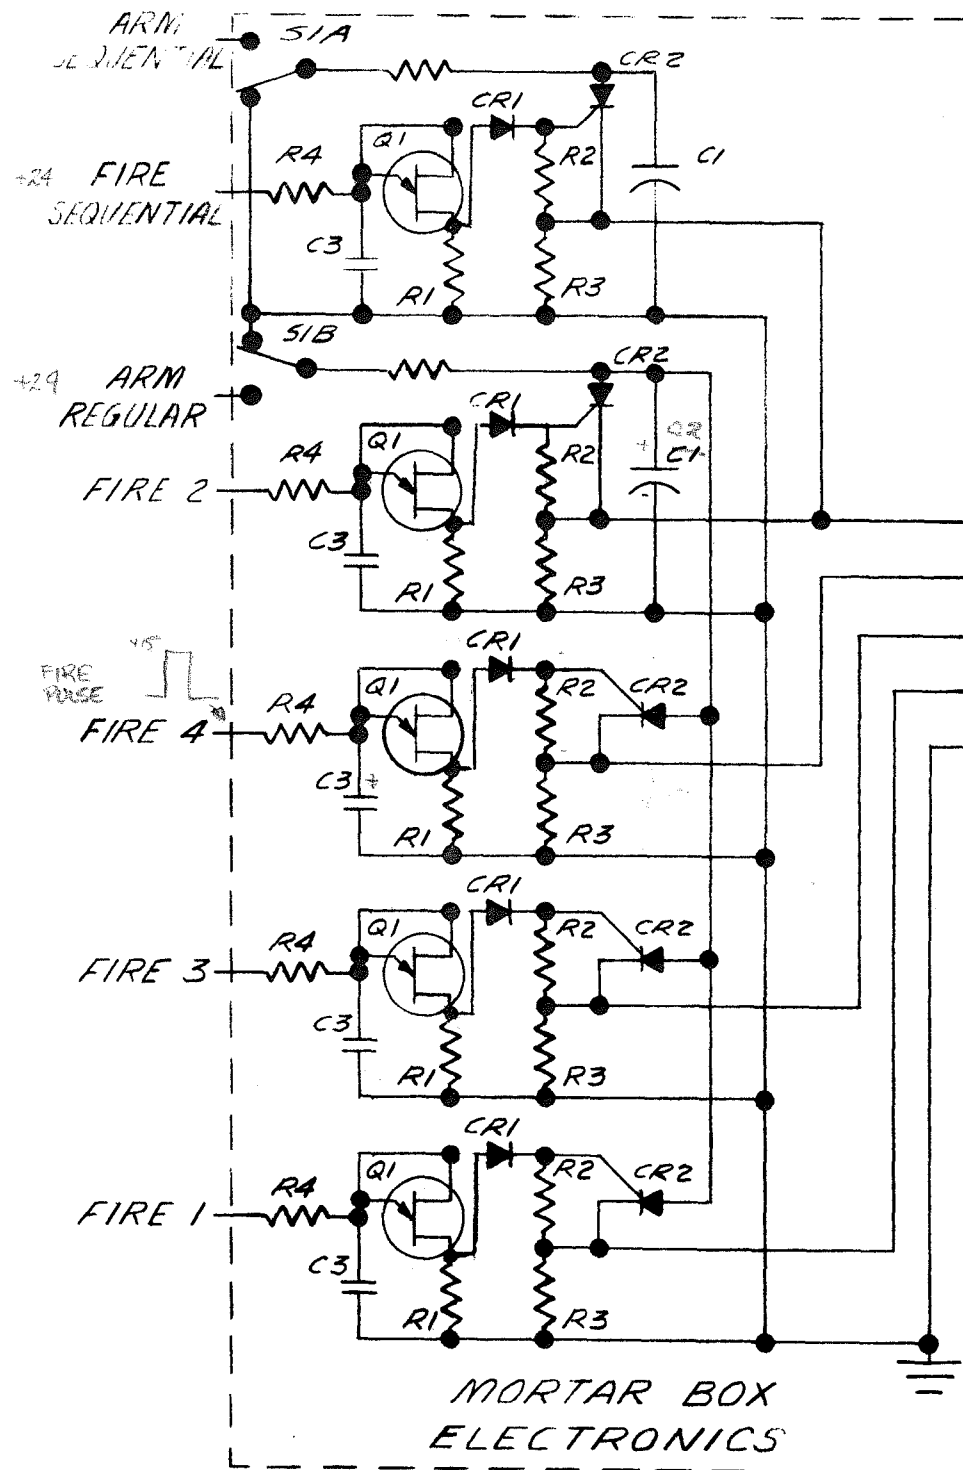
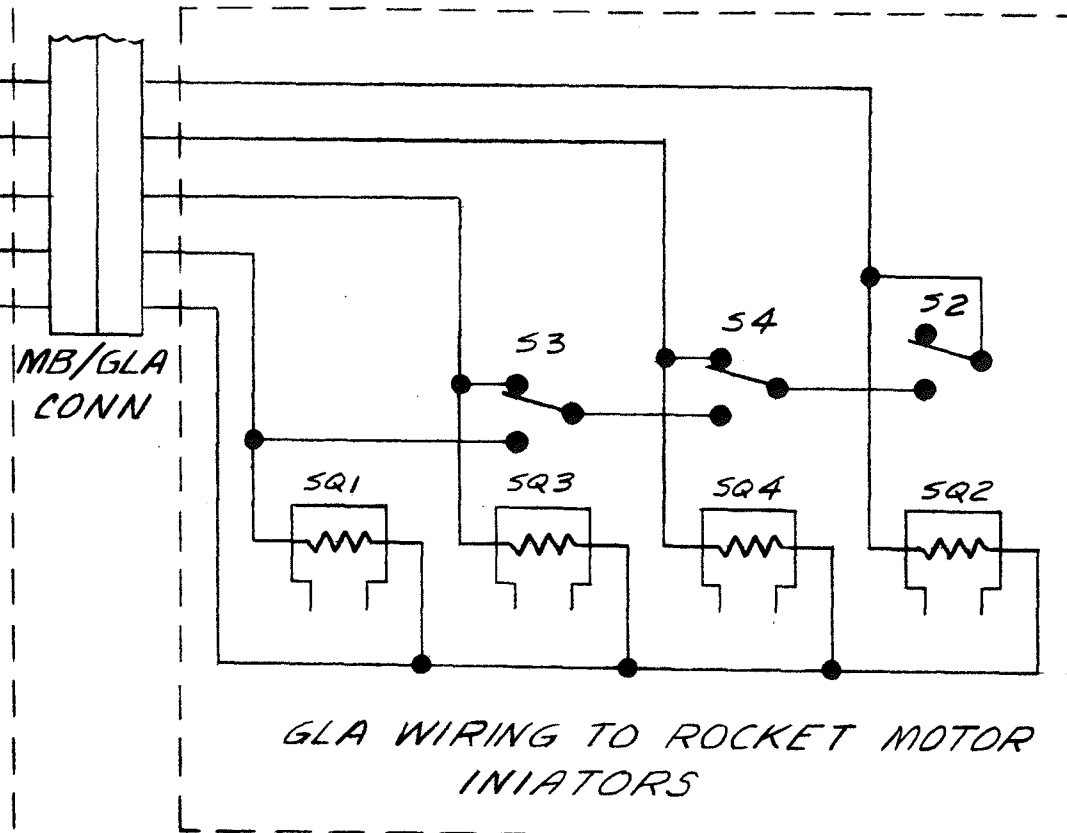
FIGURE NO. 1
SIMPLIFIED SCHEMATIC
OF MORTAR BOX AND GLA
FIRING CIRCUITRY

A functional description of the entire firing circuit design is necessary to evaluate the tests and analysis that is reported herein. A simplified schematic of the rocket motor iniator firing circuitry is shown in Figure 1. It should be noted that each of the five firing circuits (Fire #1, #2, #3, #4 and sequential) are identical, therefore, a circuit discussion can be in terms of only one.

firing pulse, the unjunction transistor turns on, applying the charge of C_3 (thru the unjunction transistor) across the parallel paths of R_1 and the series connection D_1 , R_2 , and R_3 paralld by the $1 \sim$ resistance of the iniator in the GLA. When the voltage across R_2 reaches approx. 0.7 volts, the SCR turns on, applying the charge of C_2 (or C_1 if the sequential circuit is triggered) across the appropriate rocket motor iniator. C_1 (and C_2) has a capacity of 350 μ f which when charged to 24V is sufficient to fire the iniators.

The first modification was incorporated by decreasing the value of the resistor between the cathode and the trigger of the SCR (R_2) of Figure 1 and increasing the value of the unjunction resistor R_1 . R_2 was originally $1.2 K \Omega$ and R_1 was originally 47Ω . From Figure 1, it is obvious that with $R_2 \gg R_1$ the trigger is near ground potential (less the Diode drop). With $R_2 \ll R_1$, the potential at the trigger is very near the potential of the cathode, thus the negative voltage is essentially applied to both the trigger and the cathode and false triggering does not occur. This modification was made on all five firing circuits. The effectiveness of this desensitizing the firing circuits was then verified by connecting the modified circuit to the dummy GLA (worst case wiring) and performing firing tests with headers. 38 tests were performed with the dummy GLA with no evidence of dual firings from oscilloscope monitorings. In these tests both arming capacitors were charged and in no test did both discharge. 21 tests were also performed after the circuit was modified with the GLA that had been brought back from El Mirage with no evidence of multiple firings.

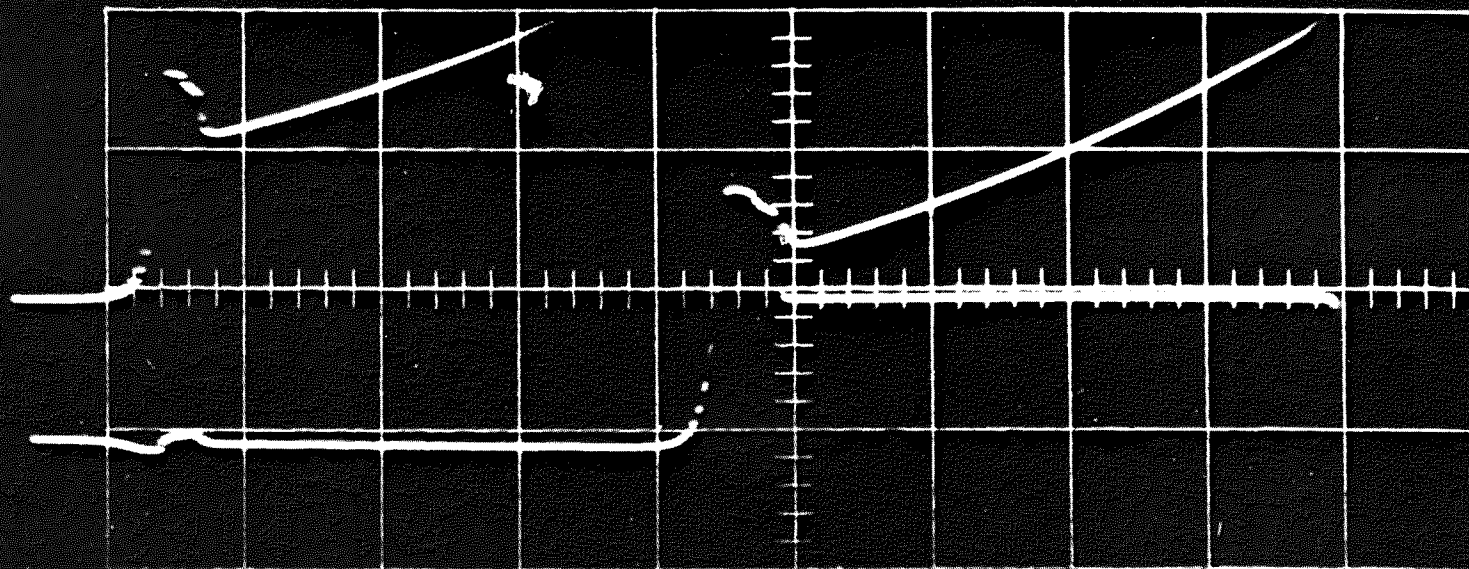
Of ten firings only one multiple header firing was observed. It was then assumed that the GLA leads were no longer tightly coupled to generate enough cross coupling to induce false triggering. Further tests were then made using a dummy GLA made with all four positive firing leads tightly compressed together in one group, and the four ground leads tightly coupled together in a second group. The ground leads were soldered together with one only connected to the GLA/MB connector to simulate actual GLA single point grounding. Each of the four positive leads were connected to the proper pin. With this test fixture (or dummy GLA) every test made with all four headers connected duplicate multiple grenade launchings by igniting two headers and discharging both sequential and regular capacitors regardless of which firing circuit was triggered. The timing of the ignition of headers was identical to those obtained while at the El Mirage test site and is again shown in Figure 3.

Analysis of the traces indicated that a negative voltage was being induced on the cathode of the SCR while the trigger of the SCR was maintained at or near ground. Note from Figure 2 and Figure 3 that the second firing pulse (measured across the header) is triggered at the time of ignition of the first header. At this time the current due to the first pulse falls rapidly to zero since the 1 ~ header has opened up making the impedance infinite. The collapse of the current induces a negative voltage in the second pair of leads which is connected to the SCR cathode (Figure 1). The negative pulse induced at the SCR was photographed both with a GLA and with the dummy GLA connected to the mortar box electronics. Reproductions of these photographs showing the induced signal characteristics is shown in Figure 4 and 5. Figure 4 is a trace of the pulse induced with a GLA. Figure 5 is a trace of the pulse induced with the dummy GLA (Worst Case Wiring).

Firing pulse across headers with worse case wiring
(Dummy GLA). Top trace at Grenade #2 header
(Fired Sequentially). Bottom trace @ Grenade #1
header (Induced Firing.)

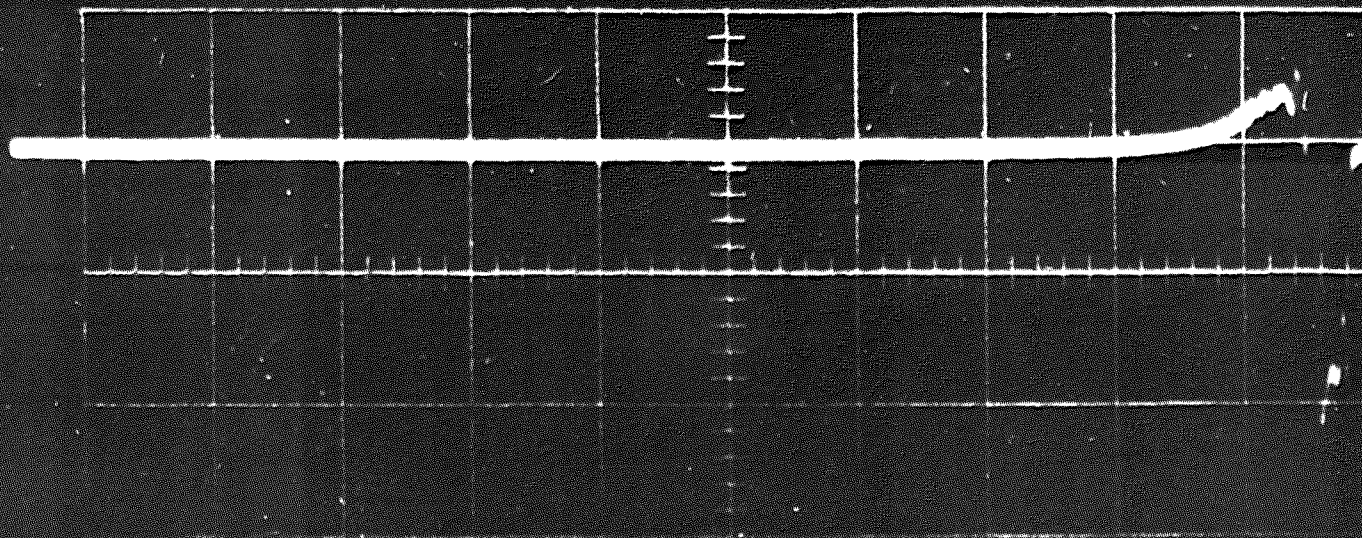
Figure 4

Negative induced pulse at SCR cathode of
#1. Firing Circuit with GLA SN 7.

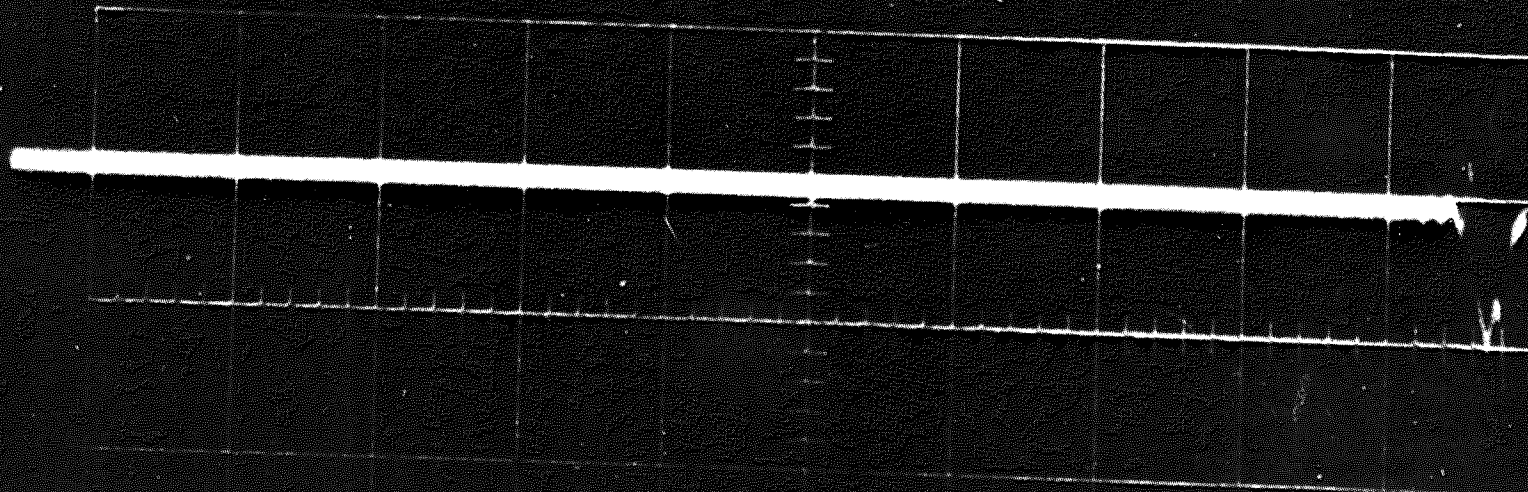
Figure 5

Negative induced pulse at SCR cathode
of #1. Firing circuit with Dummy GLA
(Worst Case Wiring).
