Apollo 12 Preliminary Science Report, NASA SP-235, Washington, D.C., 1970, pp. 217-223.

RESULTS OF EXAMINATION OF THE RETURNED SURVEYOR 3 SAMPLES FOR PARTICULATE IMPACTS

B. G. Cour-Palais, R. E. Flaherty, R. W. High, D. J. Kessler, D. S. McKay, and H. A. Zook

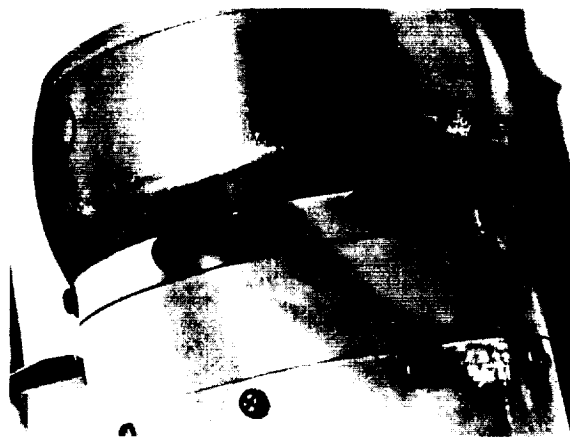
Figure 4 shows the apparatus used to hold the camera onto the Surveyor, along with the shadows it casts. The shadows are seen in figure 8, in which the mounting tubes have been removed.

FIGURE 8.—Shadows of the attachments on the television camera housing.

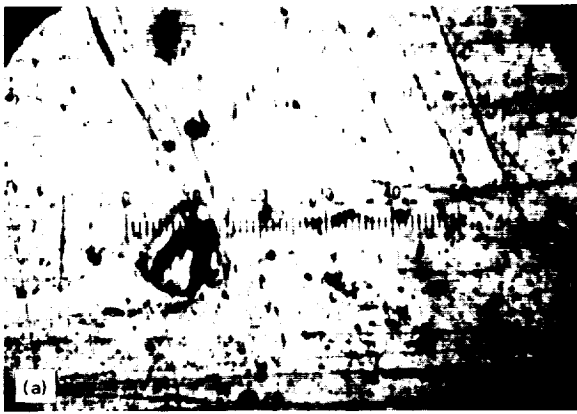
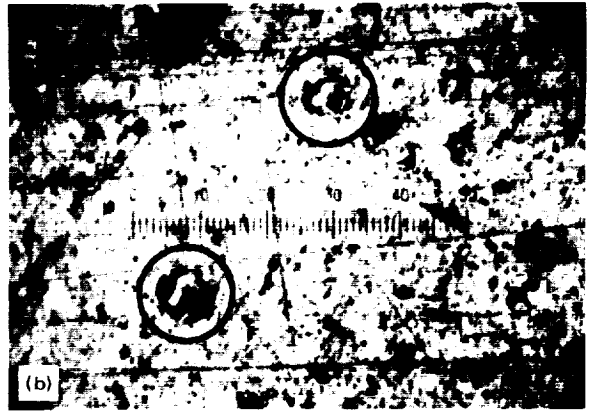
FIGURE 11.—Optical microscope and SEM views of typical impacts on polished tube section B. (a), (b) Optical microscope views. (c), (d), (e) SEM views.

Figure 11 shows SEM photographs of three craters on section B, located 280° from the scribe line. The craters obviously are not due to a hypervelocity impact; e.g., there is no smooth, raised lip entirely around the central indentation. However, it is clear that material at relatively low velocity, perhaps a few hundred meters per second, has impacted from the lower left in this photograph. The largest crater is about $30\ \mu\text{m}$ wide, and material is still in the crater. An X-ray pulse height analysis of this material showed it to be composed of silicon, calcium, and iron with significant traces of chromium and titanium.
