HIGHER MAGNIFICATION IMAGING OF THE POLISHED ALUMINUM COLLECTOR RETURNED FROM THE GENESIS MISSION. M. C. Rodriguez¹, P. J. Burkett², J. H. Allton³; ¹Geocontrol Systems- ESCG at NASA/Johnson Space Center, Houston, TX 77058; melissa.rodriguez-1@nasa.gov, ² Jacobs- ESCG at NASA/Johnson Space Center, Houston, TX 77058, ³ NASA/Johnson Space Center, Houston, TX 77058.

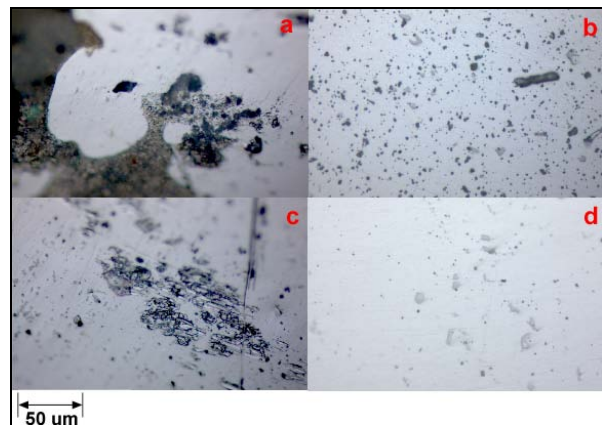
scanned at 5X magnification on a Leica DM6000M microscope using either Surveyor or Image Pro Plus software. Under higher magnification, the post-landing aluminum surface is very uneven, with many bumps and undulating ridges (Fig.2a). There are also several depressions that appear as microcraters on initial examination. Portions of these “pits” have angular walls and shallow, irregular depths; excluding them from consideration as hypervelocity impact craters. Much of the contamination observed under higher magnification is consistent with what is seen on the majority of the Genesis collector array materials: 1) dark carbon fibers and fragmented array collector fines, such as silicon dust, from the spacecraft and 2) Utahogenic particulate dispersion of salts and sediments, including dried droplets (Fig.2b). Several gouges and scratches are also seen (Fig.2c). There is one feature unique to the polished aluminum surfaces: the presence of small, transparent, irregularly shaped gray film-like specks seen at 50X. They are seen on each kidney subsample and are randomly distributed across the surface (Fig. 2d).

Fig. 2a-d. Examples of surface contamination on the polished aluminum pieces found at 50X magnification

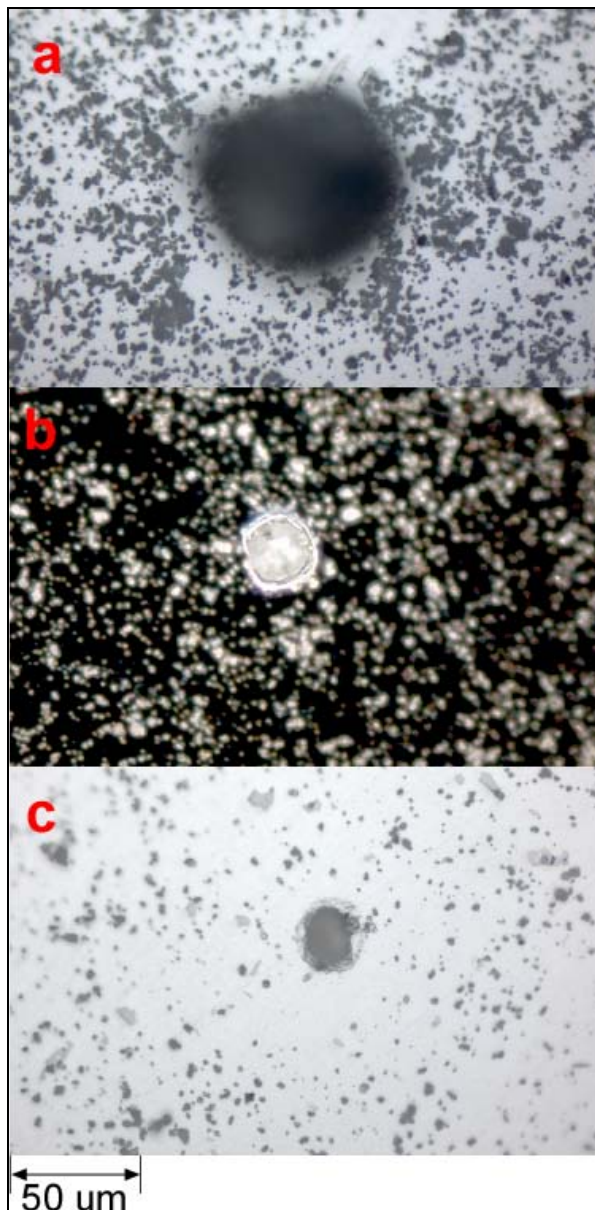
Additional microcrater documentation. Additional work has been done to identify three additional microcraters in two subsamples (50684.8 and 50684.11) of the polished aluminum kidney. All of the craters have similarly shaped round, raised walls with varying pit depths (measured from collector surface to pit bottom). Crater 1 was measured to have a depth of 49 μm and outer rim dimensions of 74 μm (Fig. 3a). Crater 2 was measured to have a depth of 11 μm and outer rim di-

mensions of 32 μm (Fig.3b). Crater 3 was measured to have a depth of 8 μm and outer rim dimensions of 28 μm (Fig.3c).

Fig.3. Microcrater features found in subsamples 50684.8 (a and b) and in 50684.11 (c).
