**RECENT OPTICAL AND SEM CHARACTERIZATION OF GENESIS SOLAR WIND CONCENTRATOR DIAMOND-ON-SILICON COLLECTOR.** J. H. Allton<sup>1</sup>, M. C. Rodriguez<sup>2</sup>, P. J. Burkett<sup>3</sup>, D. K. Ross<sup>3</sup> and C. P. Gonzalez<sup>3</sup> and K. M. McNamara<sup>1</sup>, <sup>1</sup>NASA/Johnson Space Center, 2101 NASA Parkway, Mail Code KT, Houston, TX 77058, USA, [Judith.h.allton@nasa.gov](mailto:Judith.h.allton@nasa.gov), <sup>2</sup>ESGC Geocontrol Systems- ESCG at NASA/JSC, <sup>3</sup>Jacobs- ESCG at NASA /JSC.

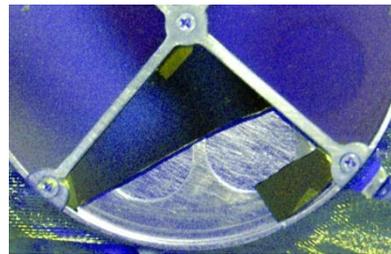
**Description of collector 60000:** Fig. 1 shows the largest piece of the concentrator DOS collector, as recovered in Utah. This piece was located at the focal point of the concentrator; thus, having the greatest concentration of solar ions. Additionally, this piece had two areas inadvertently not covered by the carbon coating and, thus exposing the silicon to capture solar ions. The exposed silicon, set up a potential opportunity to measure solar carbon. Fig. 2 shows sample 60000 prior to subdivision.

Fig. 1. False color image of DOS collector fragment 60000 mounted in frame and location of frame shadow. Green areas show solar-wind-exposed silicon.

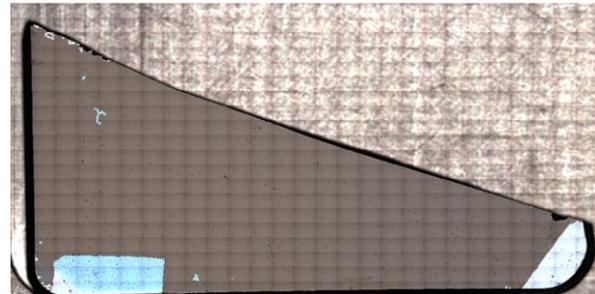
Fig. 2. Fragment 60000 color-enhanced to show increased blueness of silicon areas near focal point, presumably due to irradiation. The bright areas are silicon, called “heel” and “toe” of sock shape.

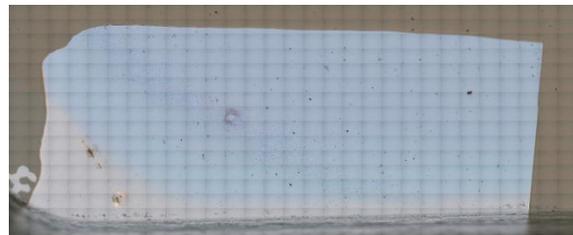
*Typical post-landing particulate contamination.* Optical imaging of 60000 reveals glass microsphere shards and carbon fibers (both return capsule structural materials), dried droplets, miscellaneous fibers, smears and particles. Near the frame attachments, on the silicon “heel” and “toe” surfaces, smears of gold-colored material are noted (Figs. 3 & 4). A brief survey of related fragment, 60737, was undertaken via SEM (JEOL 7600F). Most abundant particles were gold (with nickel and/or aluminum) and GaZnAl-oxide bearing paint. Less abundant particles consisted of silicate glass, germanium metal, stainless steel, and terrestrial soil.

Fig. 3. Silicon “heel” showing frame shadow and gold-colored smears.

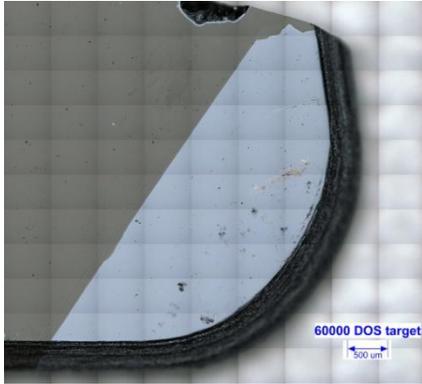
Fig. 4. Silicon "toe" showing gold-colored smear and debris.

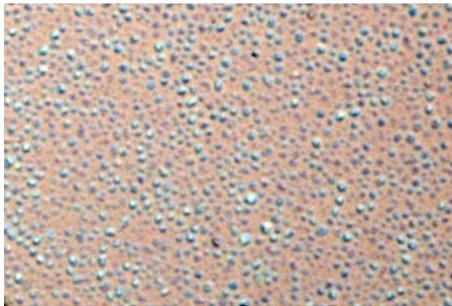
*Evidence of irradiation damage near focal point silicon.* Optical imaging revealed a correlation of “blueness” and presence of bubble texture (Fig. 5). No gradient was noted across “heel”. Bubble texture is not observable on “toe”. Estimated flux gradient is 20X near focal point vs 6X near outer radius (Wiens, personal communication).

Fig. 5. Bubble texture on blue areas of silicon. Bubble features are micrometer diameter.

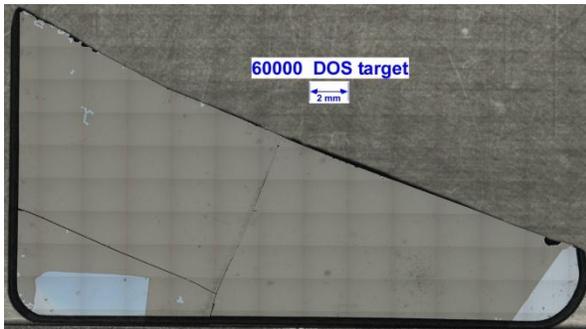
Fig. 6. Post-subdivision solar wind surface.

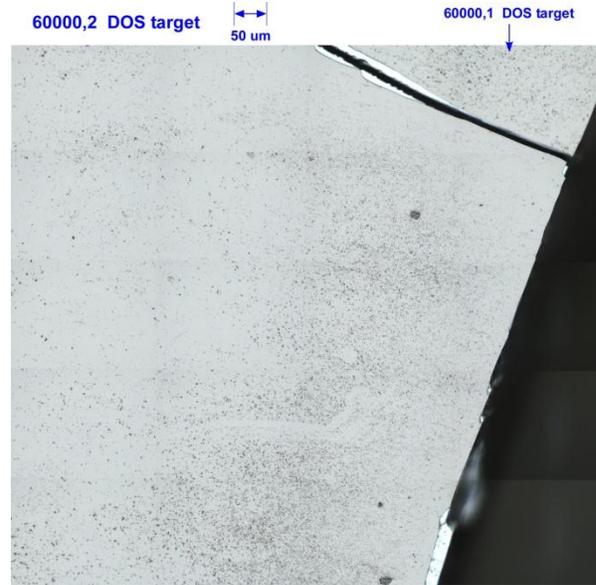
**Imaging after subdivision:** Fig. 6 shows solar wind surface after subdivision by laser scribe/cleaving. The subdivision process [4, 5] produces silicon/silicon oxide debris which gets onto the solar wind surface (Fig. 7) and needs to be removed. Further imaging of the subdivided surfaces is in progress.

Fig. 7. Subdivision process debris added near edges.
