NO.	REV. NO.
ATM 1012	
PAGE <u>1</u>	OF <u>22</u>
DATE 14 June 1971

LEAM DVT MECHANICAL FUNCTIONAL TEST

LEAM DVT Mechanical Functional Test

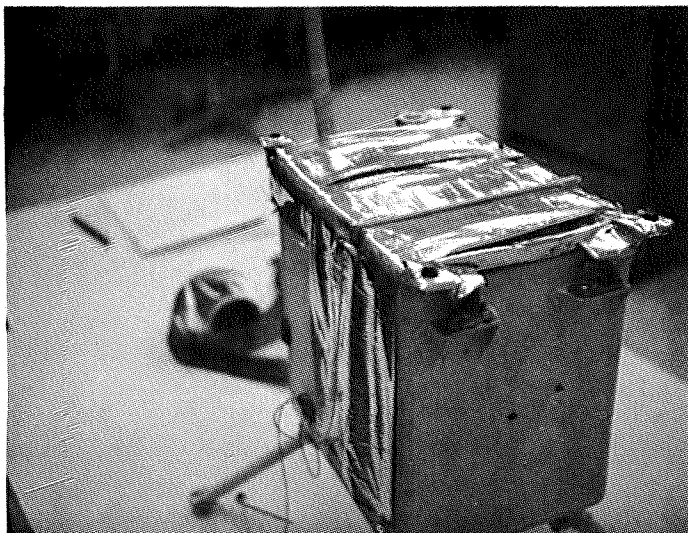
Figure 7-3 Gnomon Release Design

1. The location of the lanyard pull ring and velcro pad has adequate access.
2. The velcro pad holding the lanyard cord should be in-line with the force vectors required to pull the leg and gnomon release pins.
3. The legs release system works satisfactorily.
4. The gnomon release pin at times "hung-up" and could not be removed. The gnomon shaft length seemed too short and the pivot spring rate too low. A picture of the gnomon and release clip is shown as Figure 7-3.

1. The lanyard pad in the DVT model is in-line with the pull direction for the leg release pin. (The mock-up had the velcro pad on the north end, see Figure 6-1, where as the DVT has it on the west side, see Figure 7-3). The gnomon will be turned so that it stows at an angle running northwest and aligning the pull direction for gnomon release with the pull direction for leg release (See Figure 7-2).
2. The gnomon length was increased to allow more clearance on the west edges of the experiment, the pivot spring rate was increased, and the release clip replaced by a velcro pad.
