GENESIS SPACECRAFT SCIENCE CANISTER PRELIMINARY INSPECTION AND CLEANING. J. D. Hittle¹, M. J. Calaway¹, J. H. Allton², J. L. Warren¹, C. M. Schwarz³ and E. K. Stansbery², ¹Jacobs Sverdrup/ESC, Houston, TX, ²NASA/Johnson Space Center, Houston, TX, ³MEI Technologies/ESC, Houston, TX. judith.h.allton@nasa.gov

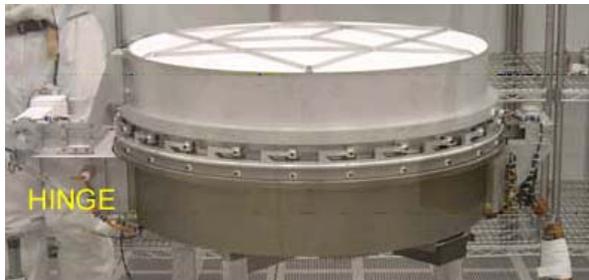
Introduction: The Genesis science canister is an aluminum cylinder (75 cm diameter and 35 cm tall) hinged at the mid-line for opening (fig. 1). This canister was cleaned and assembled in an ISO level 4 (Class 10) cleanroom at Johnson Space Center (JSC) prior to launch. The clean solar collectors were installed and the canister closed in the cleanroom to preserve collector cleanliness. The canister remained closed until opened on station at Earth-Sun L1 for solar wind collection. At the conclusion of collection, the canister was again closed to preserve collector cleanliness during Earth return and re-entry. Upon impacting the dry Utah lakebed at 300 kph the science canister integrity was breached [1]. The canister was returned to JSC. The canister shell was briefly examined, imaged, gently cleaned of dust and packaged for storage in anticipation of future detailed examination. The condition of the science canister shell noted during this brief examination is presented here. The canister interior components were packaged and stored without imaging due to time constraints.

Fig. 1. Pre-flight configuration of the science canister.

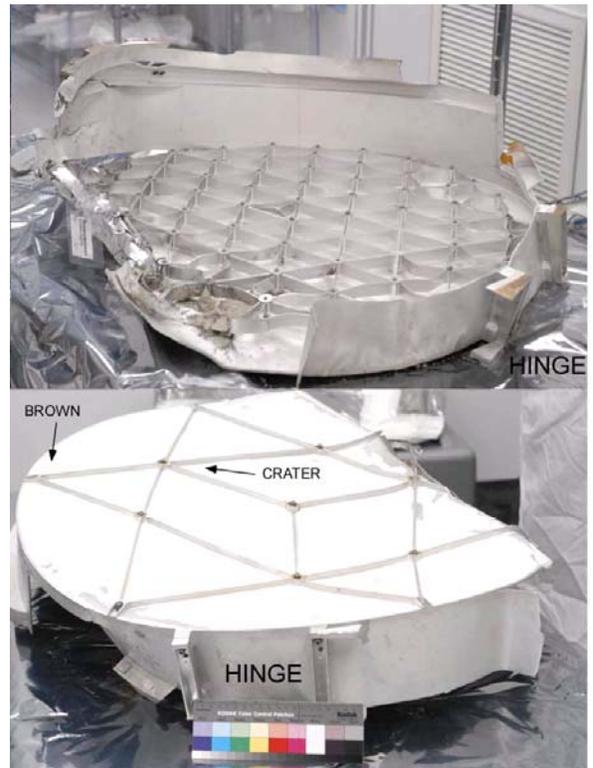
Fig. 3. Interior (upper) and exterior (lower) views of the science canister cover, as received at JSC. Arrows point to the location of the micrometeorite crater (fig. 4) and brown discoloration (fig. 5).

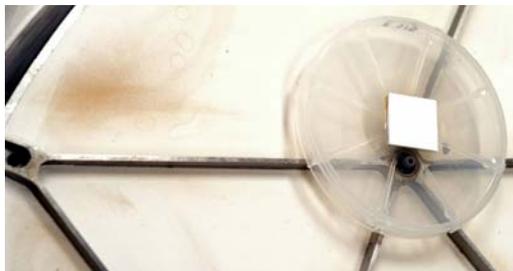
Brown discoloration: Fig. 5 shows a gradient of discoloration on the canister's white painted surface. Discoloration appears around rib "shadows". Accurately mapping and analyzing the distribution of discoloration may be useful. Interior parts of the canister, which are unpainted and unanodized aluminum, also have discoloration referred to as "brown stain" which is thought to be due to UV polymerization of a hydrocarbon or siloxane contaminant [2]. However, it is unclear whether the two types of discolorations are due to related mechanisms.

Fig. 5. Gradient of discoloration on the canister cover. The white square, sitting in a 4-inch dish, is pre-flight reference material.

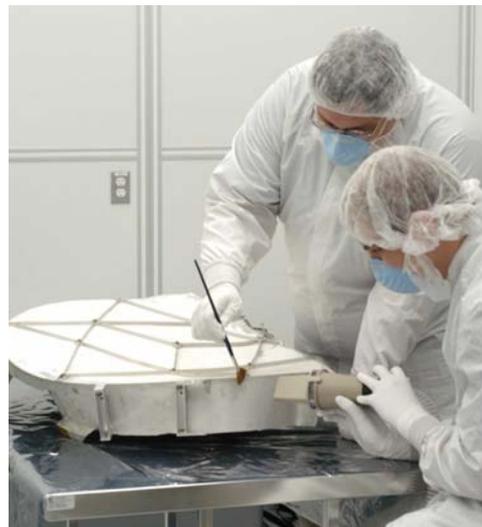
Fig. 6. Cleaning of the canister cover by gentle brushing into vacuum filter.

Cleaning and storage. The canister was cleaned for storage so that loose dust would not further react with the hardware surfaces and to prevent cross-contamination during storage. Gentle cleaning of the surface was done by using a fine-haired brush to sweep loose particles into a filtered vacuum cleaner, as shown in fig. 6. The vacuumed debris was collected on a filter and saved for analysis. However, the white painted surface was not cleaned. Finally, both items were enclosed in a black bag to inhibit UV degradation and placed in permanent storage.
