STATUS OF RECONSTRUCTION OF FRAGMENTED DIAMOND-ON-SILICON COLLECTOR FROM GENESIS SPACECRAFT SOLAR WIND CONCENTRATOR. M. C. Rodriguez¹, M. C. Calaway², J. H. Allton³, K. M. McNamara³ and J. D. Hittle². ¹GeoControl Systems (ESCG) at NASA Johnson Space Center, Houston, TX, 77058, Melissa.Rodriguez-1@nasa.gov; ²Jacobs (ESCG) at NASA Johnson Space Center, Houston, TX; ³ NASA, Johnson Space Center, Houston, TX.

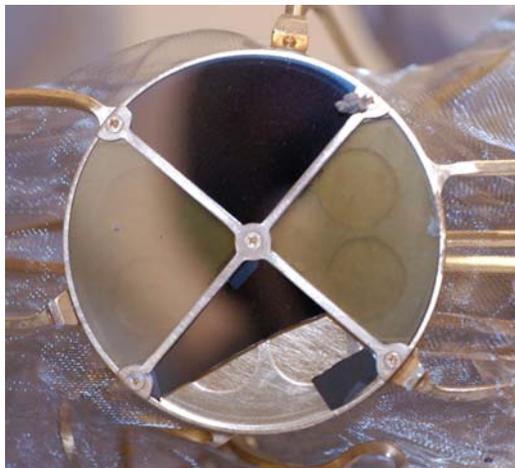
Fig. 1. Configuration of quadrants as removed from the concentrator in Utah. Additional fragments of the broken quadrant were recovered from the concentrator interior.

Condition of the Concentrator Targets as Recovered in Utah: The target quadrants, in a steel holder, were relatively protected inside of the concentrator, suspended on steel ribs and cushioned by steel mesh. After the concentrator was removed from the canister, the target holder with 3 intact targets and one broken target was extracted and stabilized for transport to Johnson Space Center in Houston. All loose pieces of collector fragments were carefully picked out of the concentrator, imaged and packaged separately.

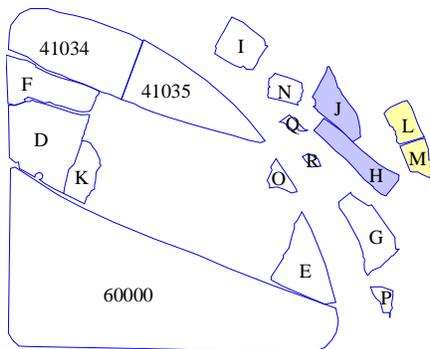
Fig. 2. Key to identification of samples in Figs. 3 & 4. Fragments H & J fit together. Fragments L & M fit together.

Pre-flight Preparation of the Diamond-like Carbon on Silicon: The diamond-like-carbon thick film (1.5 to 3.0 μm) was applied to the 550- μm -thick silicon substrate at Sandia National Laboratories under vacuum by sputtering multiple thin layers. An annealing step was performed after each thin layer deposition to reduce internal stresses in the bulk material. Since the annealing process introduced additional contamination, the second to last annealing step was omitted to preserve a relatively clean upper 2000-3000 \AA layer for solar wind capture [1]. Clip marks from the sputtering process are visible in the recovered target (Fig.2).

Key for Figs. 2-4. Samples are sorted by area. Eight confirmed and oriented samples are shown with an asterisk*.

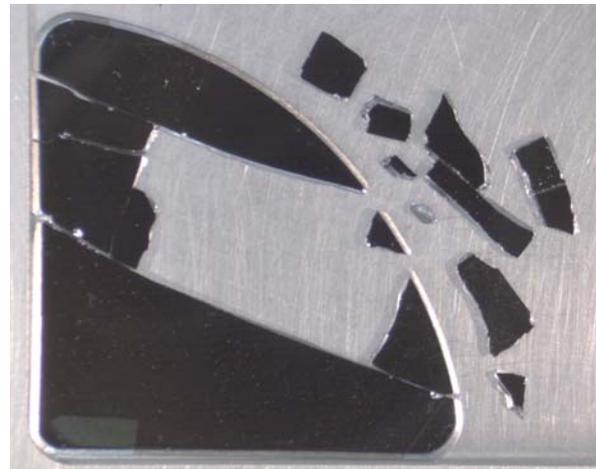
Fig. 3. DLC-on-silicon quadrant fragments fitted together, ambient illumination, Leica MZ9 microscope.

Fitting together DLC-on-silicon target pieces. The candidate target pieces were fitted together to a) confirm a fragment was indeed a target specimen, and b) to establish orientation. Orientation with respect to the concentrator focal point is critical, since solar wind fluence and isotopic fractionation differ with distance from focal point. Pieces confirmed by fitting together are shown in Figs. 2-4. Also shown are additional pieces recovered from the concentrator which are “very likely” to be target fragments, but their orientation cannot be established at this time. Table 2 compiles the sample numbers for “confirmed” and for “very likely” DLC-on-silicon target specimens.

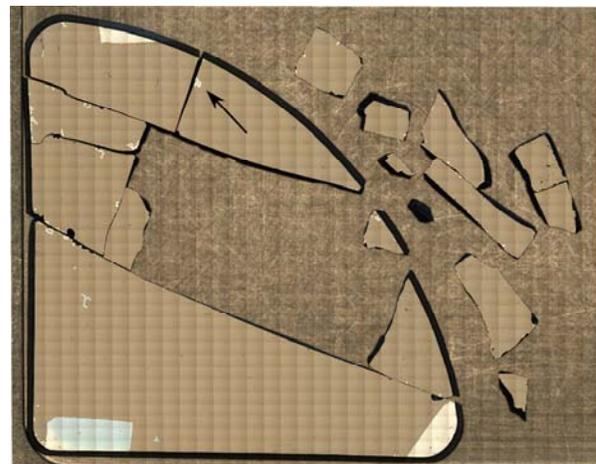
Fig. 4. Mosaic of DLC-on-silicon quadrant fragments fitted together, bright field illumination, Leica DM6000 M microscope. Clip marks from carbon coating process are visible as bright areas on perimeter. Closer inspection reveals shadow from target holder in lower left clip mark. Arrow indicates example of "sinuous" area.

Features seen on DLC target images. Crash-related particulate debris is similar to that found on the other concentrator quadrants and includes spacecraft and Utah sediments [2]. Particulate debris has not yet been quantified. Unique to the DLC-on-silicon quadrant are sinuous areas where the DLC layer was separated from the silicon during quadrant breakup (example indicated by arrow in Fig. 4).
