STATUS OF GENESIS Mo-Pt FOILS. K. Nishiizumi¹, J. H. Allton², D. S. Burnett³, A. L. Butterworth¹, M. W. Caffee⁴, B. Clark⁵, A. J. G. Jurewicz³, K. Komura⁶, A. J. Westphal¹, K. C. Welten¹, and D. S. Woolum⁷, ¹Space Sciences Laboratory, Univ. of California, Berkeley, CA 94720-7450 (kuni@ssl.berkeley.edu), ²Johnson Space Center, Houston, TX 77058, ³California Institute of Technology, Pasadena, CA 91125, ⁴Dept. of Physics, Purdue Univ., West Lafayette, IN 47907, ⁵Lockheed Martin, Littleton, CO 80127, ⁶Low Level Radioactivity Lab., Kanazawa Univ., Ishikawa, Japan, ⁷Dept. of Physics, California State Univ., Fullerton, CA 92834.

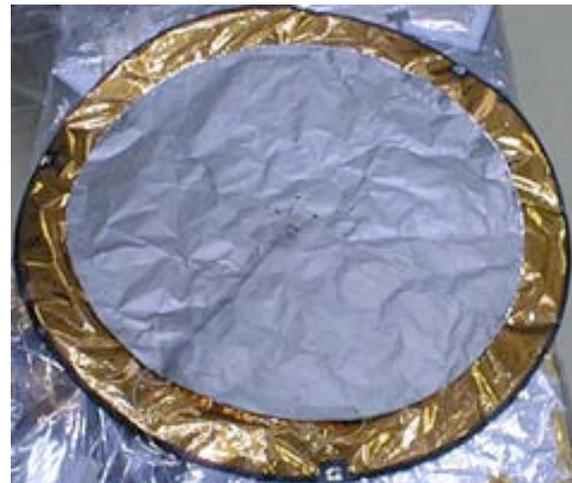
Fig. 1. 80 cm diameter of circular foil before launch.

Original Plan: The collector foils consist of a Mo coating (~300 nm in thickness) on a Pt substrate (~48 μm in thickness)[1]. We originally planed to (1) to remove dust from contamination by UTTR soil, which was expected to attach to the SRC, and carbon composite contamination from heat shield materials on the Pt foils, leaving no more than 1 mg of terrestrial contamination on the entire collector, while leaving the Mo coating intact; (2) to identify and remove micrometeorite (MM) impacts, leaving no more than 1 μg of residual meteoritic contamination on the entire collector; (3) to dissolve the Mo and separate all radionuclides from the Mo without introducing contaminants; and (4) to measure the concentration of these extremely low abundance radionuclides. The events of September 8, 2004 have made the original scope of work more challenging since the Pt foils must first be unfolded to allow for cleaning of the unexpected terrestrial contamination.

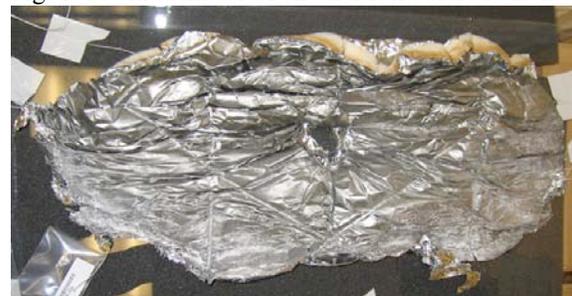
Foils After Hard Landing: Over 90% of the Mo-Pt foils were recovered. All recovered foils were transferred from UTTR to Berkeley on September 20. We have examined the foils using optical microscopy and backscatter SEM and found the following features: (1) all foils were heavily crumpled by the impact; (2) in general, the Mo coatings were in good shape and looked better than the Mo on the non-flight foils; (3) portions of Mo coatings have flaked off or been lost by scratching; (4) the Mo-Pt foils were much stiffer than our archived non-flight foils, possibly due to solar wind hydrogen implantation and the 2 yrs heating by the Sun; (5) all foils had Utah

dirt contamination on the surface, but the amount is highly variable.

Fig. 2. Circular foil after landing.

Unwrinkling the foils. The stiffness of the foils makes unwrinkling them a challenge. We observed that less crumpled annular foils had the greatest contamination and surface damage. We have been able to manually unwrinkle a few small foils by exerting pressure, using our fingers, from the backside of the Pt.

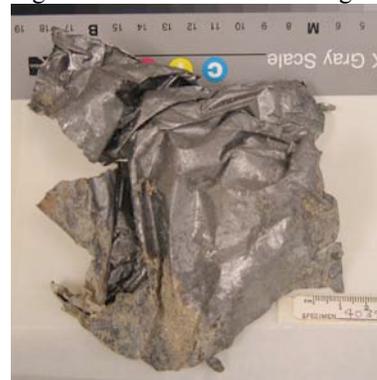
Dirt contamination. We received surface soils collected from the SRC landing site at the UTTR. Based on preliminary work, we found 2x10⁷ atom ³⁶Cl/g and 4x10⁸ atom ¹⁰Be/g in the soil. 1 mg of the soil contains more ³⁶Cl (half-life = 3.0x10⁵ yr) and ¹⁰Be (1.5x10⁶ yr) than 1 μg of MM and more than 10% of the expected SW ¹⁰Be and ³⁶Cl on the entire Mo-Pt foil. The soil contains 3.7% Cl, as NaCl. The most contaminated foil (40391) was used for cleaning tests. A large portion of bulky dirt was removed from the foil by light shaking or using very gentle

Fig. 3. One of the most contaminated foils (40391,1).

brushing. However, thin-coated dirt, that was wet when it splashed on the Mo surface, was hard to remove. (a) We applied the CO₂-snow method for removing dirt from the Mo surface with limited success. Weak CO₂-snow application blew out large chunks of dirt without visual damage to the Mo surface. Strong CO₂-snow application removed slightly more contamination than the weak application did, but the CO₂ didn't remove thin layers of dry soil and did damage to creased portions of the Mo surface. (b) Replication methods were applied for removing dirt from the Mo surface by coating and then removing a thin film. This method is widely used for cleaning optical surfaces and making thin film grids. We applied 1-10% solution of Collodion (nitrocellulose), 0.25-1% of Formvar resin (in ethylene dichloride), and 2-4% of polyvinyl alcohol on surface of non-flight Mo-Pt foils or Mo coated stainless steel foils. Lightly attached contamination was removed by peeling off the thin film but the thin-coated contamination was not. Furthermore, some Mo was flaked off with the films. (c) Preliminary tests using ultrasonic cleaning (40 kHz) removed a few percent of the Mo coat, as measured in the washing solutions (ethanol, isopropanol, and water). The Mo coat was likely removed by ultrasonic erosion. We will continue to test more gentle washing methods such as a high frequency megasonic cleaning.
