EARLY LROC VIEWS OF LUNAR 'HERITAGE' SITES. P. J. Stooke¹, ¹Department of Geography, and Centre for Planetary Science and Exploration, University of Western Ontario, London, Ontario, Canada N6A 5C2, pjstooke@uwo.ca.

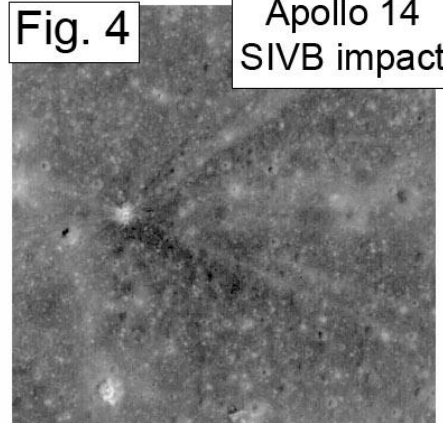
Artificial Impact Sites: The Apollo 14 SIVB (upper stage) impact crater, first located by Ewen Whitaker [1], has now been revealed by LROC at high sun (Figure 4). LROC images will reveal details of crater morphology and possibly impactor fragments, perhaps helping explain why some artificial impacts have dark rays and others do not in Apollo images. Are rapidly venting fuel vapors involved? Perhaps venting fuel brightens the surface, and then ejecta rays darken it in a manner akin to features seen at each Apollo site. LROC images already show many natural impact craters at high sun, showing some of them have partial dark ray systems. Do they involve comet impacts with

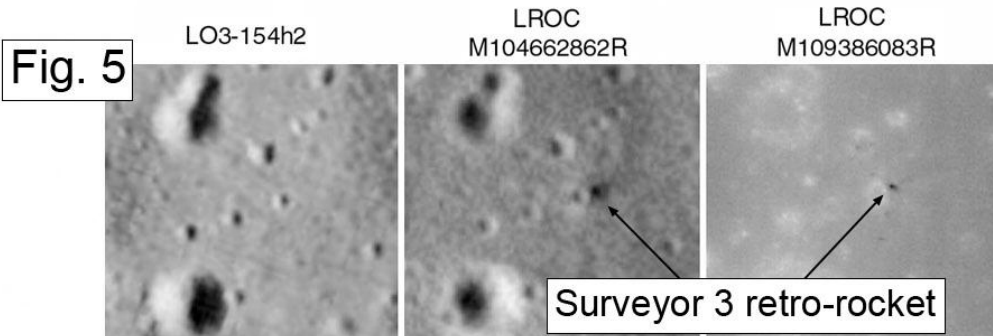
Other Landing Sites: LROC images offer the potential to reveal new details of other landing sites. This has already occurred at the Surveyor 3 site, where the discarded retro-rocket may have been identified [2]. Figure 5 shows a dark spot 200 m north of the Surveyor 3 lander and about 2 m across, with possible bounce marks to the south. It was not present in early 1967 when a Lunar Orbiter image was taken, but it is visible in both low sun and high sun LROC images. It was first noticed in the high sun image, suggesting that this lighting will be most useful for finding other examples. The released LROC image of the Surveyor 1 site does not show any similar dark spot near the old lander, suggesting its retro-rocket may have fallen in an area in shadow in that low-sun image.
