RECOVERY, TRANSPORTATION AND ACCEPTANCE TO THE CURATION FACILITY OF THE HAYABUSA RE-ENTRY CAPSULE. M. Abe^{1,2}, A. Fujimura^{1,2}, H. Yano^{1,2}, C. Okamoto², T. Okada^{1,2}, T. Yada², Y. Ishibashi², K. Shirai², T. Nakamura³, T. Noguchi⁴, R. Okazaki⁵, M. E. Zolensky⁶, S. A. Sandford⁷, T. Ireland⁸, M. Ueno¹, T. Mukai⁹, M. Yoshikawa^{1,2}, T. Yamada^{1,2}, H. Kuninaka^{1,2}, and J. Kawaguchi^{1,2}, ¹Institute of Space and Astronautical Science, Japan Aerospace Exploration Agency (3-1-1 Yoshinodai, Chuo-ku, Sagami-hara-shi, Kanagawa-ken 252-5210, Japan; abe@planeta.sci.isas.jaxa.jp), ²JAXA Space Exploration Center, Japan Aerospace Exploration Agency (3-1-1 Yoshinodai, Chuo-ku, Sagami-hara-shi, Kanagawa-ken 252-5210, Japan), ³Tohoku University (Department of Earth and Planetary Materials Science, Faculty of Science, Tohoku University, Aramaki, Aoba, Sendai, Miyagi 980-8578, Japan), ⁴Ibaraki University (The College of Science, Ibaraki University, 2-1-1 Bunkyo, Mito 310-8512, Ibaraki, Japan), ⁵Kyushu University (Department of Earth and Planetary Sciences, Faculty of Sciences, Kyushu University, Hakozaki, Fukuoka 812-8581, Japan), ⁶Johnson Space Center, National Aeronautics and Space Adm

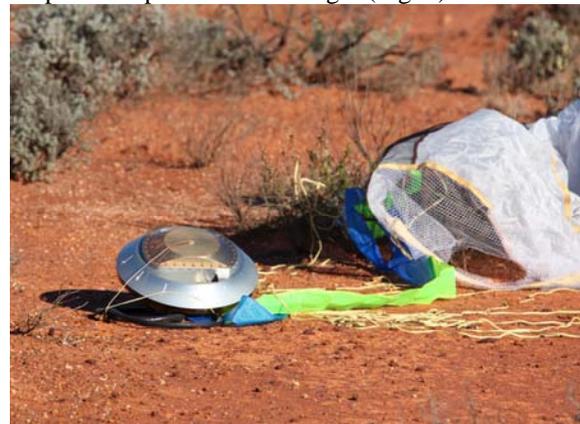
Fig. 1: The re-entry capsule at the landing site before its recovery.

At the landing point, acquisition of scientific documentary photography, collection of the circumference soil samples, environmental measurements such as GPS positioning, temperature and humidity, and

packaging the capsule into the temporarily plastic bag and initial/temporary transportation box for the recovery activity only were performed (Fig. 1). The recovery capsule was then transported to the WPA Instrument Building where both the headquarters (HQ) of the Hayabusa capsule recovery team and Quick Look Facility (QLF) for this purpose were temporarily installed. One day was spent on the removal of the explosive device and the battery in the capsule. The next day was spent on the removal of contaminants adhering to the capsule and the packing the capsule into the another clean transportation box for internal transport (Fig. 2). The surface cleaning of the capsule and packing operation were both executed in the temporary cleanroom at the QLF installed in the building. The transportation box has a purge function of pure nitrogen gas, and can ease the shock under transportation. On the afternoon of June 17, the remaining capsule I/M was flown from Woomera's Airfield in Australia, which is the nearest airport from the WPA, to Haneda Airport in Japan in a direct flight (Fig. 3).

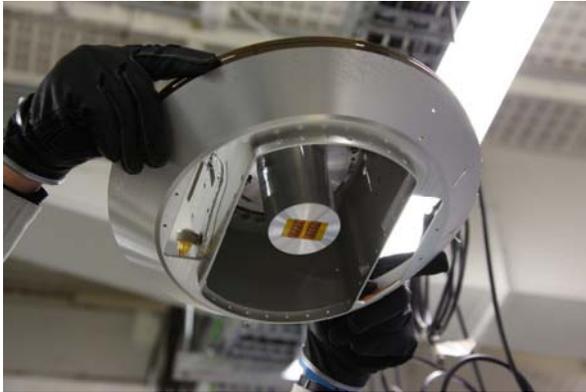
Fig. 2: The re-entry capsule after safety operation at the headquarters building.

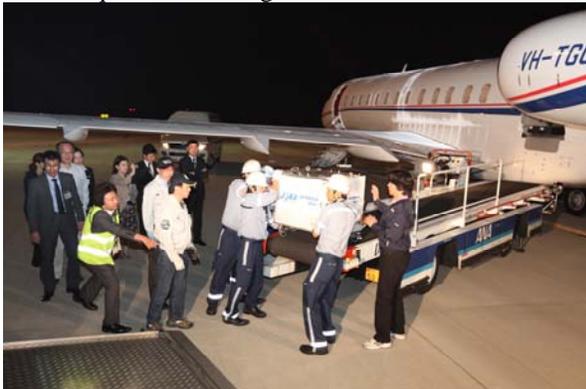
Fig. 3: Arrival in Japan of the capsule transportation box

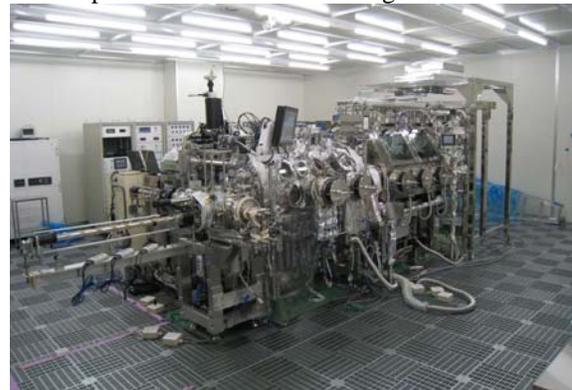
Fig. 4: Clean chamber of the Sagamiyara Planetary Sample Curation Facility in JAXA.

After cleaning of the sample container, using the container opening jigs, the container opening system with the sample container was installed to the clean chamber. Installation of the sample container to the clean chamber (Fig. 4), in which the gas environment was controlled, was completed in 63 hours after domestic arrival.

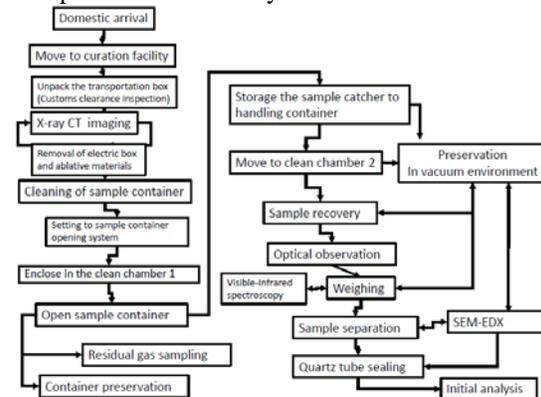
Fig. 5: Flowchart of processing of the Hayabusa sample container from domestic arrival to preliminary analysis of the sample

Fortunately the work of the curation facility is being conducted as shown in the scheduled flowchart (Fig. 5). This is because the capsule functioned and landed nominally on as planned despite the three-year-delay of its Earth return and was recovered in the shortest possible duration under a nearly ideal condition, and the sample container was not damaged at all.
