APOLLO 15

30-DAY FAILURE AND ANOMALY LISTING REPORT

SEPTEMBER 1971

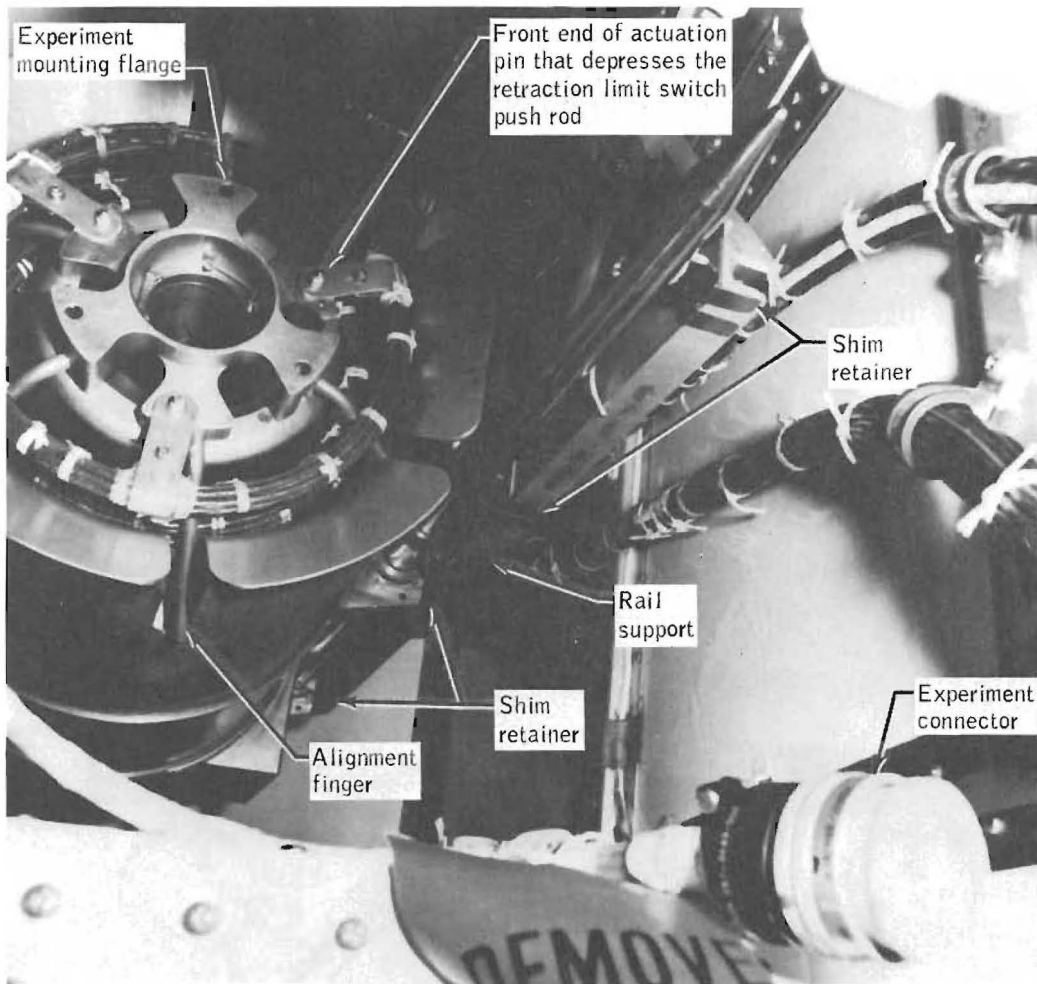
Figure 2-8.- Mass spectrometer boom mechanism (spectrometer not installed).

The following possible causes of the problem are being considered:

- a. Interference between the rail support assembly and the spectrometer bearing assembly (fig. 2-7).
- b. Binding in the floating rail.
- c. Spectrometer cable low temperature stiffness or interference problems such as improper stacking, retraction limit switch push rod being blocked, and pinching of cable between bearings and the funnel (fig 2-8).
- d. Interference of tie-down rod end.
- e. Interference of limit switch actuating pin with housing (fig. 2-9).
- f. Cover mechanism interference.
- g. Step lock binding.

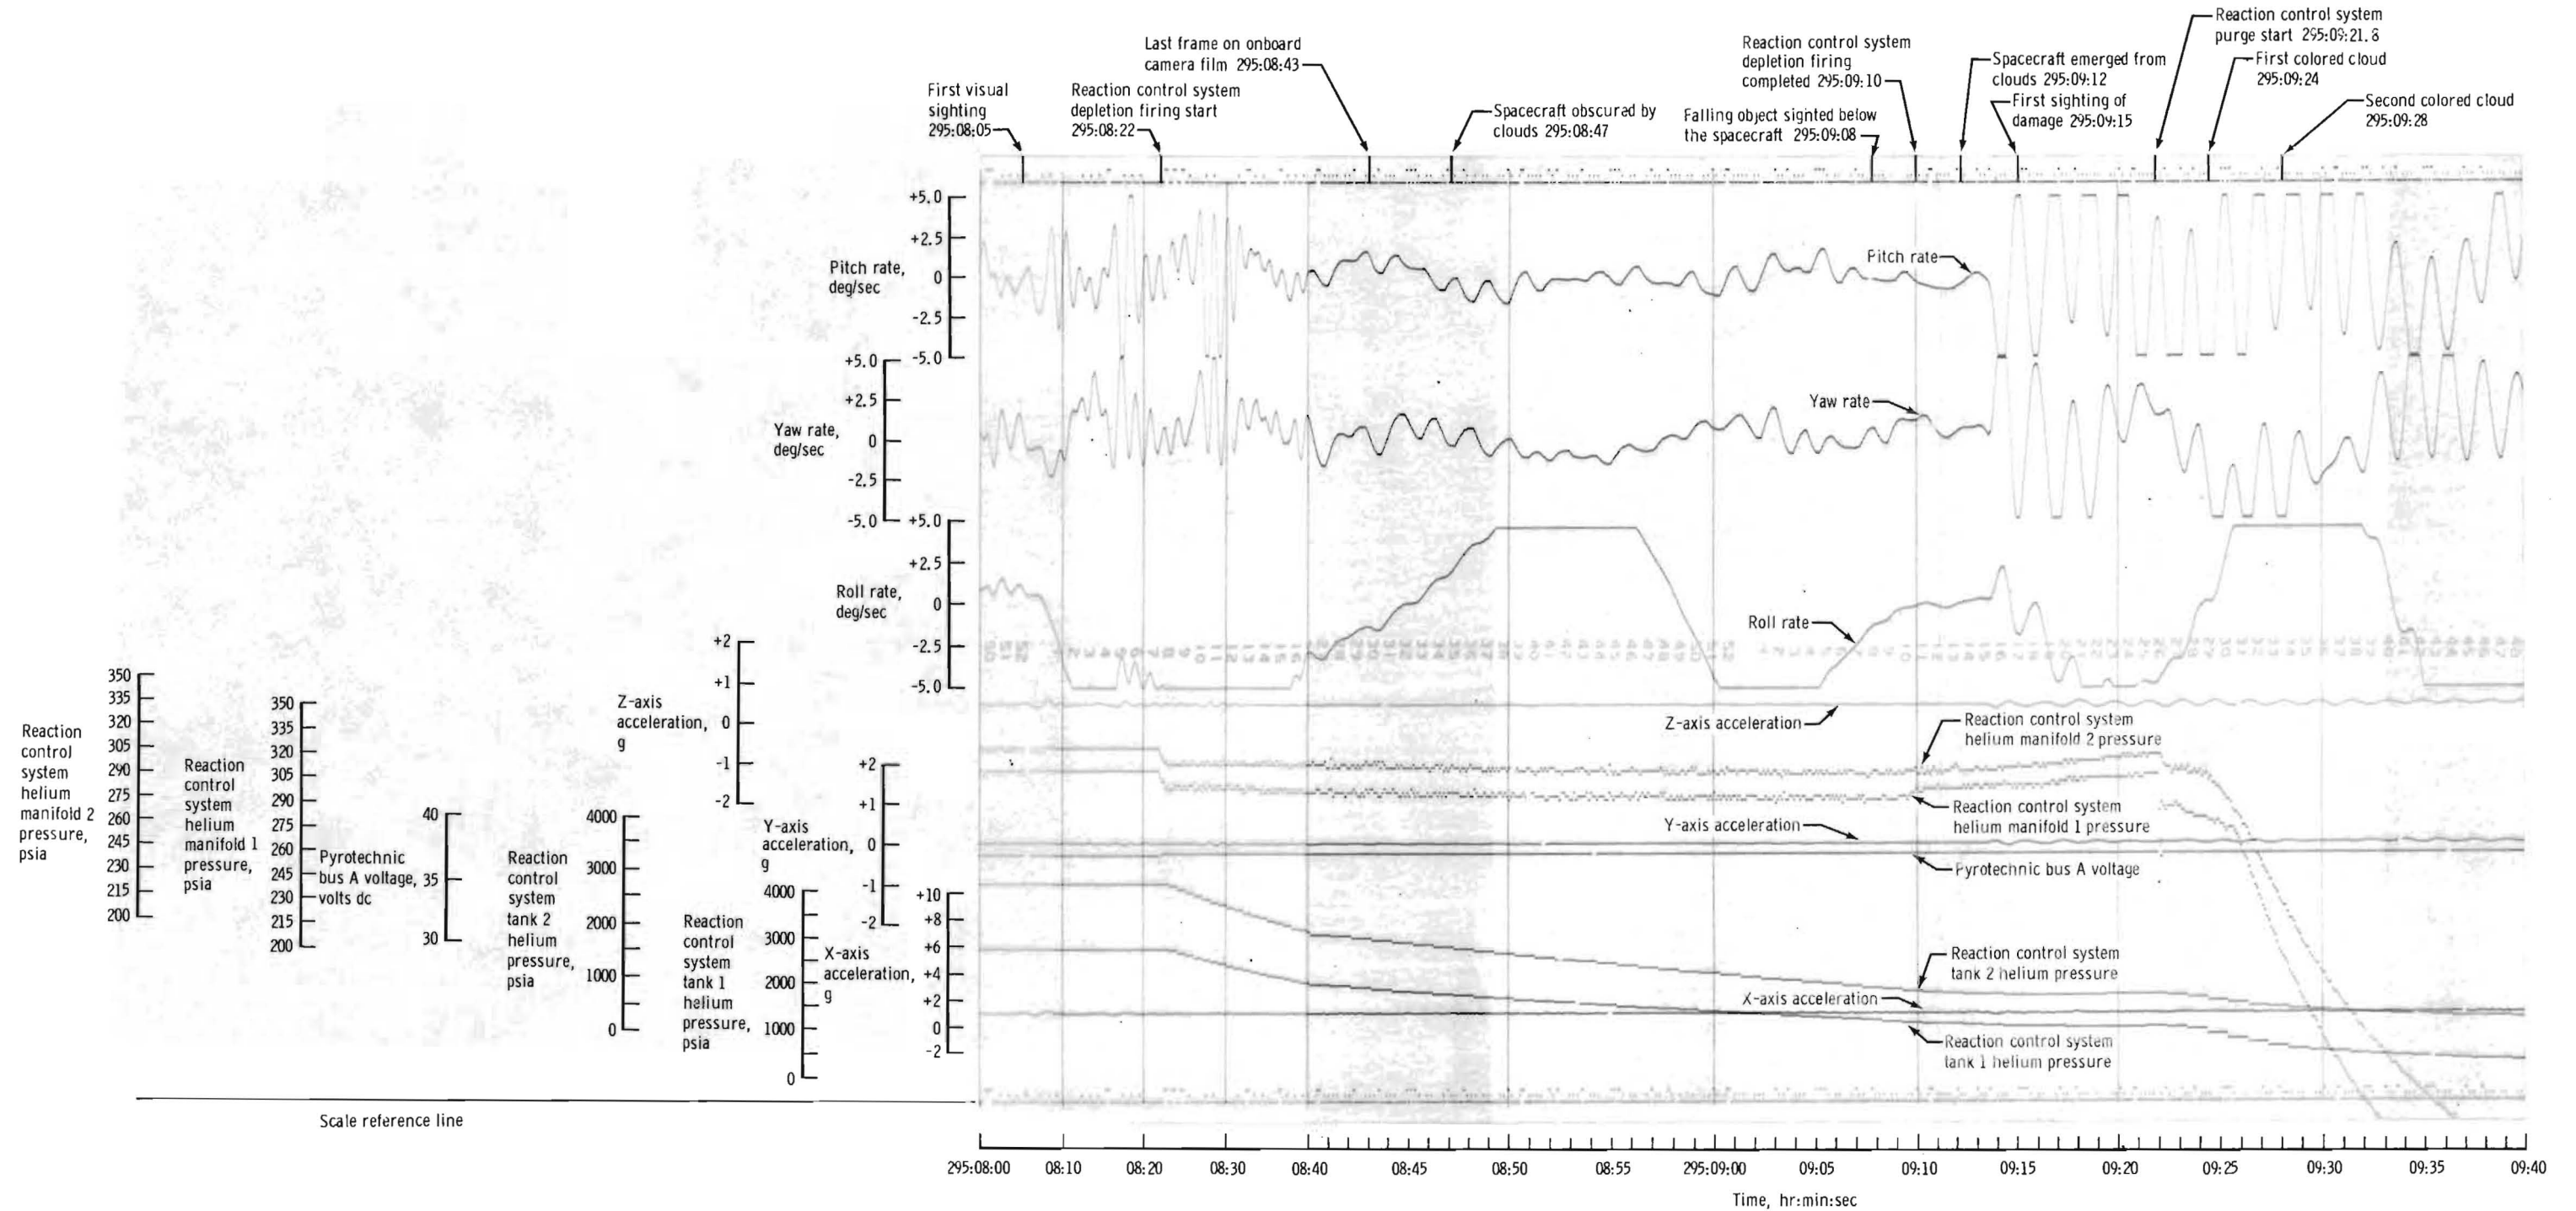
Figure 2-11. - Sequence of events during descent on the main parachutes.

Onboard and photographic data indicate that the forward heat shield was about 720 feet below the spacecraft at the time of the failure. One other point which indicates that the forward heat shield was not involved is that ground tests have shown that the heat shield would have damaged potting material (room temperature vulcanizing) on the leading edge had the heat shield hit either the riser or suspension lines. There was no indication of damage associated with cutting of the riser or suspension lines on the recovered forward heat shield. The recovery swimmers who observed the forward heat shield parachute before it was lost did not notice any damage.

The command module reaction control system depletion firing was considered a possible candidate because of the known susceptibility of the parachute material (nylon) to damage from the oxidizer, and the fact that the depletion firing was completed 4 seconds prior to the occurrence of the anomaly. Further, the command module position at the time of the anomaly placed the failed parachute in close proximity to the reaction control system minus pitch engines. To destroy the nylon risers with oxidizer, a significant amount of wetting would be required. A malfunctioning reaction control system, such that only oxidizer valves would be open,

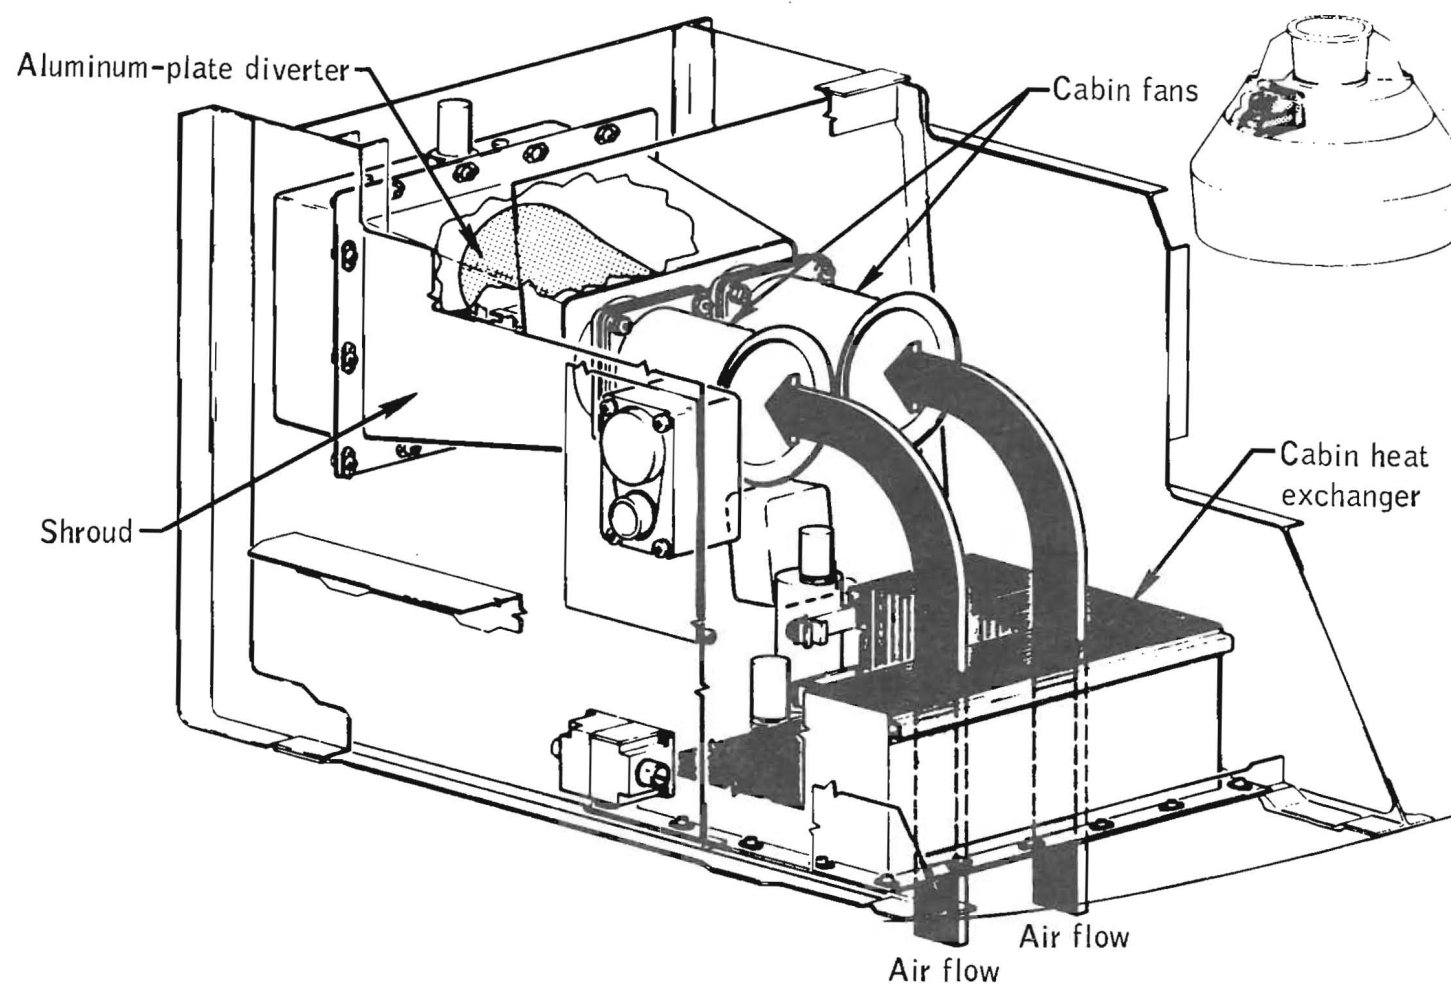
Figure 2-15.- Cabin fan installation.

During portions of the flight when the cabin fans (fig. 2-15) were activated, noises were heard which sounded like an object striking the blades, and lodging of the object within the fan housing even stopped the fan. Cycling the fans several times allowed the fan to run again.

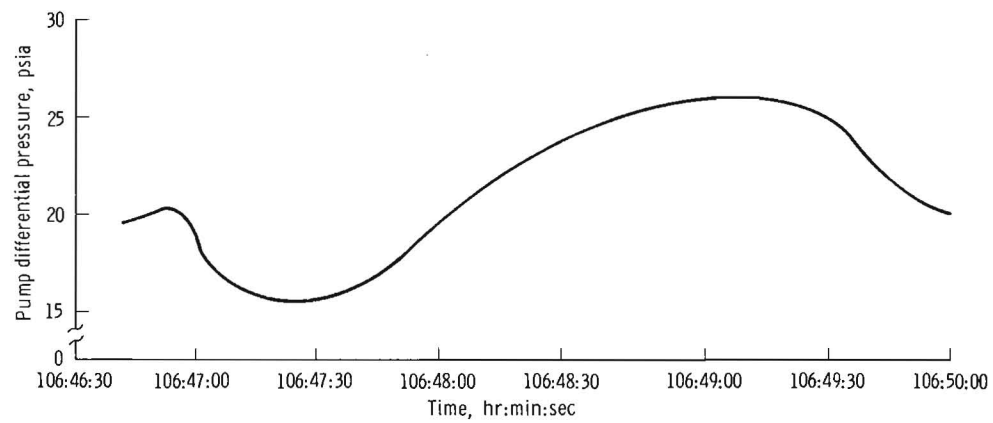
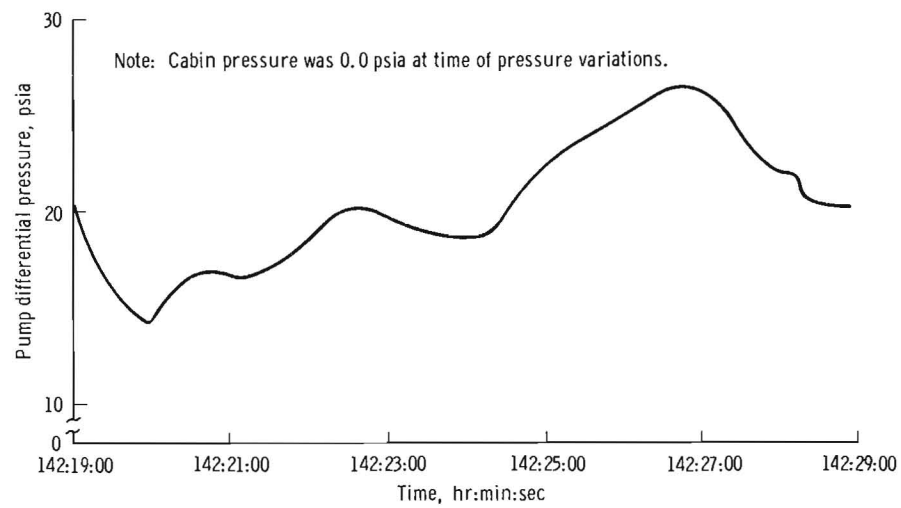
Figure 3-1. - Glycol pump differential pressure variations during extravehicular periods.

Variations were noted in the water/glycol pump differential pressure shortly after the cabin depressurizations for the standup extravehicular activity and the second extravehicular activity. The variations were similar on both occasions. The pressure differential decreased from about 20 psid (normal) to about 15 psid, then increased to about 27 psid and returned to normal (fig. 3-1). The total time for the cycles took 3 minutes (standup extravehicular activity), and 10 minutes (second extravehicular activity). The pump discharge pressure remained relatively stable throughout both periods.

The lunar module cabin humidity was high at initial manning for descent because the command module cabin humidity was high. Furthermore, a water spill in the lunar module cabin after the first extravehicular activity again produced high humidity. Consequently, water would have condensed on the cold glycol lines and would have frozen and sublimed at the next cabin depressurization. There is no glycol flow in the 1/8-inch sense lines between the pump assembly and the pressure transducer (fig. 3-2). Analysis shows that as little as 0.01 inch of condensed moisture on the outside of these lines would freeze the fluid in the sense lines and cause the fluctuations in the indicated differential pressure, but would not affect system operation. Consequently, no corrective action is required.

(a) Glycol pump differential pressure variations during standup extravehicular activity.

(b) Glycol pump differential pressure variations during second extravehicular activity.

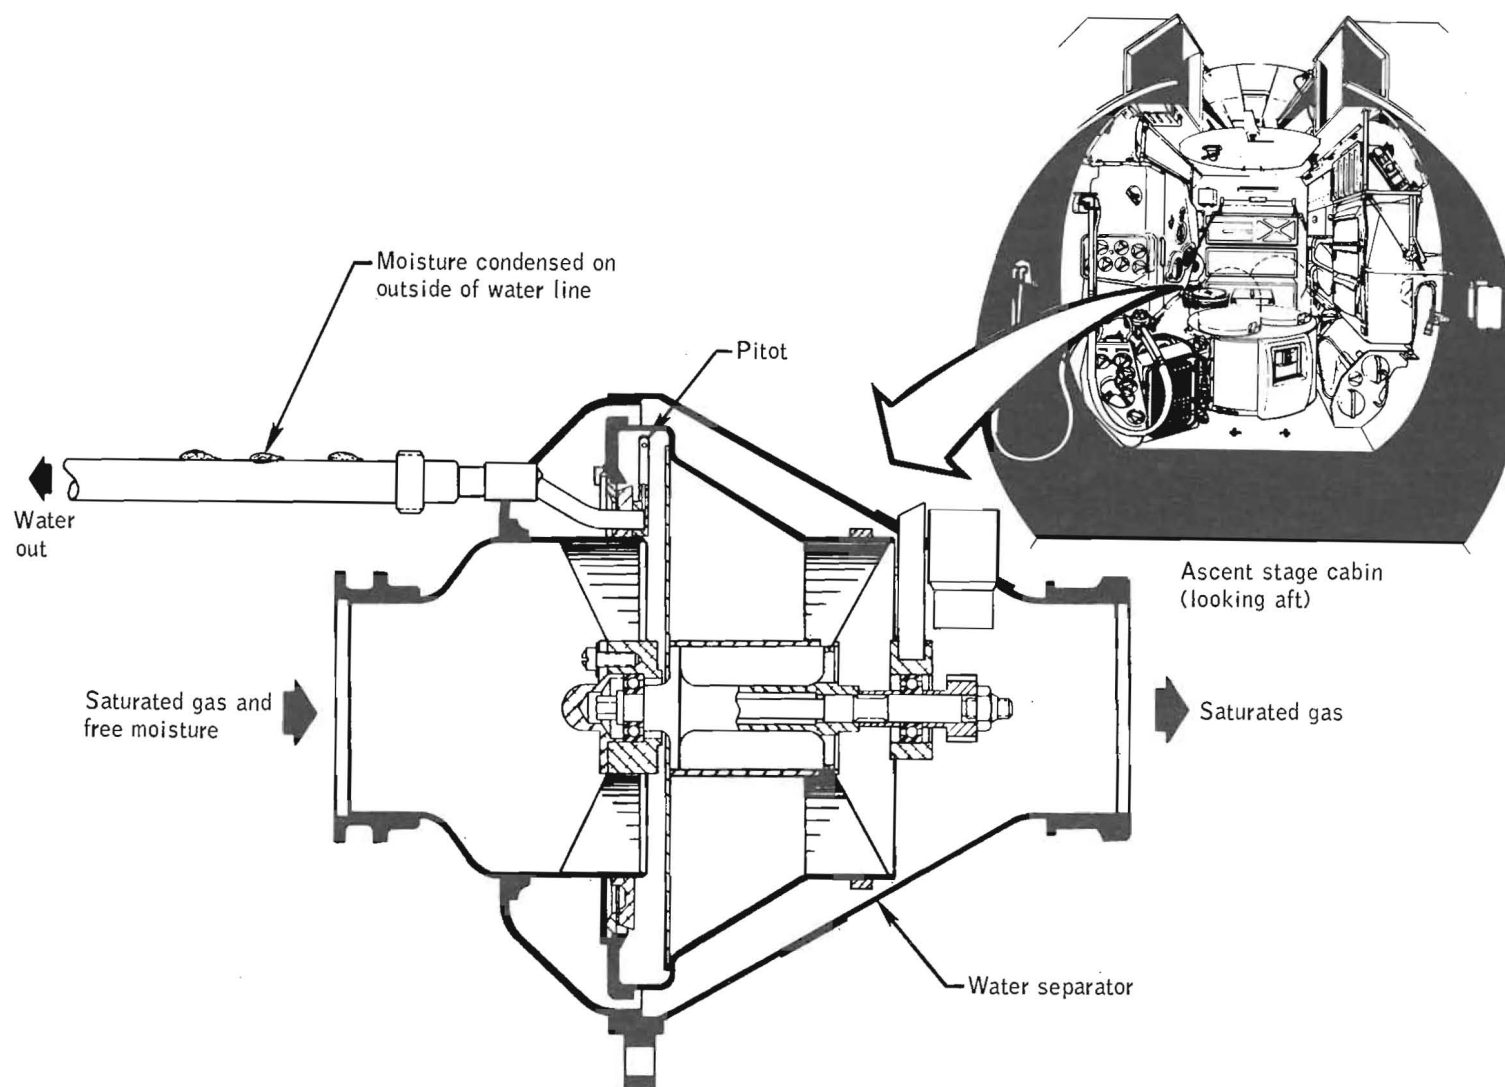
Figure 3-3.- Cross section of water separator.

Cabin atmosphere is cooled and passed through one of the water separators (fig. 3-3) where condensed water is separated by centrifugal force and picked up by a pitot tube. The water is then piped from the pitot tube, through a check valve, to the water management system where it is used in the sublimator.

Analysis shows that as little as a 0.01-inch film of water on the outside of the line would freeze the line at cabin depressurization. Freezing within the line would cause the separator to slow down and stall because of excessive water. Since separator 2 had not been in use, there was no water in its outlet line to freeze, and therefore, it operated successfully at startup. In any event, analysis and tests have shown that freezing of the line will not damage any spacecraft hardware. In addition, no cabin depressurization is planned for any future mission where the crew would be using the spacecraft water separators and where cabin humidity would be high. If such a depressurization is performed, the water separator line would probably again freeze. If this were to occur, however, the other separator would be used. Therefore, no corrective action is required.

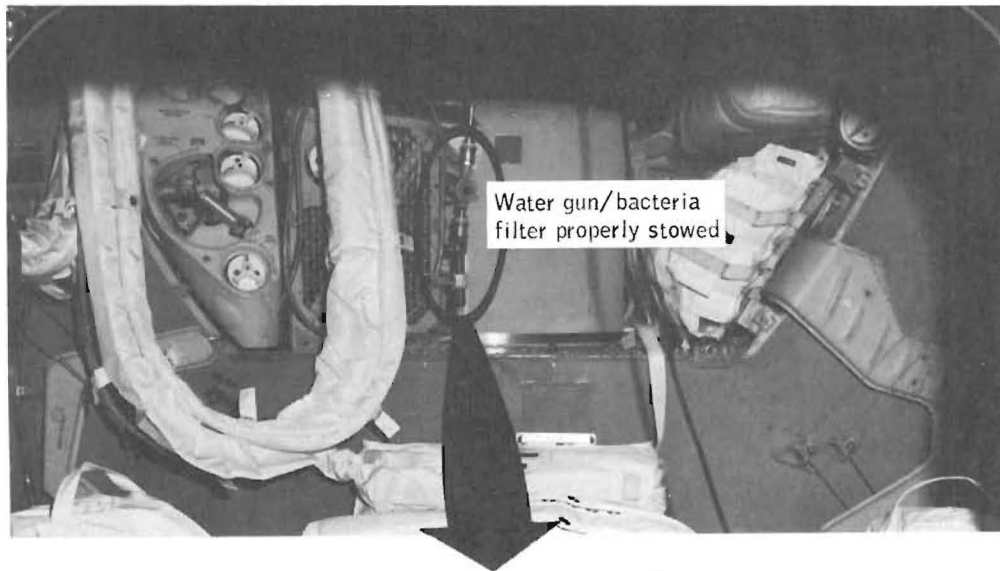
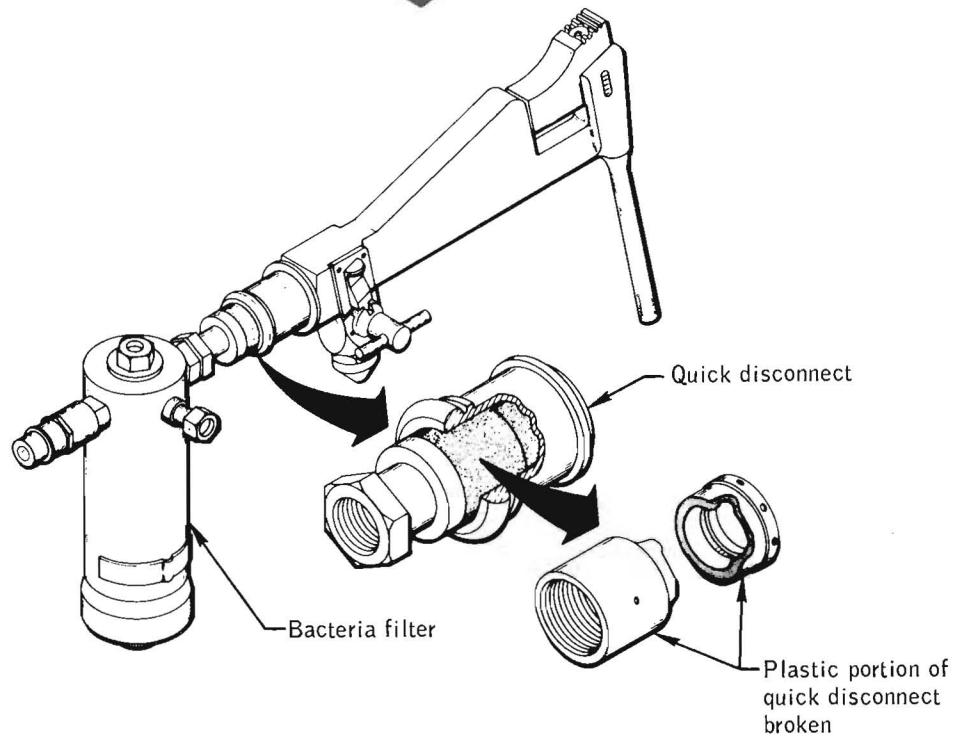
Figure 3-4.- Water gun/bacteria filter.

A water leak developed in the lunar module cabin shortly after crew ingress following the first extravehicular activity. The leakage occurred at the quick disconnect between the bacteria filter and the water gun (fig. 3-4). The leakage was stopped by removing the filter. The plastic (Delrin) portion of the disconnect had broken in half, thus causing the leakage.

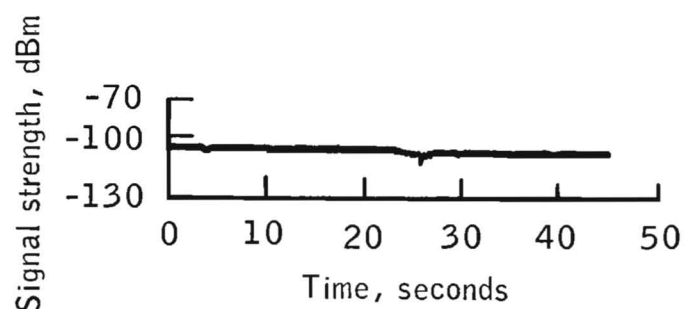
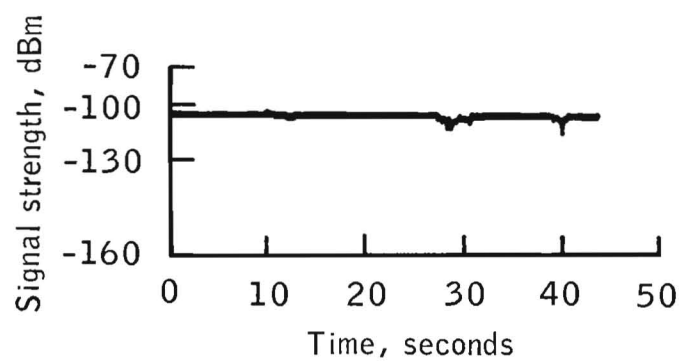
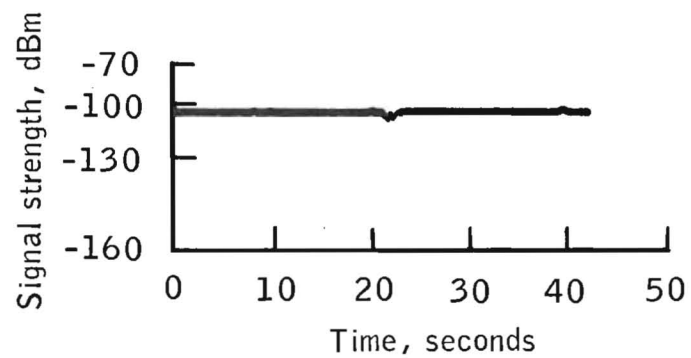
Figure 3-5.- Damped antenna oscillations at random times.

Small oscillations occurred at random while the steerable antenna was in the auto-track mode of operation. With the following exceptions, the oscillations were small and damped out without losing auto-track capability (fig. 3-5). At the following three times the oscillations became divergent as shown in figure 3-6.

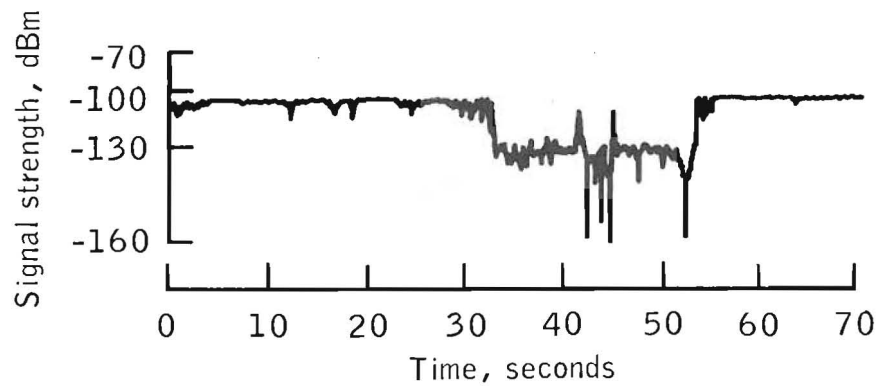
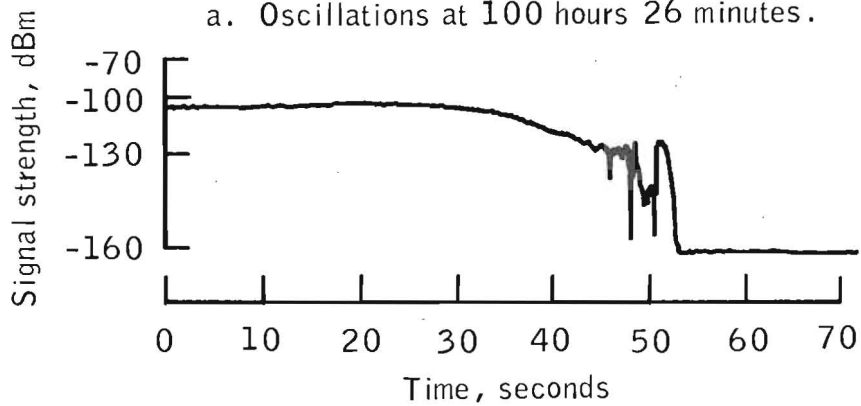
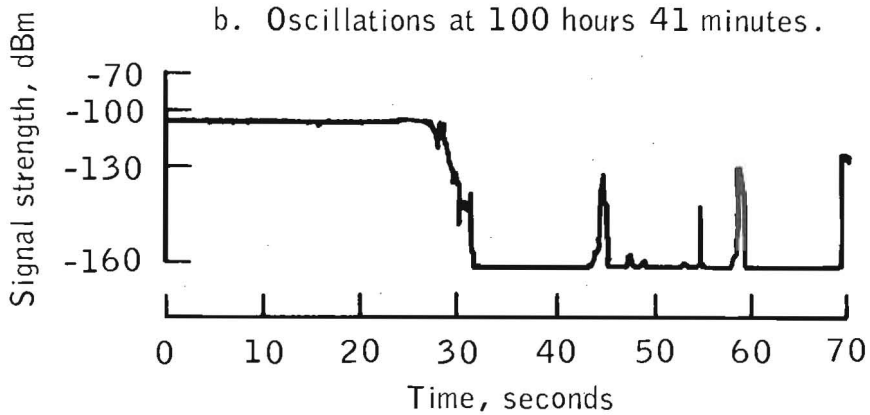
Figure 3-6.- Received signal strength plots associated with divergent antenna oscillations.

a. 100:26 (revolution 12): This divergence occurred prior to separation and was not caused by vehicle blockage or reflections from the command and service module structure.

b. 100:41 (revolution 12): The lunar module maneuver performed approximately 2 minutes after separation caused the antenna to track into vehicle blockage which resulted in the antenna oscillation and loss of lock.

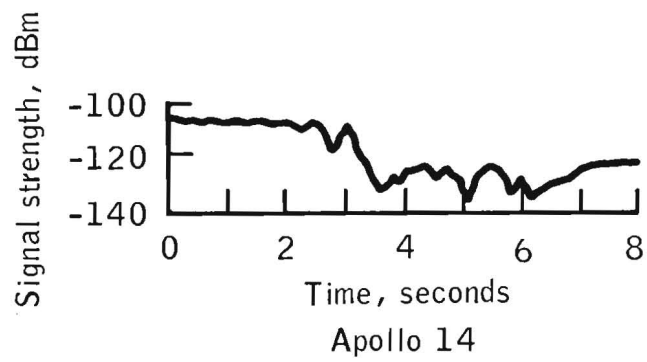
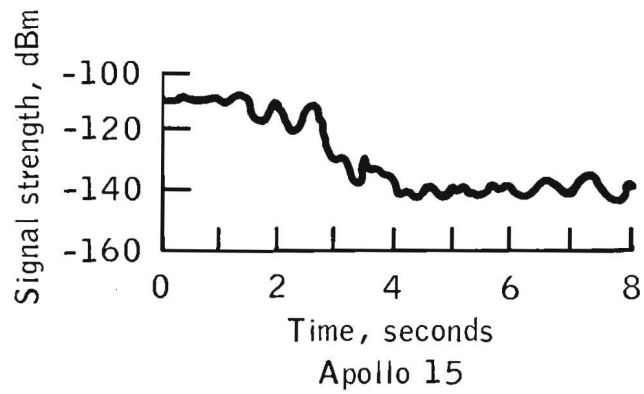
Figure 3-7.- Apollo 14 and 15 antenna oscillation characteristics.

Both the small oscillations which damped out and those which became divergent indicated characteristics identical to the conditions experienced on Apollo 14 (fig. 3-7). One of the prime candidates considered after Apollo 14 as a possible cause was incidental amplitude modulation on the uplink signal. A monitor capable of detecting very small amounts of incidental amplitude modulation was installed at the Madrid Manned Space Flight Network site for Apollo 15. The data from this monitor have indicated that no amplitude modulation at the frequencies critical to antenna stability existed on the uplink during the problem times. Consequently, incidental amplitude modulation has been eliminated as a possible cause of the antenna oscillations, and the problem must be in the spacecraft.

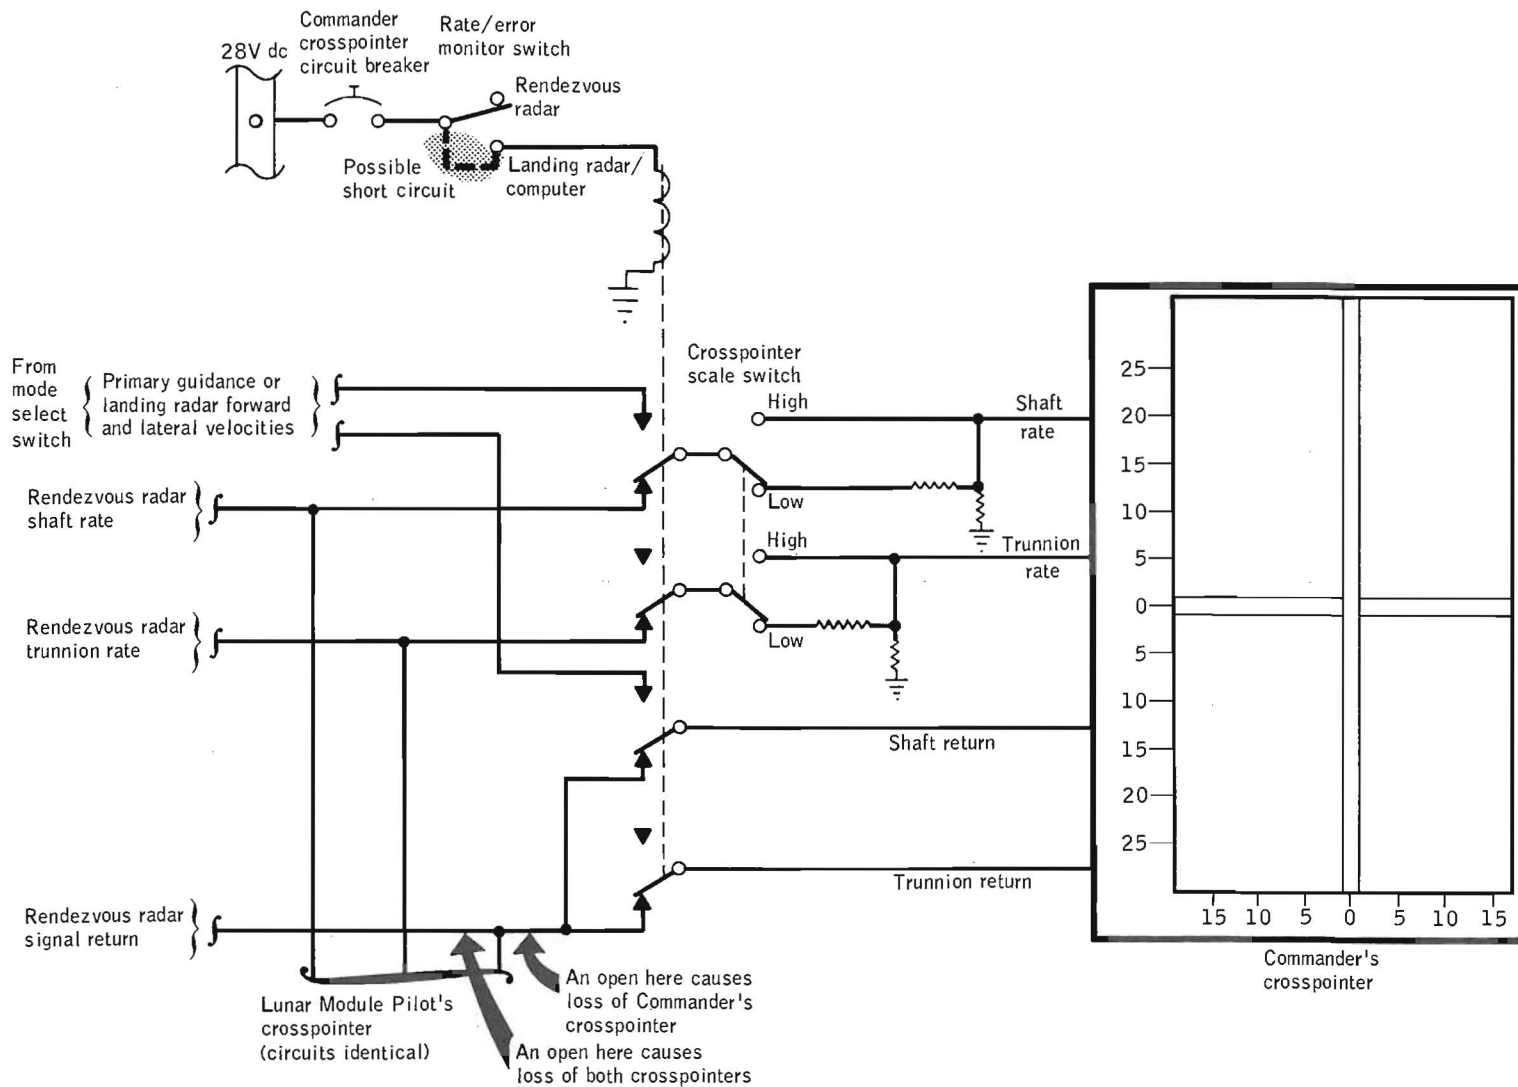
Figure 3-10.- Simplified schematic of crosspointer circuits.

The Commander reported that there was no line-of-sight rate data on his crosspointers during the braking phase of rendezvous. The existence of line-of-sight rates was verified by visually observing the relative position of the command module. The scale switch was verified to be in the low position; however, none of the other switch positions were verified. The power fail light was reported to be off, indicating that the Commander's crosspointer circuit breaker was properly closed.

Adequate redundancy is built into the antenna display circuits. Even an open in the return line to the rendezvous radar does not mean loss of all rate data. Position data can still be displayed on the flight director attitude indicator error needles, from which rate data could be deduced.

More than likely, the failure was caused by an open in the ground return wire. Ground tests and checkout may not show this type of failure. If the open is temperature sensitive, a complete vehicle test involving vacuum, temperature, and temperature gradients would be required to insure that failures of this type would not occur in the flight environment.

This type testing is not practical at the vehicle level, consequently, no corrective is planned.

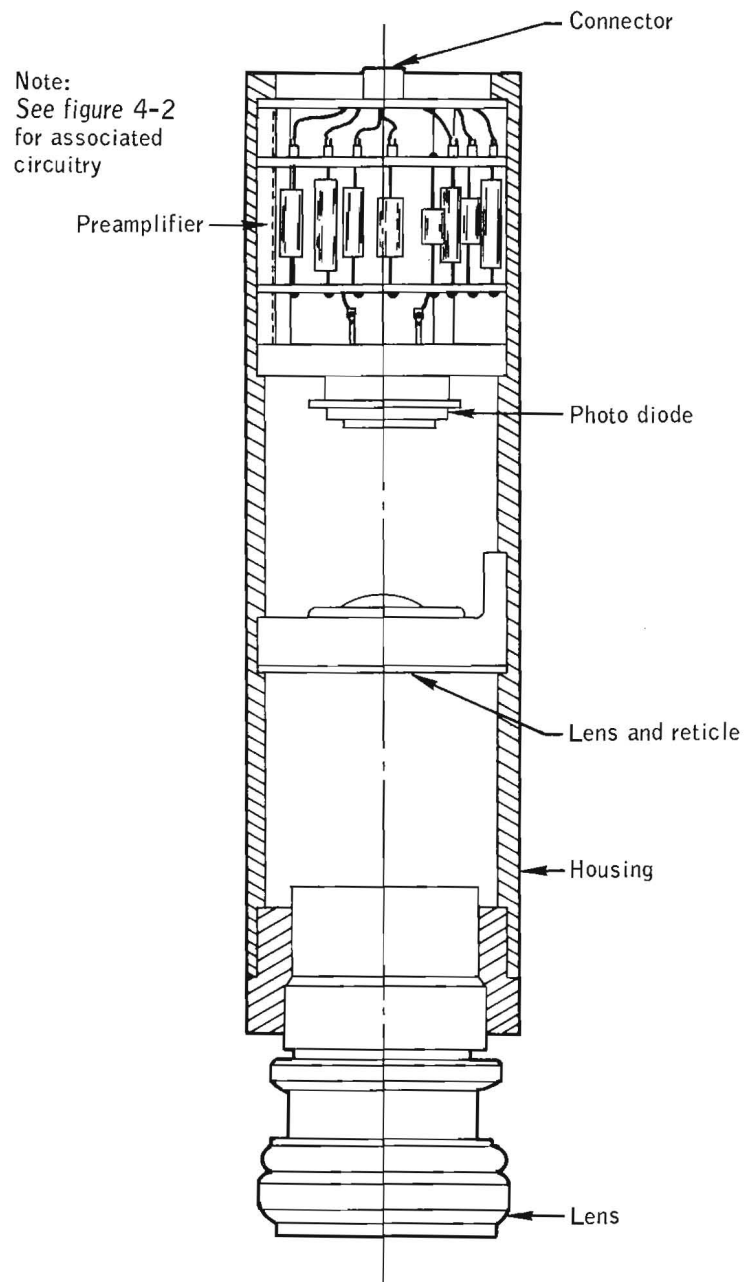
Figure 4-1.- Velocity/altitude sensor assembly.

Telemetry received from the first panoramic camera pass on revolution 4 indicated the velocity/altitude sensor (fig. 4-1) was not operating correctly.

Telemetry indicates that the velocity/altitude sensor tended to operate properly for brief periods of time, but would drift off-scale high (saturate), and then reset to the nominal value corresponding to a 60-nautical-mile altitude. Evaluation of the velocity/altitude telemetry data indicates that approximately 75 percent of the photography should be of excellent quality, with the remainder degraded to various degrees. Preliminary viewing of the developed film did not disclose gross degradation, but an extensive review using a microscope will be required for a valid quantitative assessment of overall picture quality.

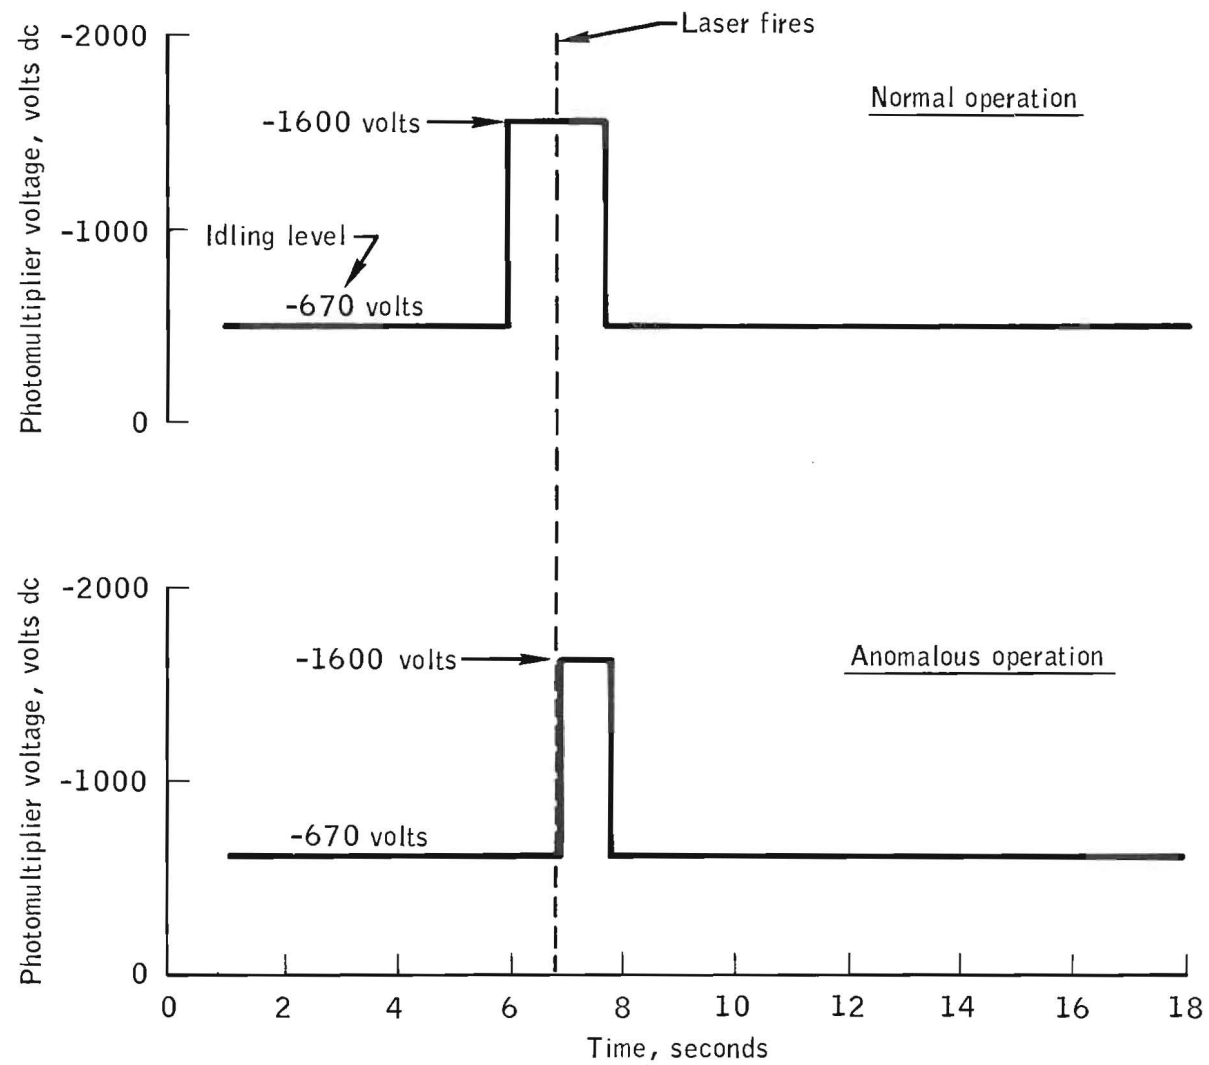
Figure 4-3.- Comparison of photomultiplier power supply voltages.

- a. Altitude data became erratic after revolution 24 as the result of a decrease in the laser output power.
- b. Starting on revolution 38, the photomultiplier tube high-voltage power supply was held in the idling (minimum-voltage level) mode until after the laser was fired, thereby causing the receiver to miss the return pulse from the lunar surface (fig. 4-3). No altitude data were obtained after this anomaly occurred.

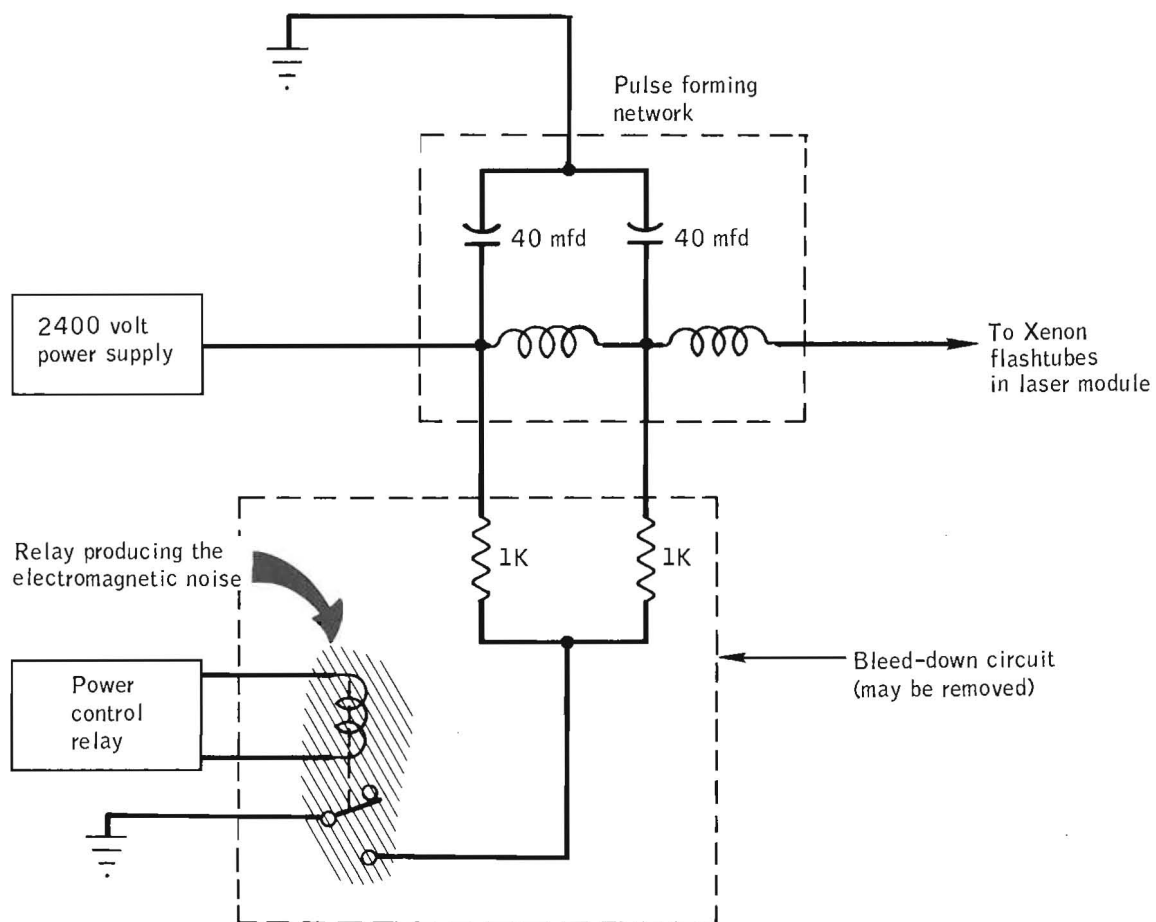
Figure 4-4.- Pulse forming network bleed-down circuit.

A relay which had been removed from a flight unit because it had exhibited an audible "buzz" was installed in the prototype altimeter and the photomultiplier tube power supply anomaly was duplicated. The relay serves no function in flight, but is used as a safety precaution for personnel working on the altimeter (fig. 4-4). The relay contacts close when the altimeter is turned off, thus discharging the high voltage stored on the pulse-forming network capacitors.

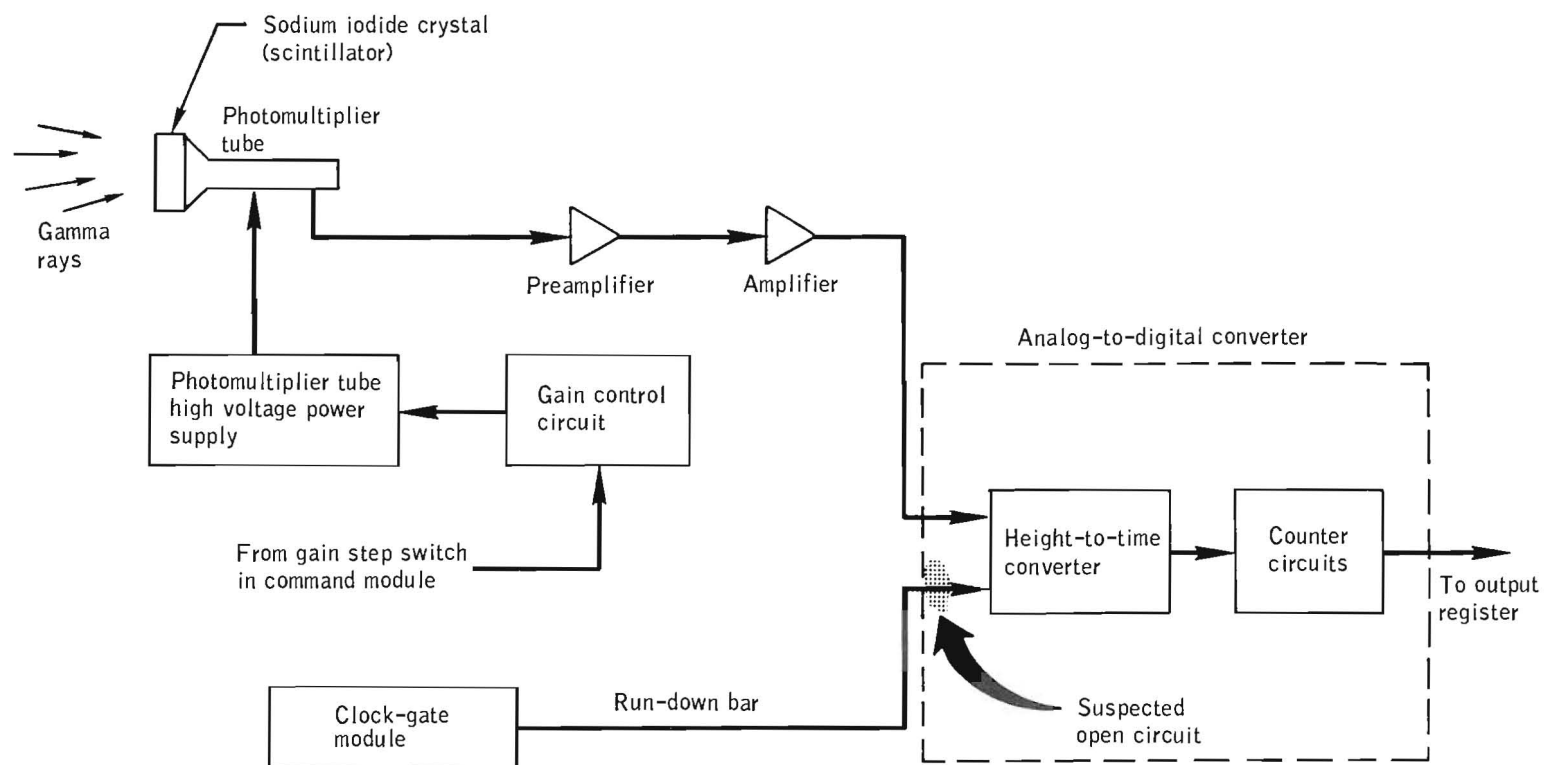
Figure 4-6.- Gamma ray spectrometer circuitry.

Evaluation to date indicates that the change in gain was possibly due to aging effects of the photomultiplier tube in the gamma ray detector assembly as a result of high cosmic ray flux rates in lunar operation. The zero shift appears to be associated with the run-down bar signal between the clock-gate module and the analog-to-digital converter (fig. 4-6). Absence of this signal at a particular point in the analog-to-digital converter removes a 3 microsecond offset in the pulse height analyzer. The resulting effect is an overall six-channel offset in the spectrum.

The qualification unit will be used to verify the gain change phenomenon at flux rates representative of those encountered in lunar operation. Subsequent to this, the qualification unit will be partially disassembled and tests will be performed to verify the nature of the zero-offset shift and identify the probable cause of the malfunction.

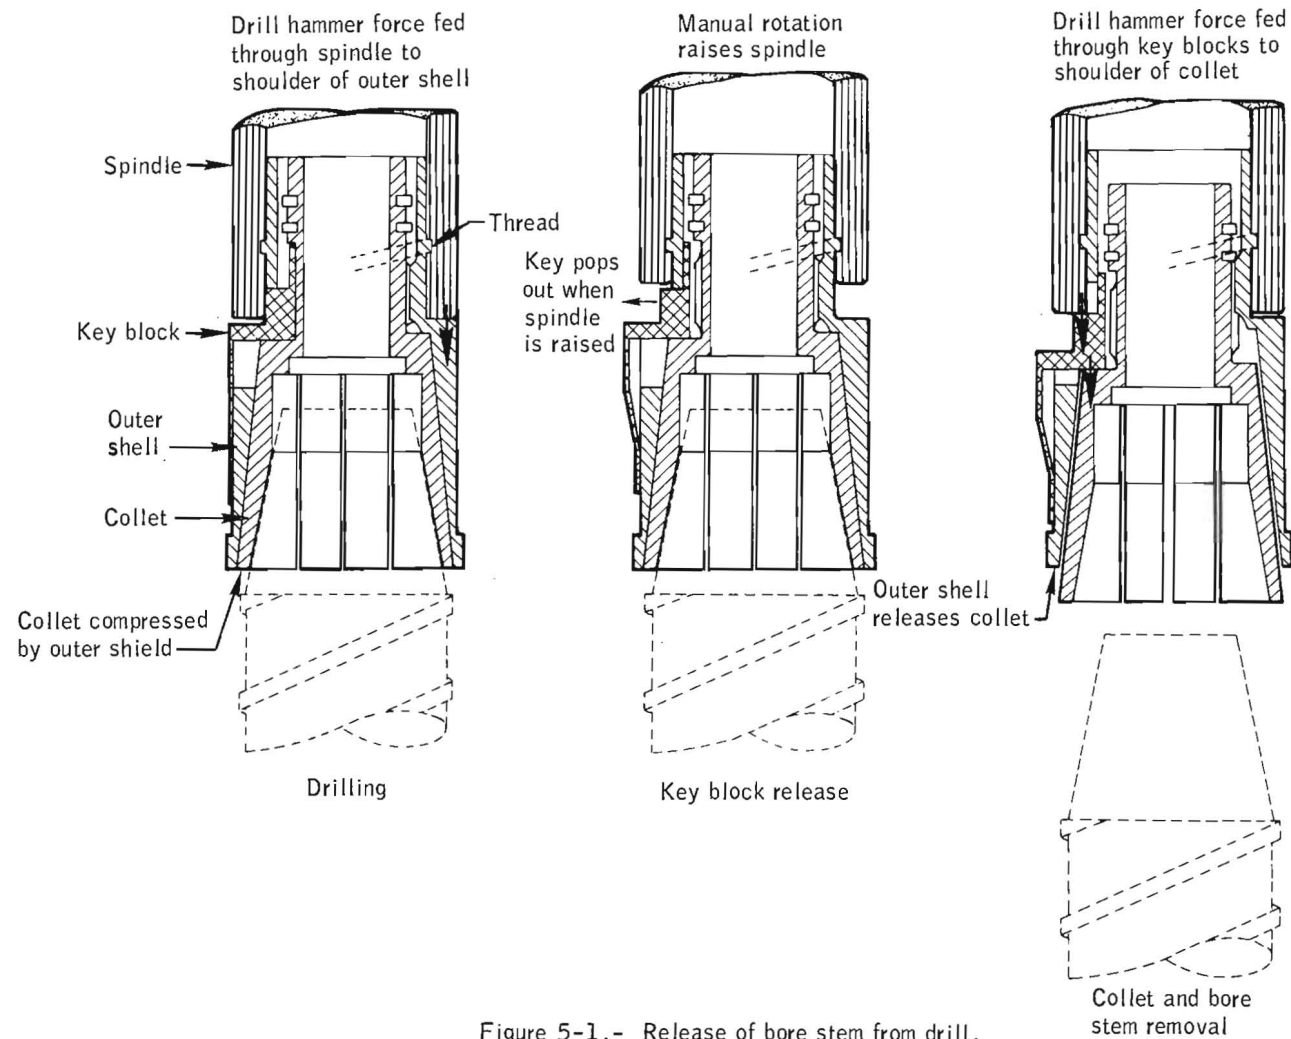
Figure 5-1.- Release of bore stem from drill.

In the bore stem drilling position, the key blocks are restrained inside, and the spindle drives against the shoulder of the adapter outer shell (fig. 5-1). The operational sequence to release the bore stem from the adapter includes the following steps:

The single-purpose core stem wrench is fitted to the 0.983-inch-diameter titanium core stem, but the 1.088-inch throat will admit the 1.075-inch-diameter bore stem. However, the softer bore stem (boron-fiberglass laminate) can be deformed and present some difficulty in wrench removal, with possible damage to the bore stem. Therefore, the wrench should not be used on the bore stem.

Of the bore stem releases accomplished in the two heat flow experiment probe locations, most of them were with the gloved hand holding the bore stem, and the collet release mechanism functioned properly.

An improved procedure, as well as possible modifications, for contingency bore-stem holding are being investigated.
