APOLLO 15

30-DAY FAILURE AND ANOMALY LISTING REPORT

SEPTEMBER 1971

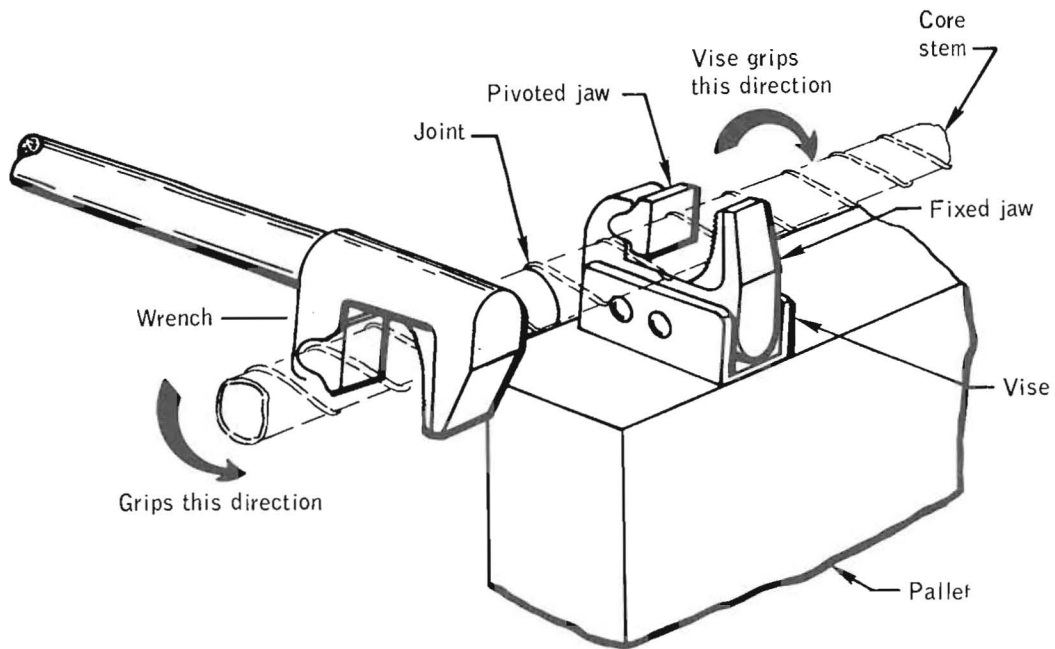
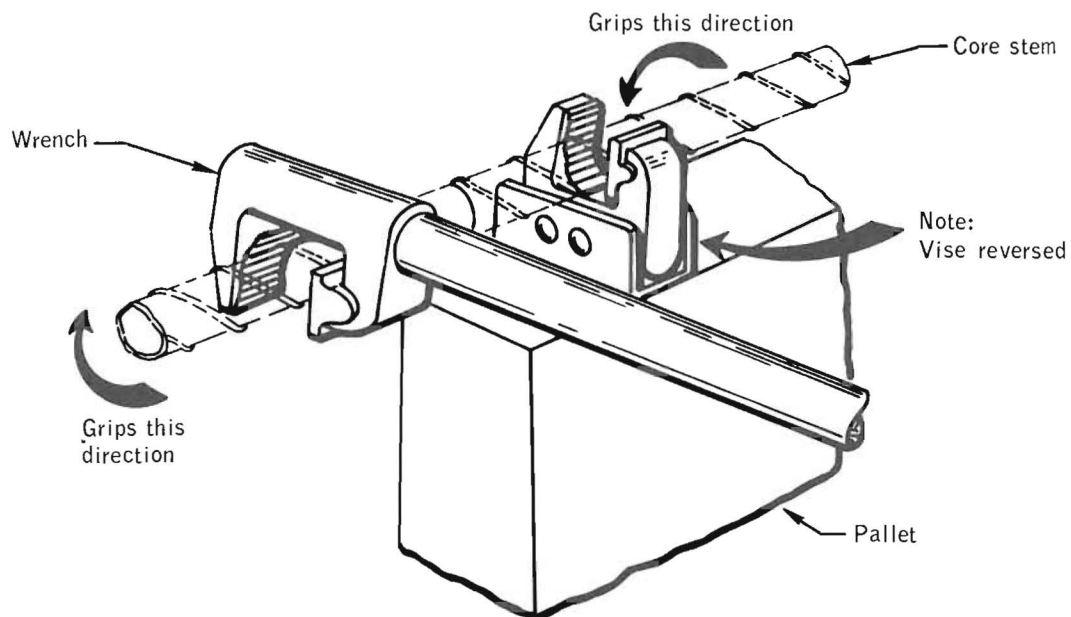
Figure 5-2.- Installation of core stem vise on rover pallet.

The wrench could be rotated to tighten, but not in the opposite direction to loosen and separate (fig. 5-2). There is insufficient clearance on the inboard side of the vise for wrench rotation, and the distance to the other side of the lunar roving vehicle is greater than the length of a core stem section.

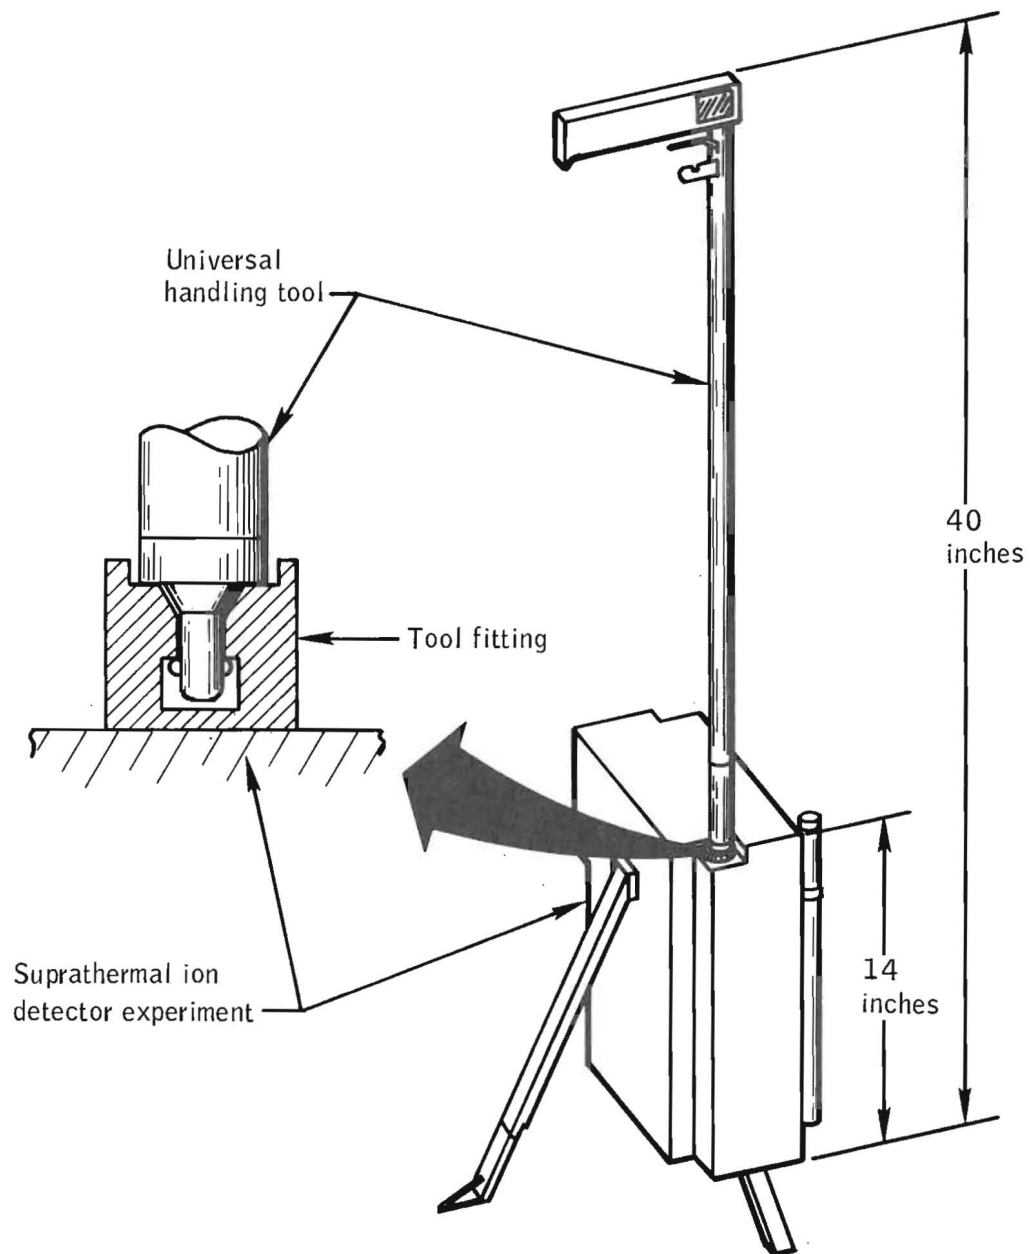
Figure 5-4.- Universal handling tool - suprathermal ion detector experiment interface.

While carrying the suprathemal ion detector experiment from the subpallet to the emplacement site, the experiment fell off the universal handling tool at least twice. The experiment experienced no visible damage and has been operating satisfactorily.

Corrective action under consideration includes procedures to avoid inadvertent tool release triggering because of the positioning of the tool. The suprathermal ion detector experiment is not presently planned for any future missions.

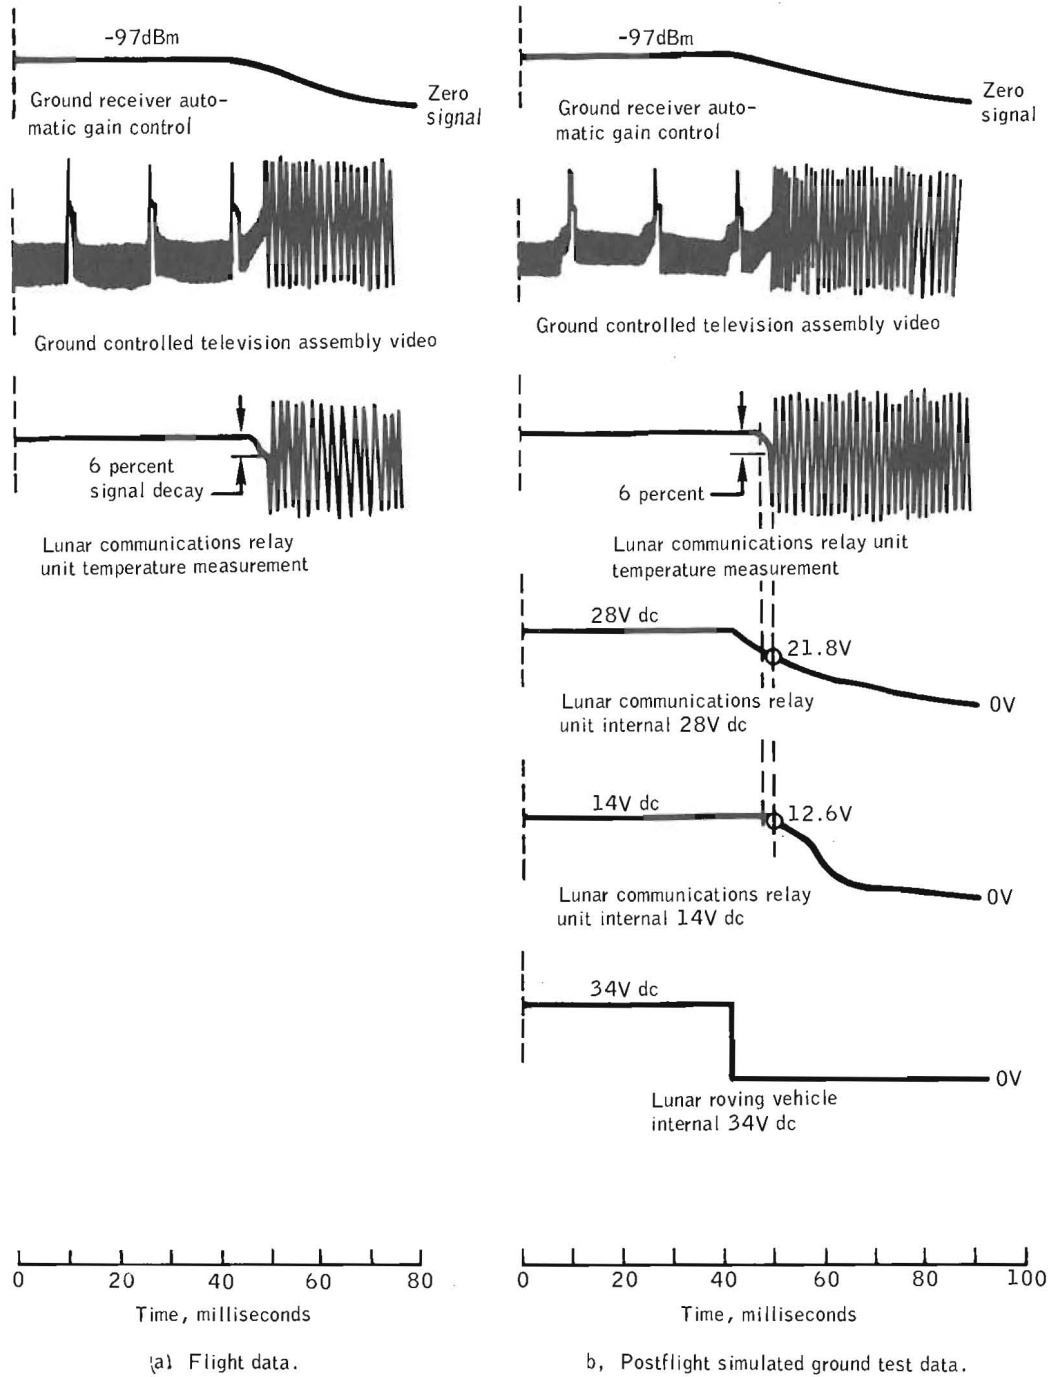
Figure 6-2.- Loss of power to lunar communications relay unit.

The lunar communications relay unit downlink signal was lost at 211:30:08, about 40 hours after lunar module ascent. The lunar communications relay unit operates on internal battery power during the extravehicular traverse but, just prior to the end of the third extravehicular

activity, the unit was manually switched to external lunar roving vehicle power in preparation for viewing lunar module ascent and for continuing television observations until 6 days after ascent. The power distribution from the lunar roving vehicle to the television is shown in figure 6-2. The television and transmitter had been commanded on from the ground 13 minutes prior to RF downlink signal loss. The lunar communications relay unit status subcarrier had been commanded on 7 minutes prior to signal loss. The television camera was stationary and a 1-second incremental iris movement was occurring at this time.

The signal deterioration transient characteristics from flight and postflight test data are shown in figure 6-3. The flight data shows that the automatic gain control measurement began to fall (transmitter power falls as 28-volt dc power decreases) followed by the video signal decay which, in turn, was followed by the decay of the lunar communications relay unit temperature measurement (temperature measurement falls as 14-volt dc power decreases). The RF signal level then decreased below the ground receiver's threshold as indicated by complete signal loss. The overall loss of the downlink signal within 5 milliseconds is indicative of 28-volt dc power loss. Decay of the temperature measurement is indicative of 16.5-volt dc power loss. The lunar communications relay unit dc-to-dc converter (fig. 6-2) supplies both the 28-volt and 16.5-volt dc power. To verify loss of 16.5-volt power, an uplink voice signal was transmitted to key the VHF transmitter on. No signal was received on the Stanford 150-foot VHF antenna which indicates that the VHF transmitter, powered via 16.8-volts dc, was inoperative.
