**Aerospace
Systems Division**

54L ALERT
BxA Response Summary

ATM 1081

DATE 30 March 1972

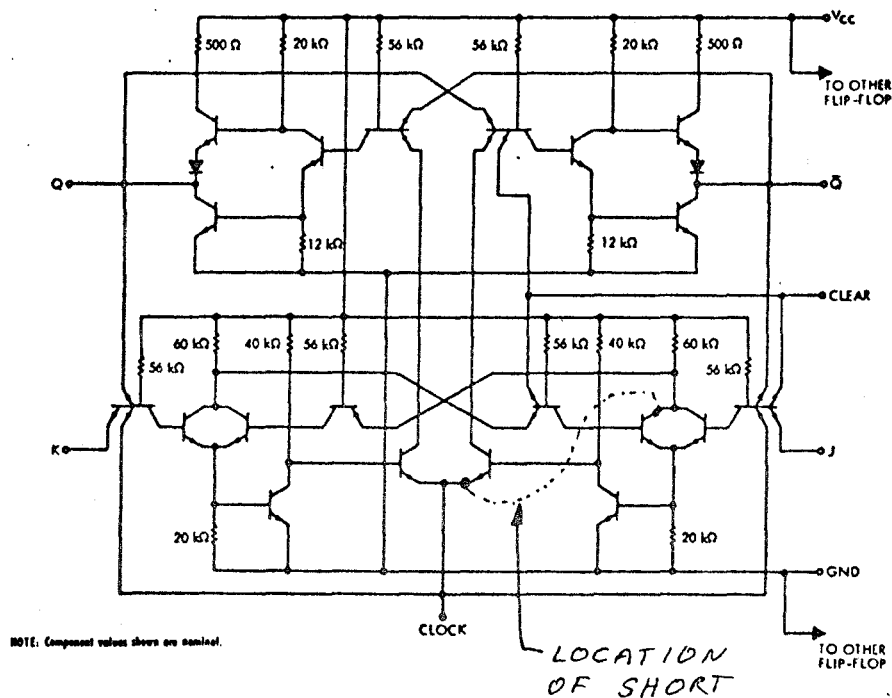
schematic (each flip-flop)

7. By tracing through the circuitry on the chip, the location of the short in the circuit on the circuit diagram was determined. The theoretical failure mode introduced by a short in this position exactly duplicated the observed failure mode. Figure 1 shows the location of the short in the circuit diagram.
