**Aerospace  
Systems Division**  
5-9-67

Prototype Experiment  
Pre-Integration, Integration  
& Crosstalk Test Results

NO.  
ATM 657

This ATM describes the test results of the Pre-Integration ,  
Integration and Crosstalk Tests performed on the Passive Seismic,  
Magnetometer and Solar Wind experiments, thru the period of March  
-April 1967.

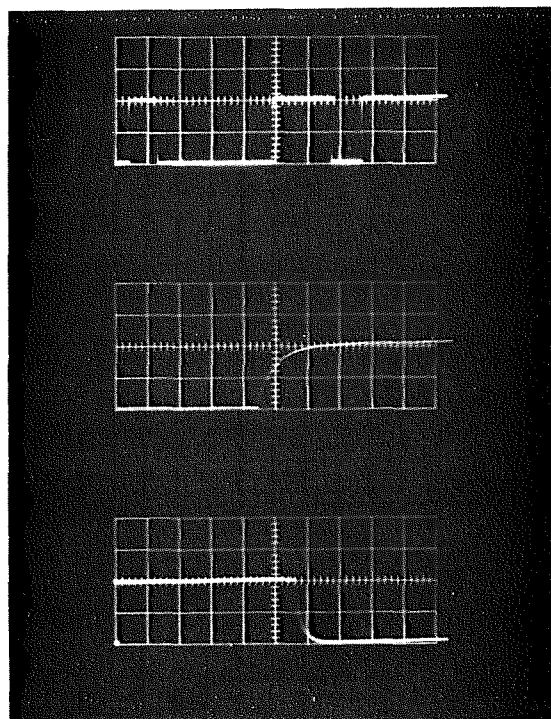
Figure 4.3.4 Shift Pulse Rise & Fall Time

Information  
Only

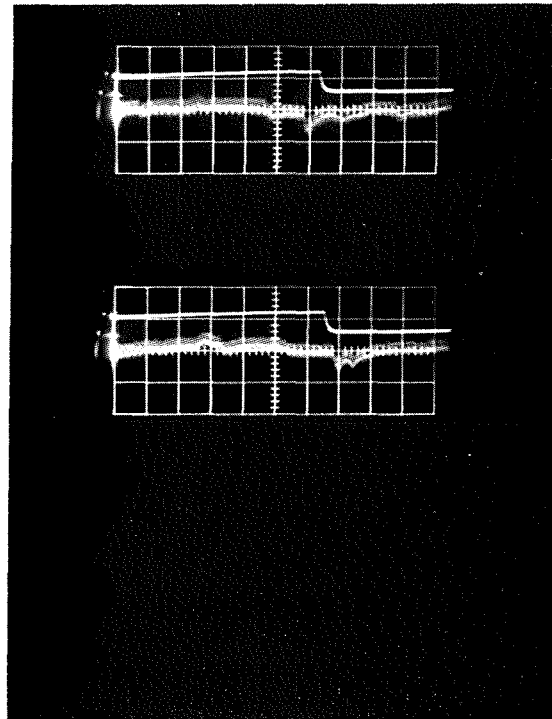
Figure 4.3.6 CCGE Analog Line Noise with Fall of  
Shift Pulse Housekeeping Channel 85

Information  
Only

<u>PROBLEM AREAS</u>	<u>ICS PARAGRAPH</u>	<u>ICS VALVE</u>	<u>REMARKS</u>
1. Noise on data lines	N/A	N/A	There is no ICS for this experiment. Typical ICS valve for this item is 100 MV p.p. See Figure 4.3.6
