**Aerospace  
Systems Division**

April Engineering Model  
Test Progress Report

ATM-661

APRIL 1967

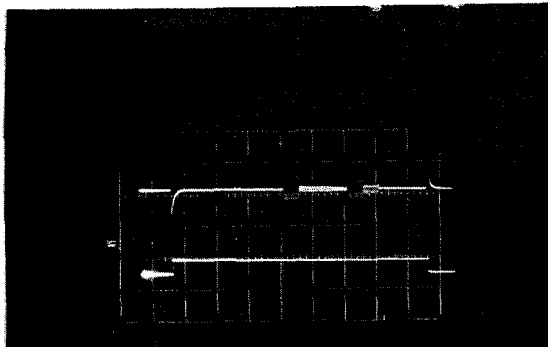
Figure 3.2-2 HFE Analog  
Line #1 Noise

An EMI problem was detected during inspection of the analog signal interface between the HFE and the Central Station during Category #2 tests. Figure 3.2-1 shows the noise level on the HFE analog line #1 during a full sequence of 90 ALSEP frames, with the experiment on; experiment power off; and with the experiment disconnected from the Central Station. Figure 3.2-2 shows the same noise during the 16 ALSEP frames in which the experiment is active. Figures 3.2-3 and 3.2-4 are similar to Figures 3.2-1 and 3.2-2 respectively but show the HFE analog line #5. Figure 3.2-5 shows the detail of the maximum amplitude of noise recorded on the HFE analog line #5.

1. The noise is not changed by turning the experiment power on and off, and is little changed by disconnecting the experiment from the Central Station.
2. The multiplexer employs a 15 x 6 gate format, and the 15 ALSEP frame repetition period of the noise level is obvious in Figures 3.2-1 and 3.2-3. Appreciable noise can only be detected on frames 8 through 13 of the 15 frame sequence, as shown in Figures 3.2-2 and 3.2-4.

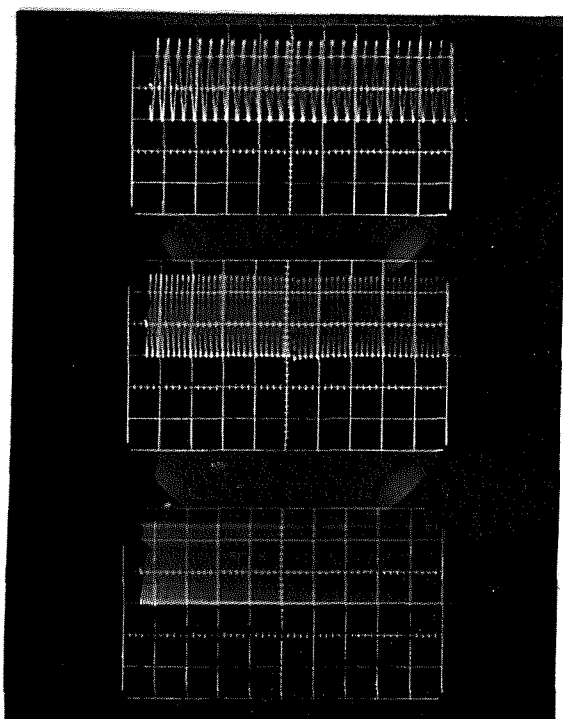
Figure 3.2-5 HFE Analog  
Line #5 Noise

Detail - Max. Noise  
Amplitude

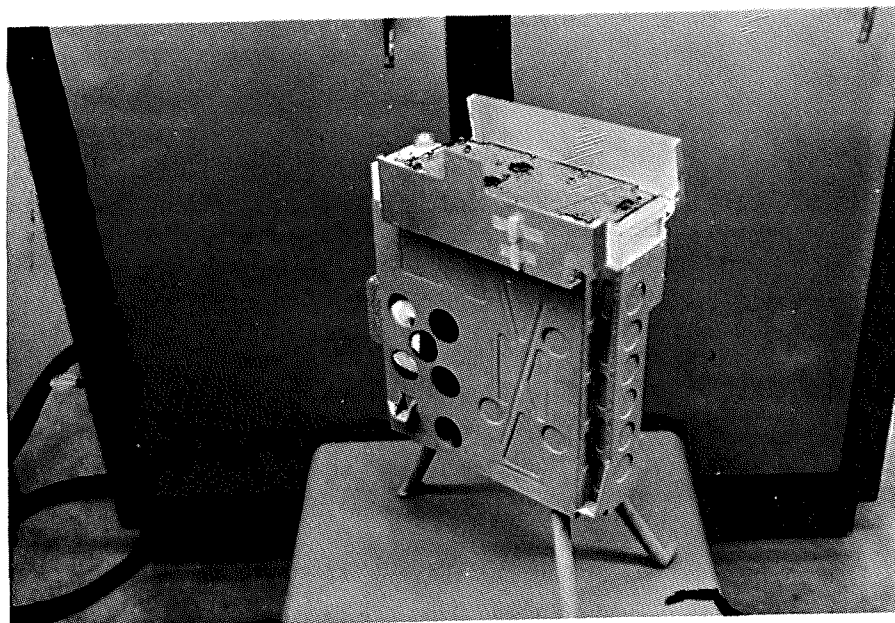
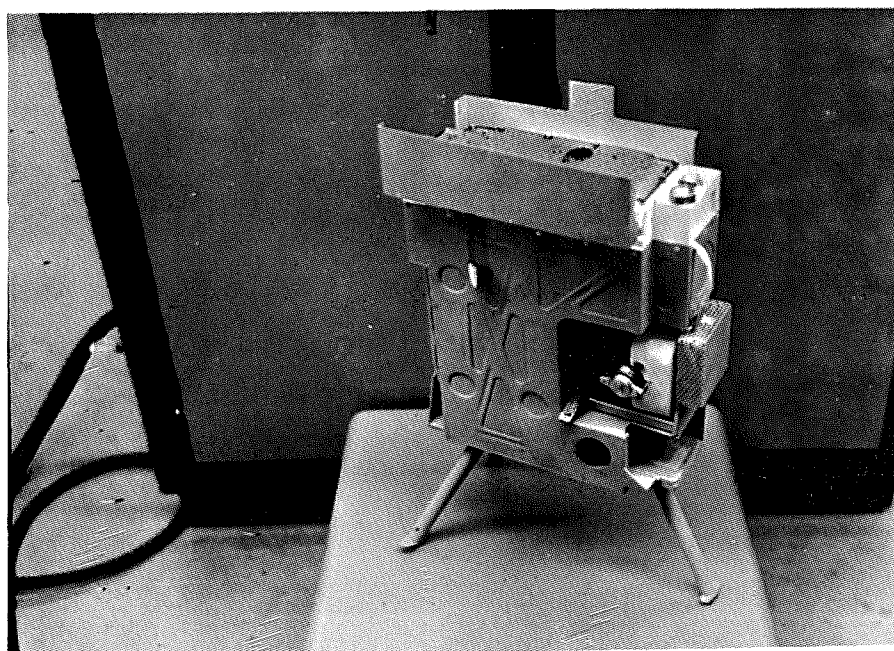
Figure 3.4.1-1 (a) and (b) Two General Views of the SIDE  
Engineering Model

Testing did not proceed smoothly, fifteen unanticipated discrepancies with either malfunctions or incomplete functional operation of the SIDE EM were recorded. The EM had been accepted at BxA with the high voltage supplies locked out and with no power line input current limiter fitted. It was discovered that the dust cover solenoid was also omitted, and it was not apparent from the test results which of the functional problems were due to malfunctions and which were due to omissions. Table 3.4.1-1 lists the discrepancies which were noted during Category #2 tests of the SIDE EM. These are discussed in greater detail in the subsequent paragraphs.

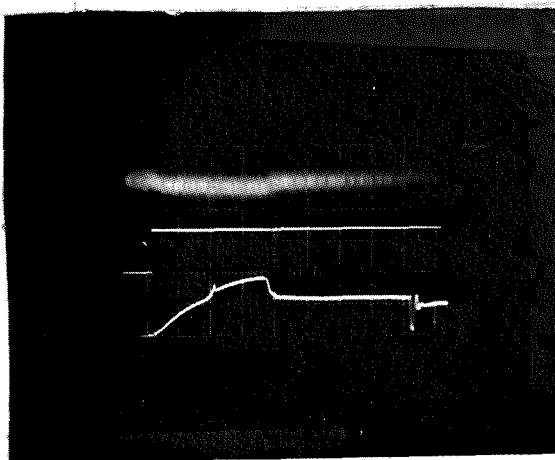
Figure 3.4.2-2 HFE Turn-On Transients

The experiment turn-on power line transients are shown in Figure 3.4.2-2.

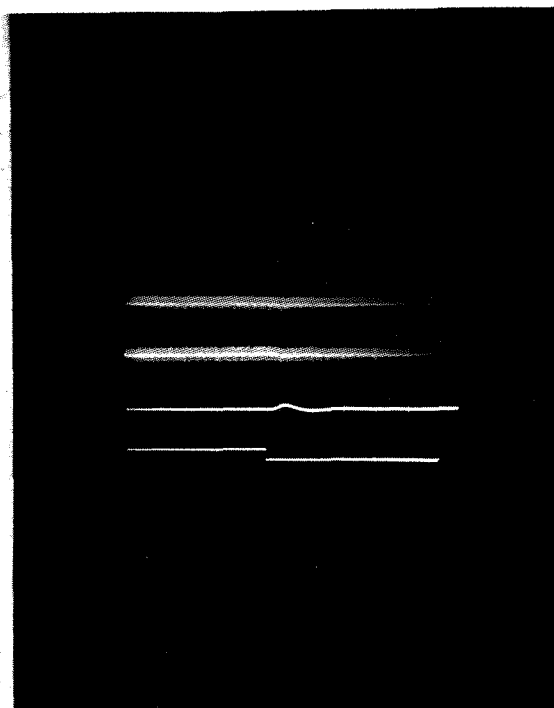
Figure 3.4.2-4 Detail of CCGE Power Profile

The only current variation during normal operation which was observed was a small fluctuation, lasting typically for 2 mS, following the transmission of a data word. A typical record is shown in Figure 3.4.2-4.

Note that the current trace is the sum of the operating power "Off" and the standby Power "On" transients. The oscillation is the standby on current.

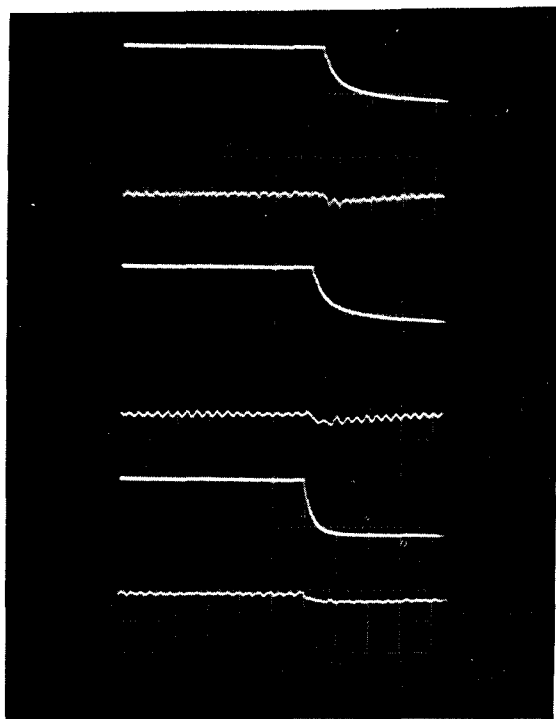
Detail oscillograph records were taken of all the waveforms, and these are available at BxA. The one discrepancy noted was the crosstalk from the shift onto the data line, the amplitude at the fall of the shift was 250 mV p-p. Also a small amount of ripple was present on the data line following the termination of a CCGE word, but this ripple is within the ICS noise limit of 100 mV p-p. The ripple is illustrated in Figure 3.4.2-6, and the shift crosstalk in Figure 3.4.2-7.

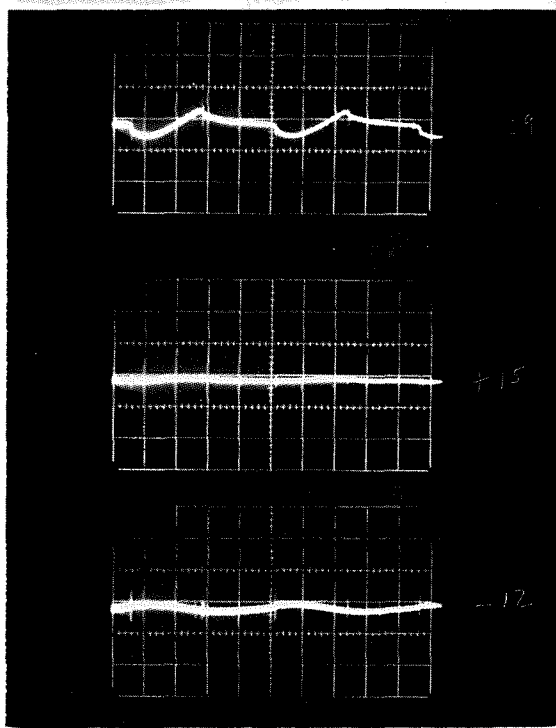
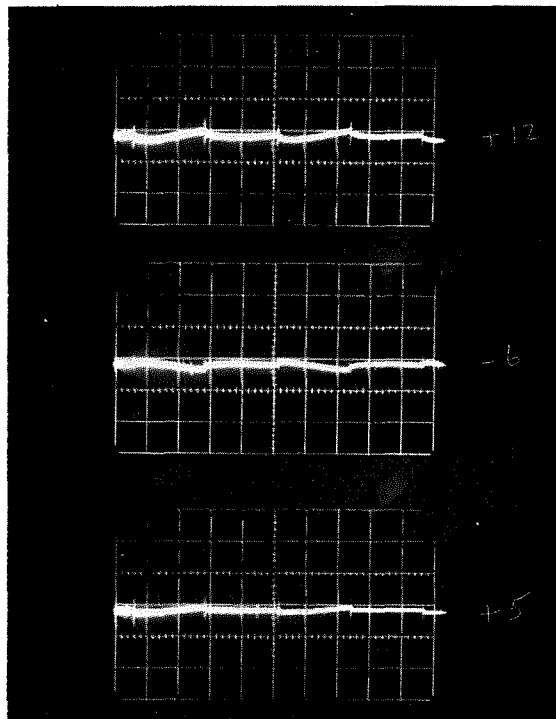
Figure 3.7-1 Prototype PCU #1 Noise

Table 3.7-1 summarizes the results of these tests. As shown the low frequency ripple is within specification of 100 mv noise for all voltages at the PCU output and on the +29V line at the experiments (SIDE signal breakout box). Two values are listed for the high-frequency noise corresponding to characteristic alternate small and large spikes observed. The amplitude of the high-frequency noise on the +29VDC lines at the experiment is greatly diminished by the filtering effects of the experiment circuit protection devices. No apparent difference between PCU #1 and #2 was noted. The test results are shown in Figures 3.7-1 through 3.7-7.

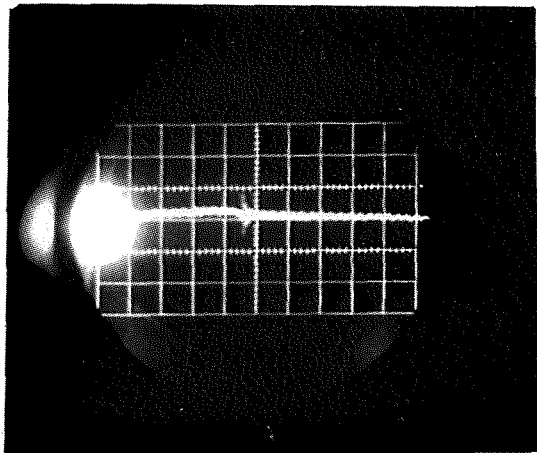
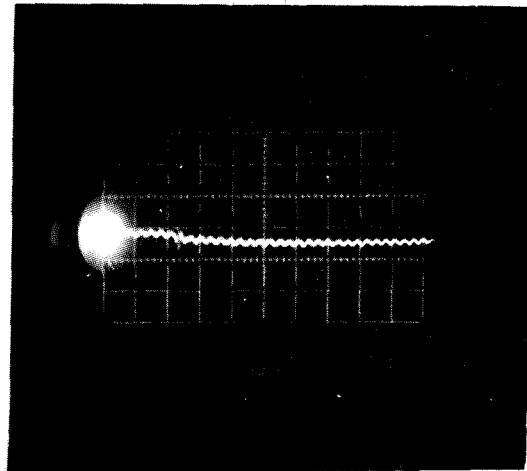
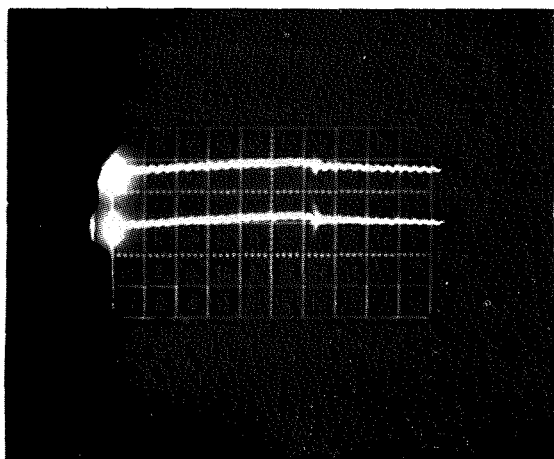
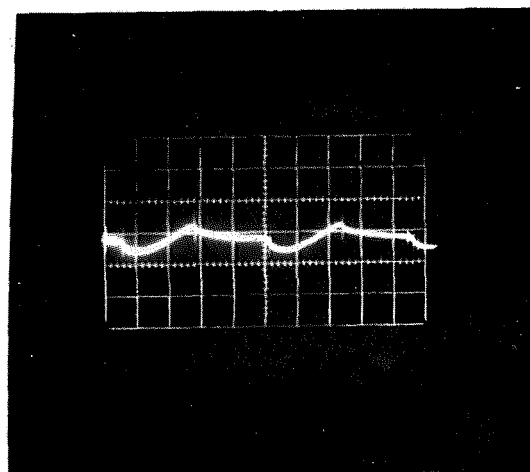
Figure 3.7-6 Prototype PCU Noise

Large Spike at PCU

Small Spike at PCU
