Apollo 12 Preliminary Science Report, NASA SP-235, Washington, D.C., 1970, pp. 217-223.

RESULTS OF EXAMINATION OF THE RETURNED SURVEYOR 3 SAMPLES FOR PARTICULATE IMPACTS

B. G. Cour-Palais, R. E. Flaherty, R. W. High, D. J. Kessler, D. S. McKay, and H. A. Zook

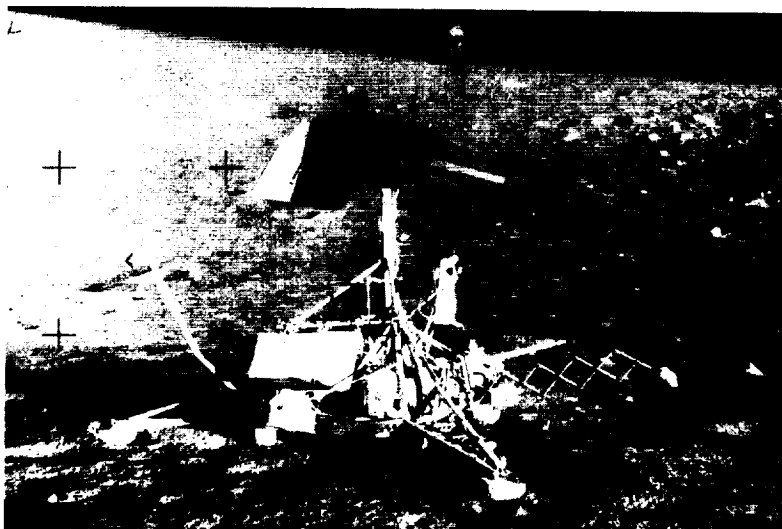
FIGURE 1.—View of the Lunar Module from the Surveyor 3 spacecraft.

Apollo 12 landed about 155 m northwest of the Surveyor 3 spacecraft (ref. 1). This closeness is dramatically shown in photographs taken by the astronauts. (See fig. 1.) From such photographs, it is obvious that the LM landed on the rim of the Surveyor crater, and is approximately sitting on the horizon as seen from the Surveyor spacecraft. Note from figure 1 that the front, flat surface of the Surveyor television camera is approximately parallel to a line joining Surveyor 3 and the LM. This is also confirmed by correlating certain craters in figure 1 and those of reference 2. Such a correlation puts the LM at a camera azimuth of about 90° . Also, from reference 2, it is found that the camera is leaning toward the LM, and that the horizon, in the direction of the LM, is at a camera elevation of 25° .

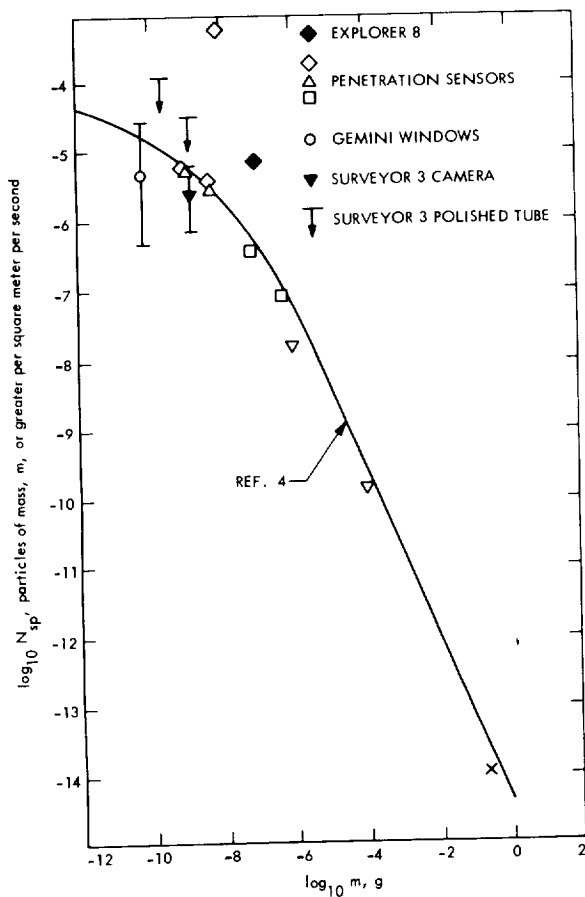
FIGURE 3.—Comparison of Surveyor 3 meteoroid flux with measured flux near Earth.

probable meteoroid mass of $10^{-8.5}$ to $10^{-9.0}$ g, then the corresponding point agrees well with Earth-orbital penetration data as shown in figure 3.

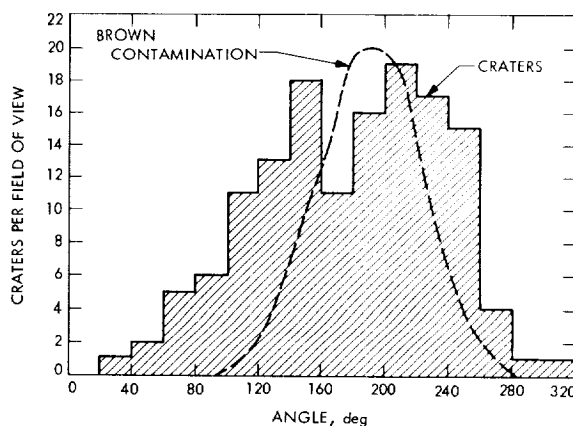
Figure 10 shows the number of craters with diameters of $20\ \mu\text{m}$ and larger that were observed in the field of view of an optical microscope at $100\times$ magnification (corresponding to an area of about $1\ \text{mm}^2$). Counts were taken as a function of angle around the tube from the scribe line, which had been ruled along the tube before cutting. This histogram is an average of two trials on section B of the tube. Very high pit densities (up to 40 per field of view) were obtained in two places, but were obviously associated with scratches and so are not included in figure 10. The reduced count rate about 170° from the scribe line is not considered significant.

Also shown in figure 10 is a measure of the relative amounts of brown contamination on section B as a function of angle around the tube. This curve was obtained by photographing the

tube at each angular position, as the tube was rotated and the lighting held constant. The contamination stood out in the photographs between the angles of 100° and 280° and seemed to peak at about 190° . Outside of these angles, section B was relatively clean. The relative heights of the ordinate of the contamination curve in figure 10 are not quantitatively significant. A high ordinate means that the photograph indicates "high" contamination relative to an angular position with a ordinate. It is immediately evident that there is a close association between the pitting rate and density of the brown contamination.

FIGURE 10.—Distribution of brown contamination and of impact craters.
