Apollo 12 Preliminary Science Report, NASA SP-235, Washington, D.C., 1970, pp. 217-223.

PART E

RESULTS OF EXAMINATION OF THE RETURNED SURVEYOR 3 SAMPLES FOR PARTICULATE IMPACTS

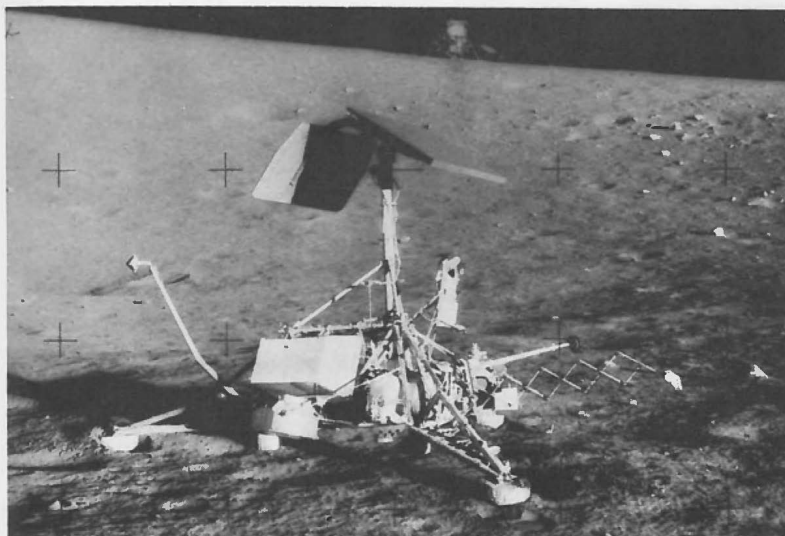
FIGURE 1.—View of the Lunar Module from the Surveyor 3 spacecraft.

Apollo 12 landed about 155 m northwest of the Surveyor 3 spacecraft (ref. 1). This closeness is dramatically shown in photographs taken by the astronauts. (See fig. 1.) From such photographs, it is obvious that the LM landed on the rim of the Surveyor crater, and is approximately sitting on the horizon as seen from the Surveyor spacecraft. Note from figure 1 that the front, flat surface of the Surveyor television camera is approximately parallel to a line joining Surveyor 3 and the LM. This is also confirmed by correlating certain craters in figure 1 and those of reference 2. Such a correlation puts the LM at a camera azimuth of about 90° . Also, from reference 2, it is found that the camera is leaning toward the LM, and that the horizon, in the direction of the LM, is at a camera elevation of 25° .

tioned by the astronaut can also be seen on the Surveyor spacecraft in figure 1.

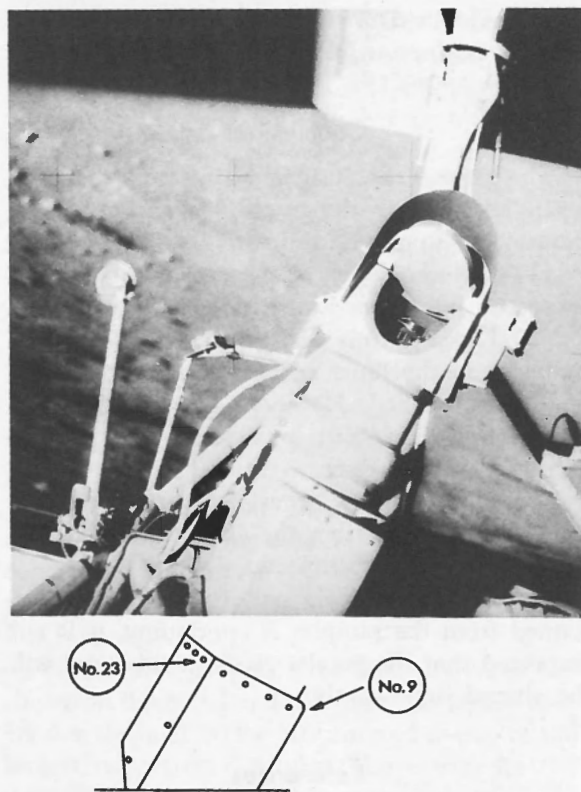
FIGURE 1.—Positions of screws 9 and 23 on the Surveyor 3 spacecraft.

tograph, screw 23 can be seen to point above the Moon's horizon at an angle of 66.6° with respect to the local upward vertical direction. Screw 9 points toward the lunar surface at the same angle with respect to the local downward vertical direction (ref. 2). Therefore, impact craters from extra-lunar particles may be expected primarily on screw 23, possibly together with low-velocity

The positions of the screws on the Surveyor 3 spacecraft are shown in figure 1. From this pho-

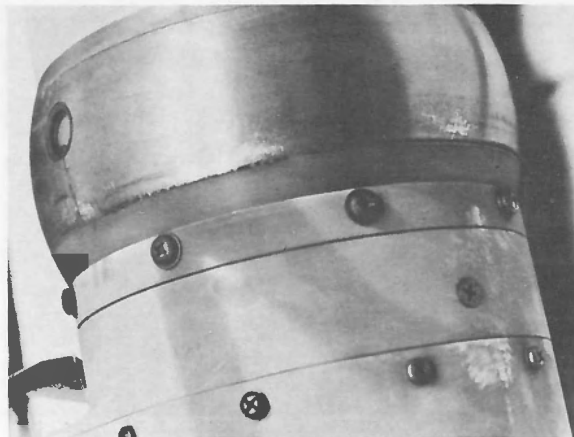
FIGURE 8.—Shadows of the attachments on the television camera housing.
