HIGHER MAGNIFICATION IMAGING OF THE POLISHED ALUMINUM COLLECTOR RETURNED FROM THE GENESIS MISSION. M. C. Rodriguez¹, P. J. Burkett², J. H. Allton³; ¹Geocontrol Systems- ESCG at NASA/Johnson Space Center, Houston, TX 77058; melissa.rodriguez-1@nasa.gov, ² Jacobs- ESCG at NASA/Johnson Space Center, Houston, TX 77058, ³ NASA/Johnson Space Center, Houston, TX 77058.

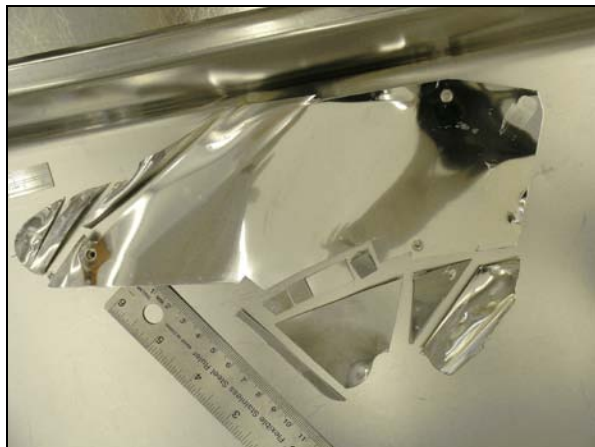
Previous and current subdivision. The collector (sample number 50684.0) has been subdivided by the use of a small handsaw in 2005 and further in 2010, resulting in 18 subsamples (Fig.1). Orientation of the cuts during subdivision of the collector was dictated by the desire to provide specific areas of flat surface for analysis by rastering techniques. The orientation was also controlled by the restrictions for securing the collector for the sawing process (attachment points). Two suspected hypervelocity impact craters (both approximately 30 μm in diameter) were reported [3] and were specifically removed in the subdivision of 2010. Analysis of the craters is reported by [4]. To date, 36 cm^2 (14%) of the total area (245 cm^2) has been allocated for scientific study.

Fig. 1. Overview image of the remaining polished aluminum kidney after the most recent subdivision.
