Apollo 17
ALSEP
Array "E"
OPERATIONS PLAN
ATR-341

August 1972

BENDIX AEROSPACE SYSTEMS DIVISION

NASA Lunar Experiments Project Office

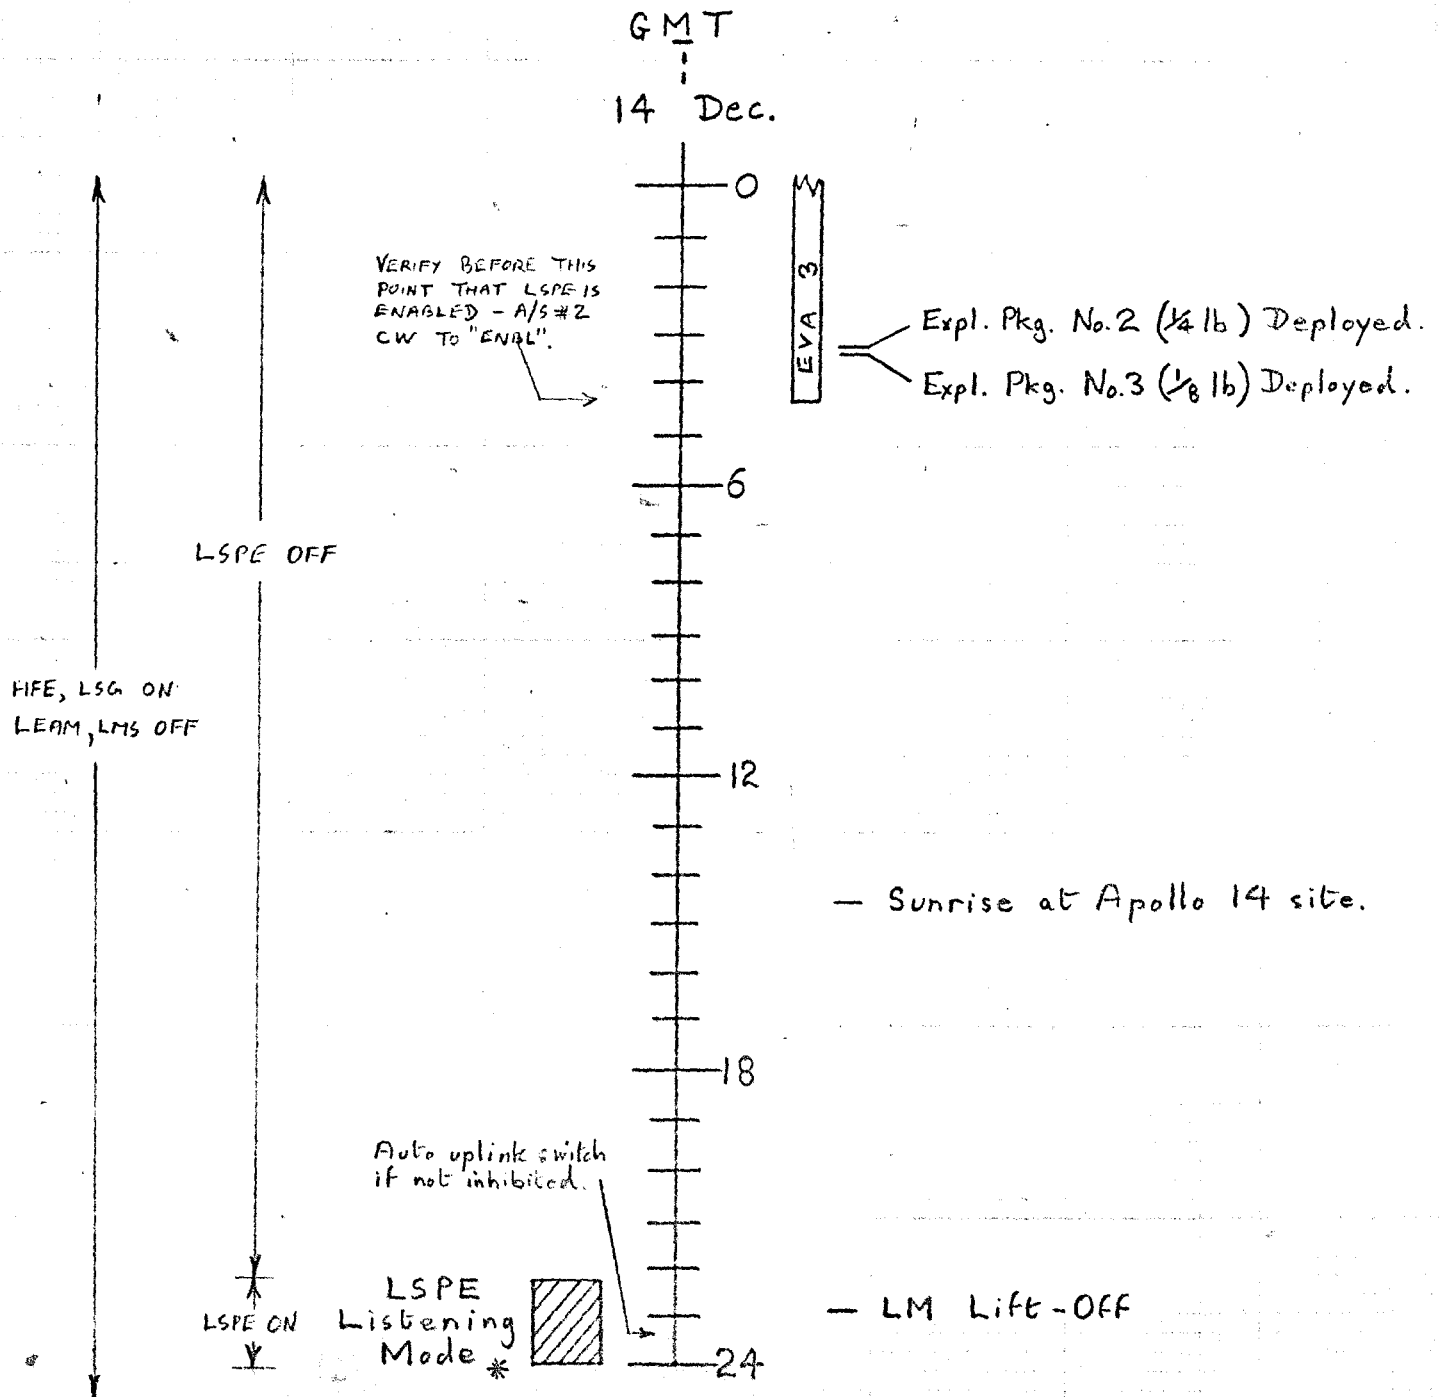
TABLE 2.1(c) INITIAL OPERATIONS SEQUENCE

* DURING LSPE FORMATTING PERIODS, DATA FROM OTHER EXPERIMENTS IS NOT TRANSMITTED. IT MAY BE DESIRABLE TO COMMAND HFE AND/OR LSG TEMPORARILY TO OFF OR STANDBY, BUT THERE IS NO GENERAL SYSTEM REQUIREMENT OR ADVANTAGE IN SO DOING.

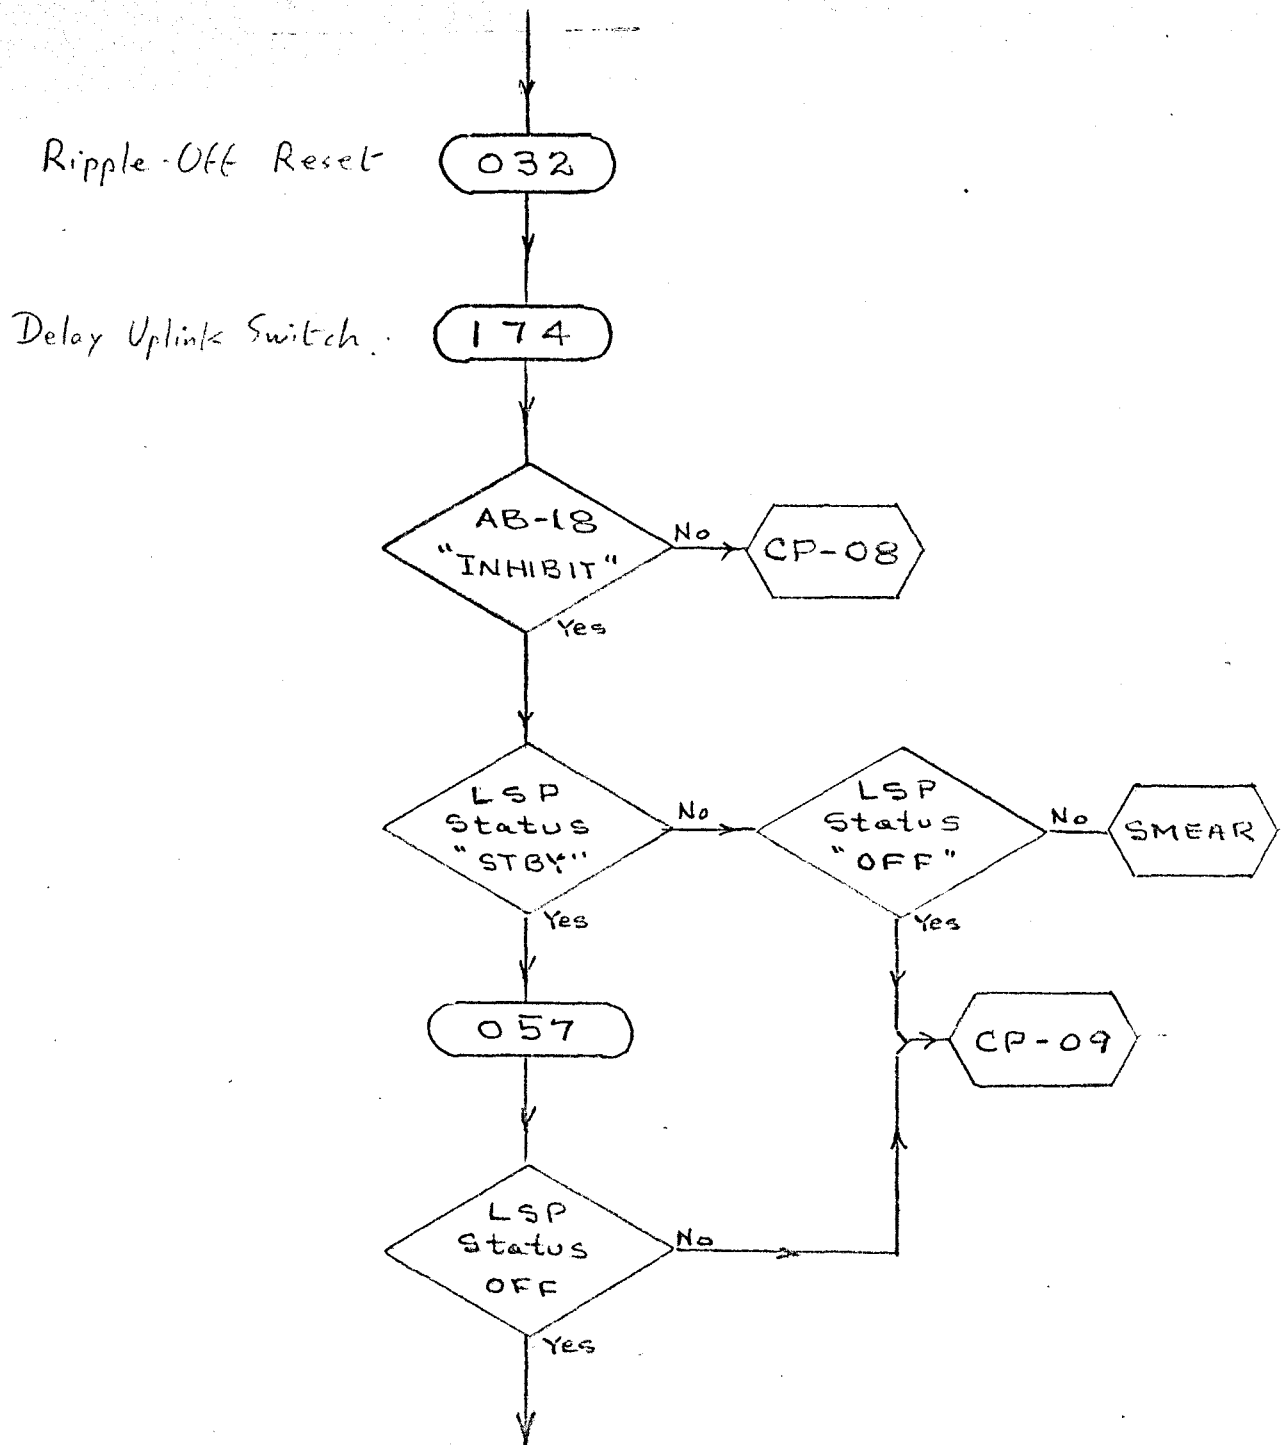
Figure 2.2-1 (c)

- Confirm that A/S #2 may be safely turned CW, to "ENBL".
- Proceed immediately to HFE initialization sequence (2.2.4).

The first level of contingency decisions are included in the flow diagram of the procedure (Figure 2.2-1), and, where appropriate, reference is made to the recommended contingency procedure (CP) presented in Section 3.

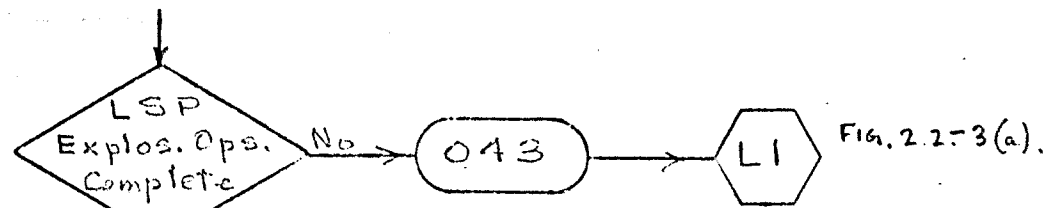
Figure 2.2-3 (b)

This sequence is to
be delayed until system
is 50 hours into first
lunar night

The initialization sequence presented in Figure 2.2-3 indicates that LEAM is turned OFF after the brief initial check-out until after conclusion of LSP explosive package operations, when the experiment is activated and the mirror cover released. LEAM operates in this mode until 2 days of lunar night environment have elapsed, at which time the sensor covers will be released allowing normal operation to begin.
